alan johnston partnership  
Consulting Structural & Civil Engineers

Ref. 219-390

# STRUCTURAL INSPECTION REPORT

Blackpool Victoria Hospital, RAAC units

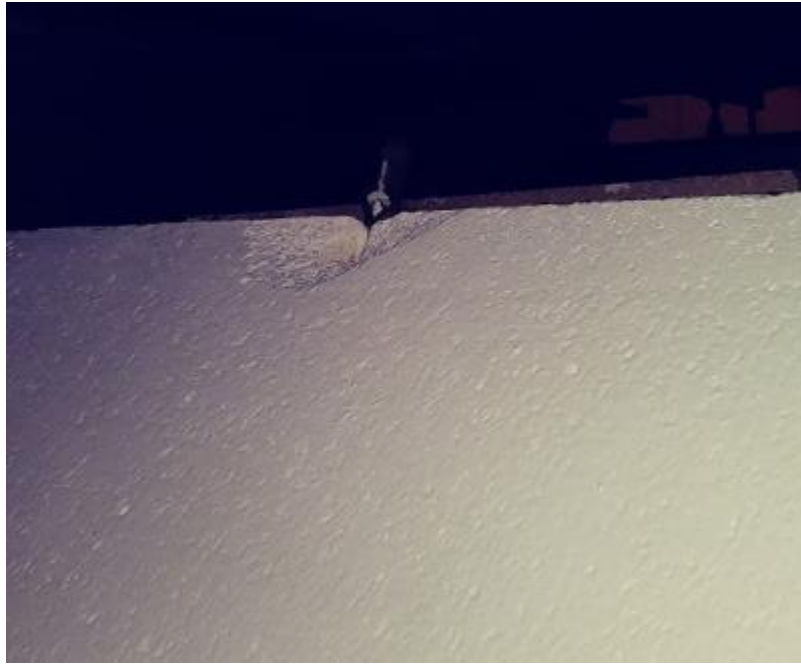
***BROKEN CONCRETE AT FIXING LOCATION***

These findings suggest that many of the panels are nearing the end of their useful life, and deterioration is light/moderate. The extent of the deflection of the horizontal planks which form the valley gutters is concerning. It will be necessary to undertake a more detailed inspection following the removal of the timber panels which prevent a clear view of the RAAC units.

The units may will require full scale replacement with an alternative construction such as structural steel metal deck. Alternatively, it may be possible to prolong the building service life with the introduction of additional steelwork to reduce the current span of the planks by approximately 50%.

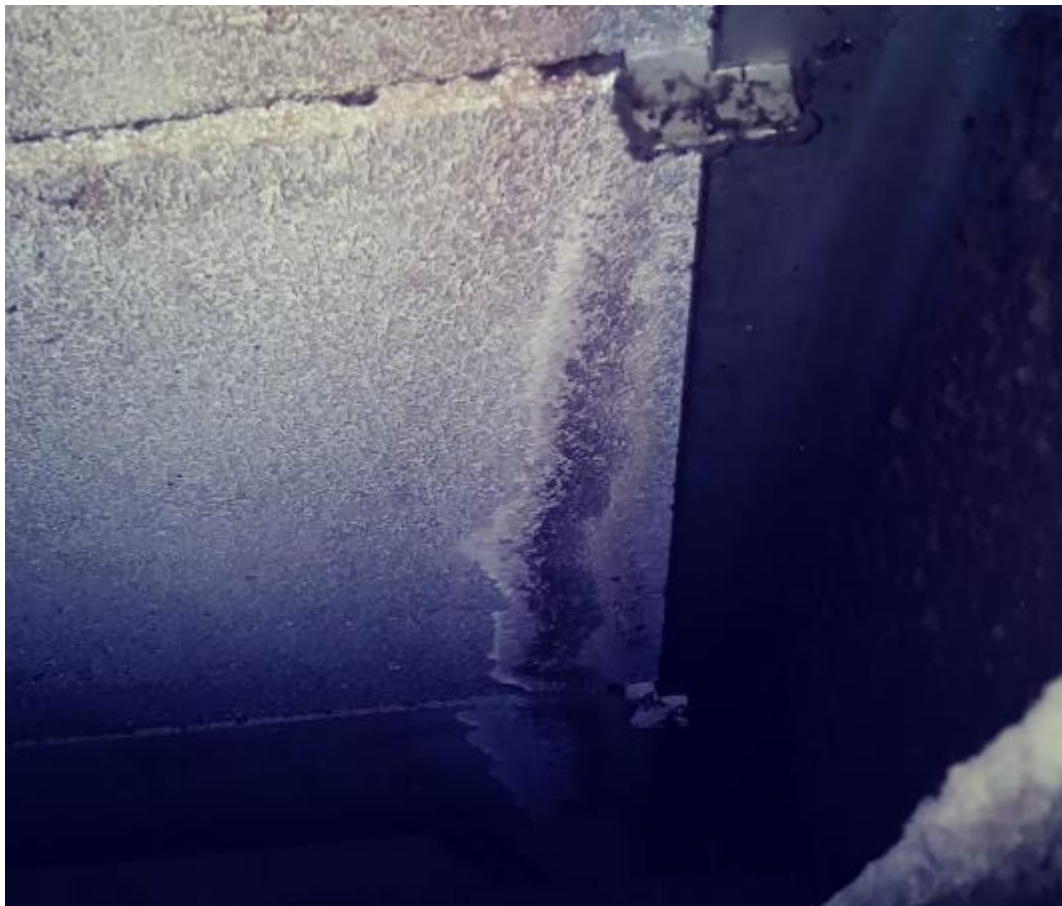
***SPALLING CONCRETE AT SUPPORT***

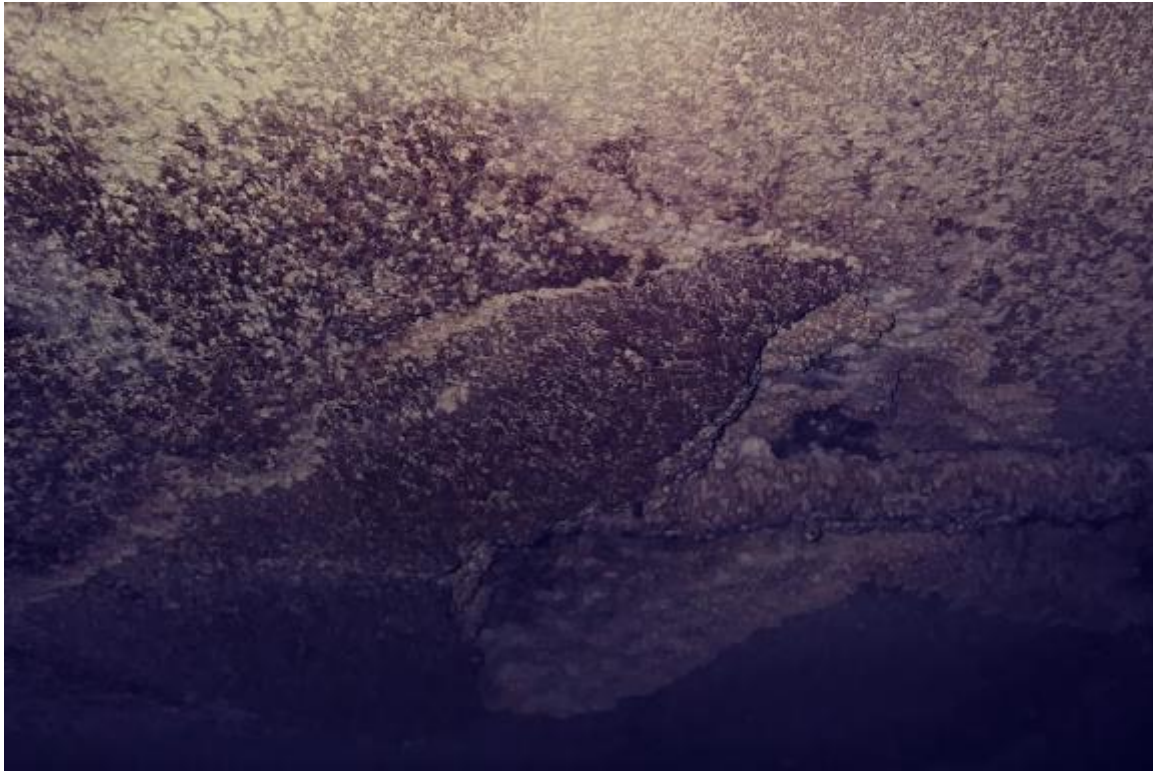
***SPALLING OF CONCRETE NEAR ROOF COWL***

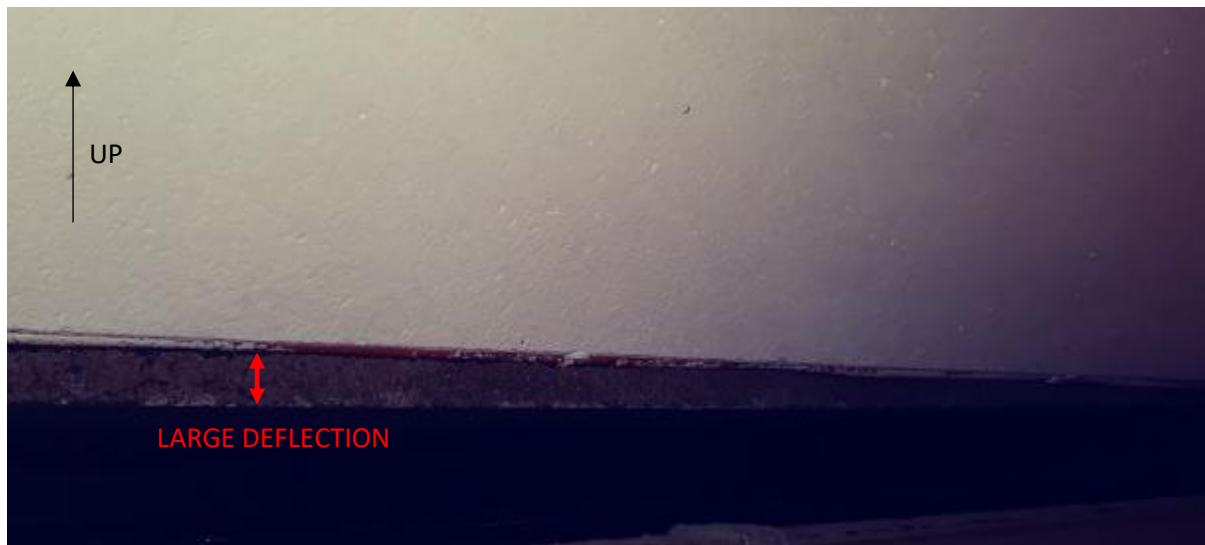
***EXCESSIVE DEFLECTION***

Until further inspections have been undertaken, based on the low risk/occupancy of the building it is recommended that evacuation is considered in certain conditions. Due to the shape of the roof there is a risk of significant snow build up in the valleys during adverse weather. We would recommend that access to the building is restricted if there is a risk of significant snow fall which could lead to a build-up of snow in the valley gutter areas. Significant loading of the units could lead to collapse if their performance is compromised. There should be no access to the roof at any time until the planks have been replaced/resupported.

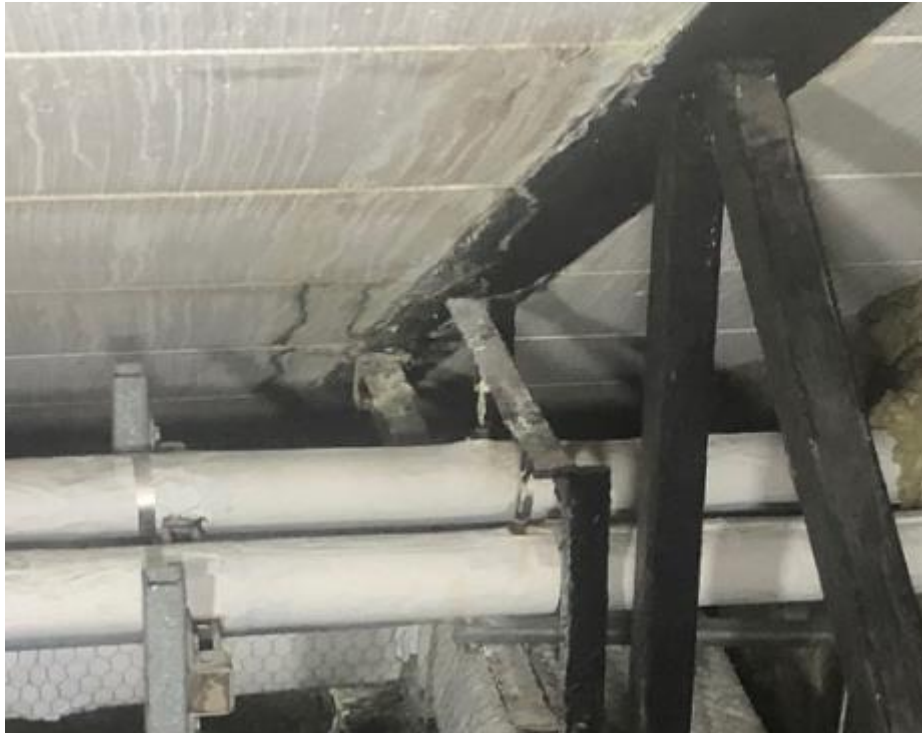
The roof in this area is pitched in all areas and finished with tiles. AJP were able to readily access the roof space and assess each RAAC unit without hindrance. The apparent signs of deterioration were very limited, none giving rise for concern. It is important to note that the tiled roof and associated waterproofing have failed in several key areas as follows:

***MATERIAL STAINING DUE TO ROOF LEAK***

It is recommended that these leaks are repaired as a matter of urgency to prevent water related damage.

- Urgently repair the leaks occurring in the areas described previously
- Repair/replace any water damaged material (namely timber/boarding)

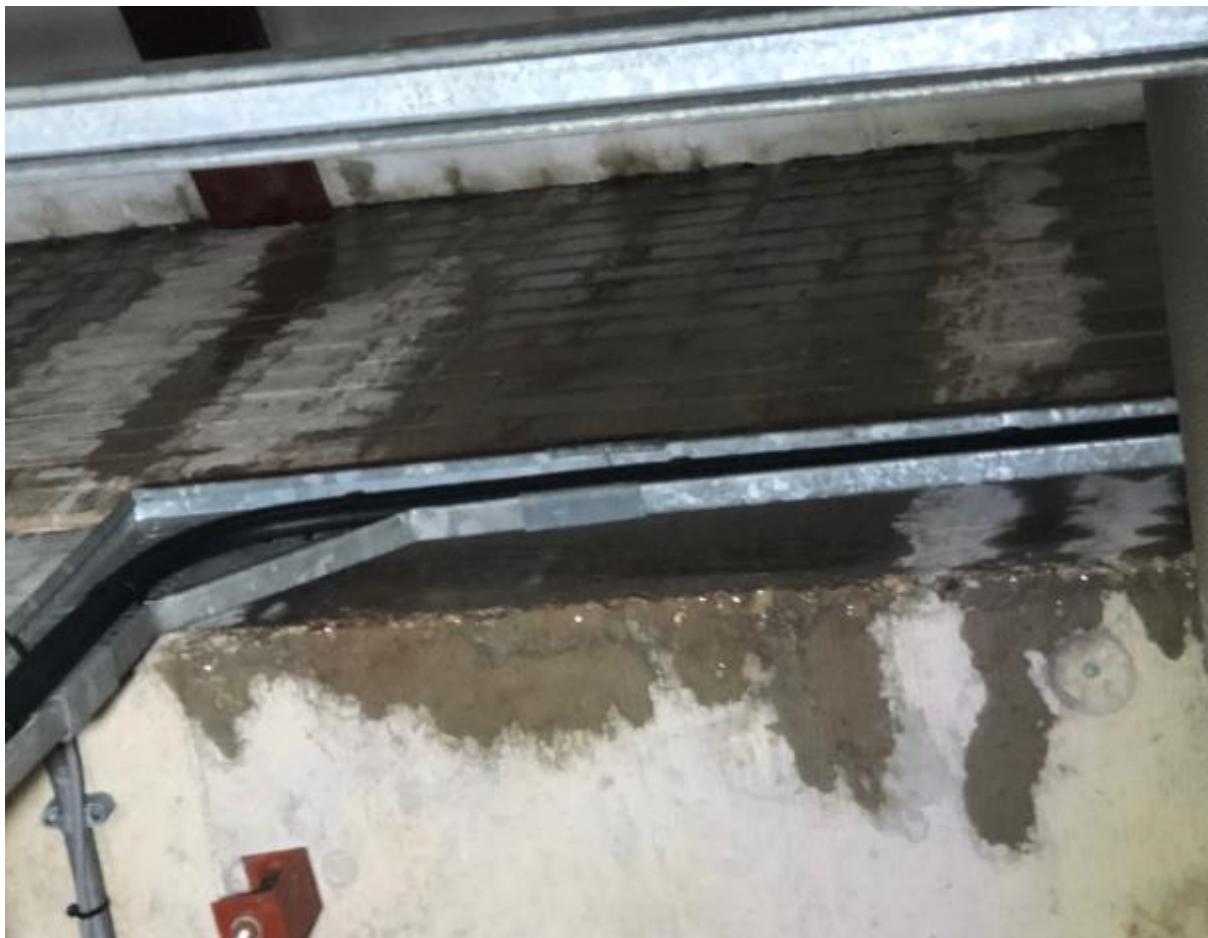
***WATER INGRESS DUE TO ROOF LEAKING***

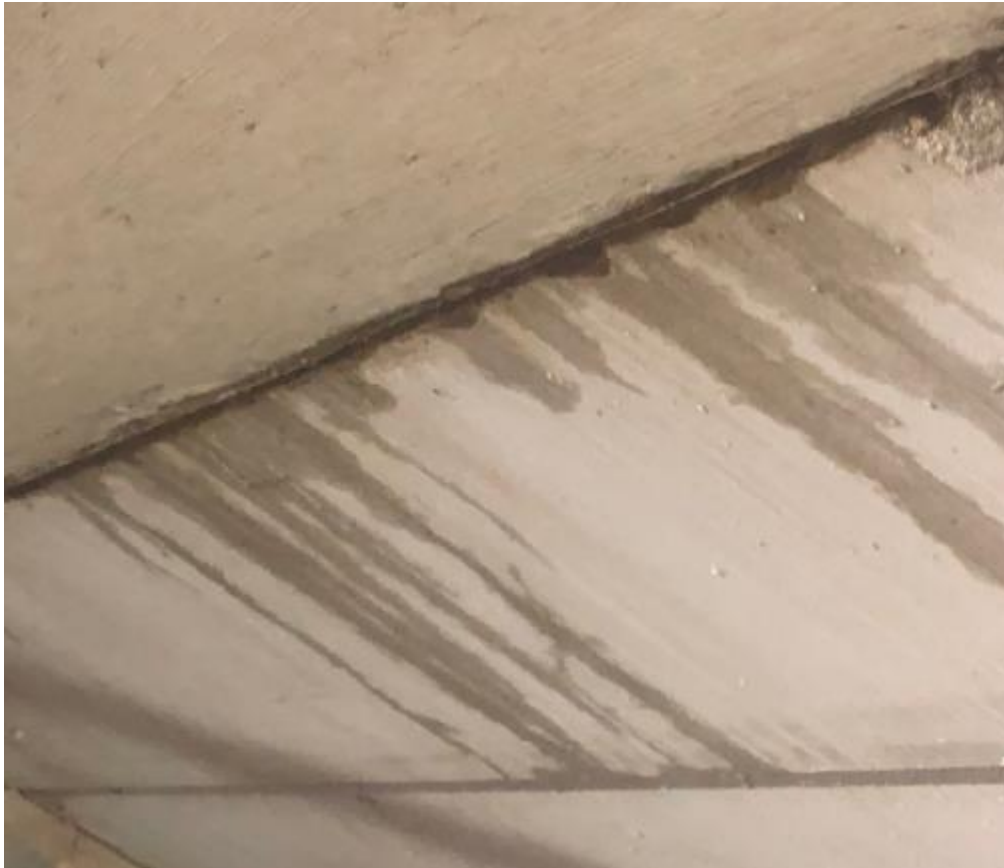
### ***WATER INGRESS AT HEAD OF PHASE 4 STAIR***

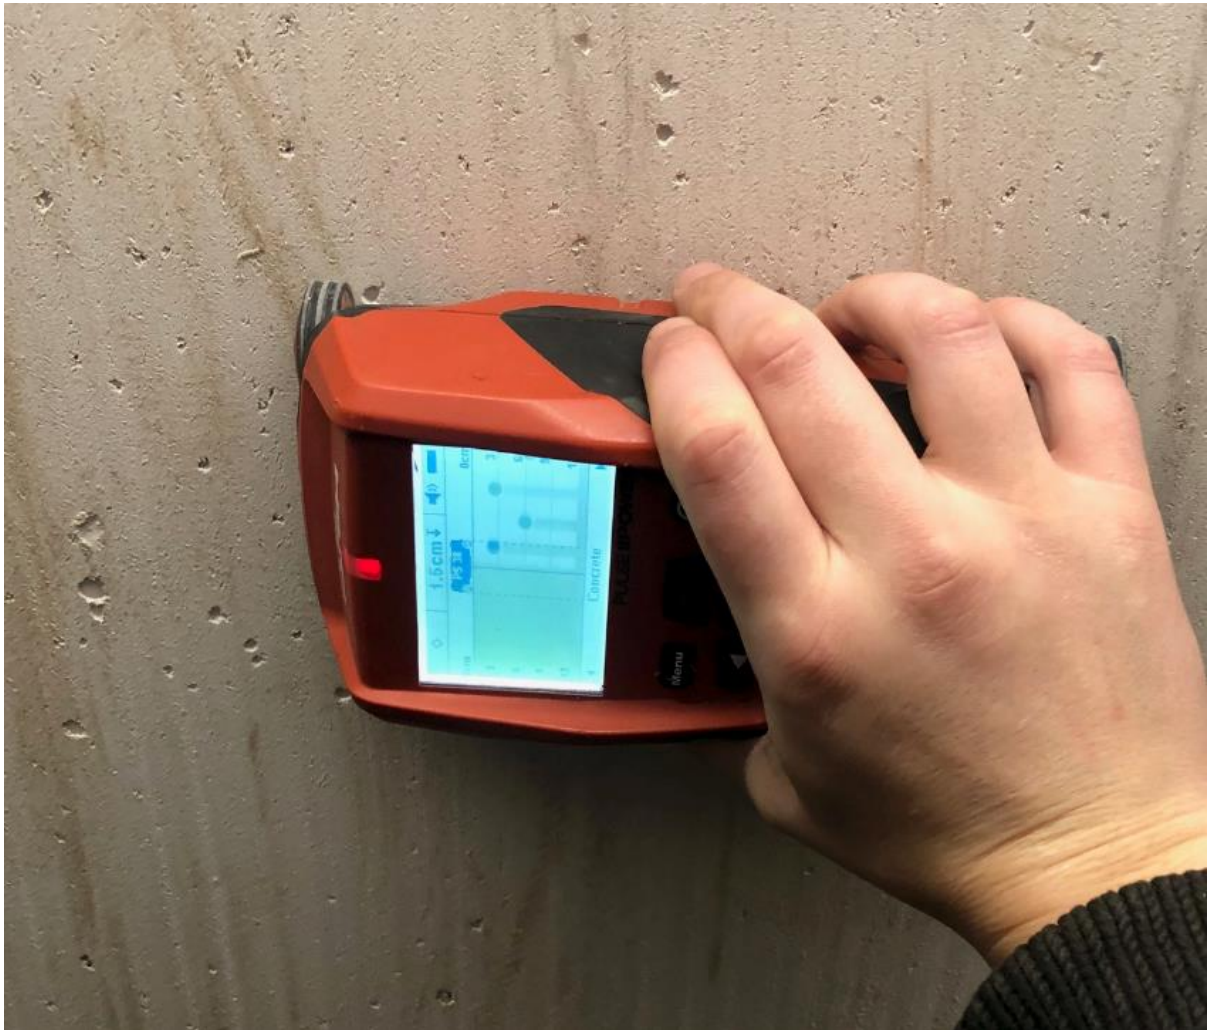
The spacing and general arrangement of the reinforcement was found to be uniform in all panels tested. Cover was measured to be a minimum of 20mm and a maximum of 30mm, typical of precast concrete and giving no cause for concern.

***HILTI PS38 MULTIDETECTOR TAKING SITE MEASUREMENTS***

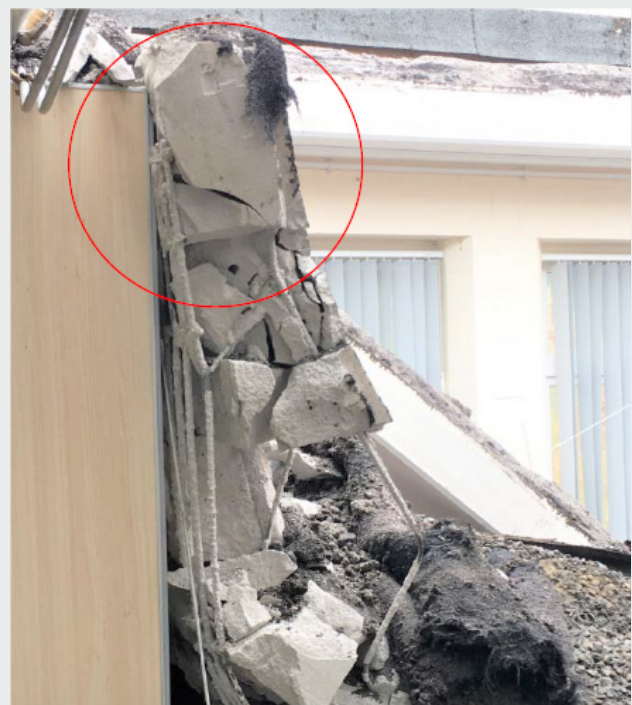
● Figure 1  
The 2018 roof slab collapse

In the case of the 2018 failure, there was evidence of shear cracking adjacent to a support and possible indications of tension reinforcement stopping short of the support. It was noted during investigation that the roof had been recently resurfaced. Also, the failure was at a time of hot weather, so there may have been a thermal influence.
