Ref. 219-390

STRUCTURAL INSPECTION REPORT

Blackpool Victoria Hospital, RAAC units

This document details the findings of the inspections carried out between December 2019 and January 2022 with regard to the Reinforced Autoclaved Aerated Concrete (RAAC) roof units in various locations

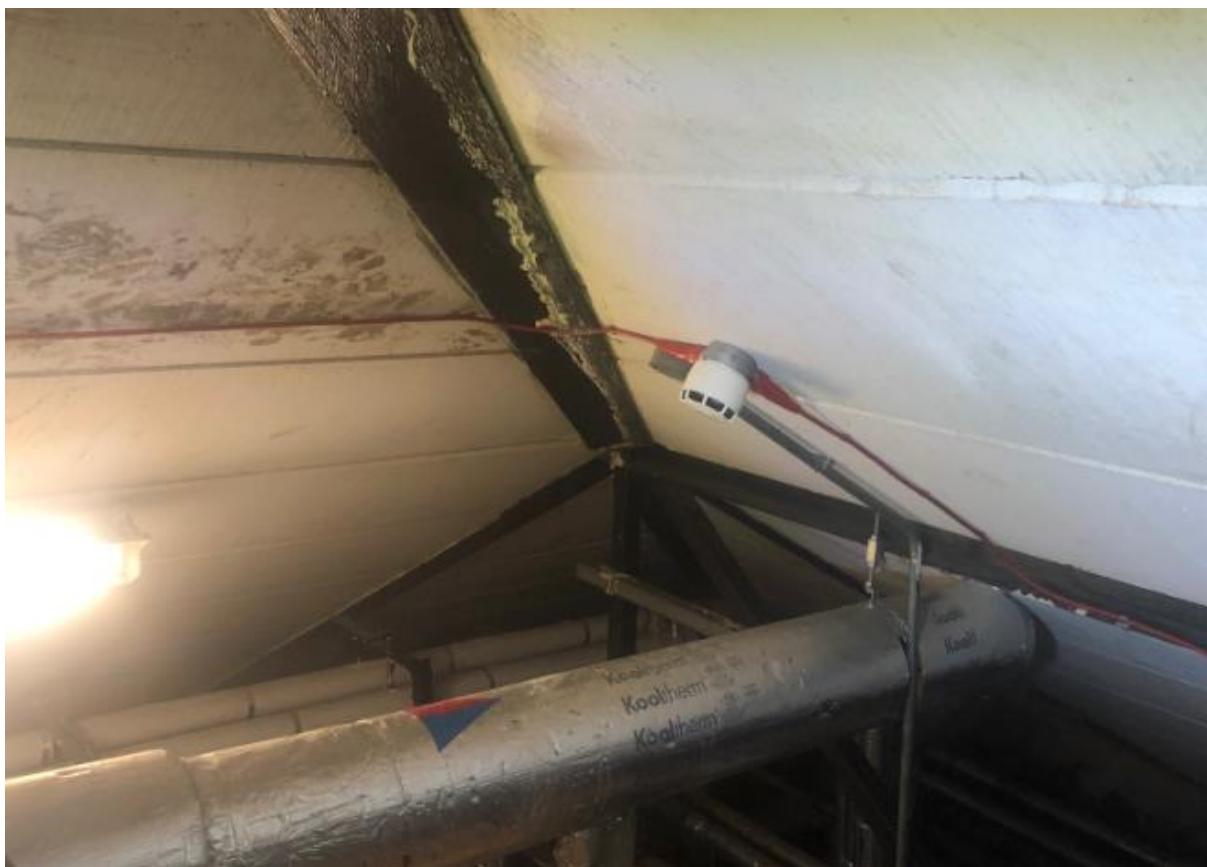
The roof in this area is pitched in all areas and finished with tiles. AJP were able to readily access the roof space and assess each RAAC unit without hindrance. The apparent signs of deterioration were very limited, none giving rise for concern. Previous inspections had shown that the tiled roof and associated waterproofing had failed in several key areas as follows:

INTERNAL ROOF SPACE IN PHASE 4

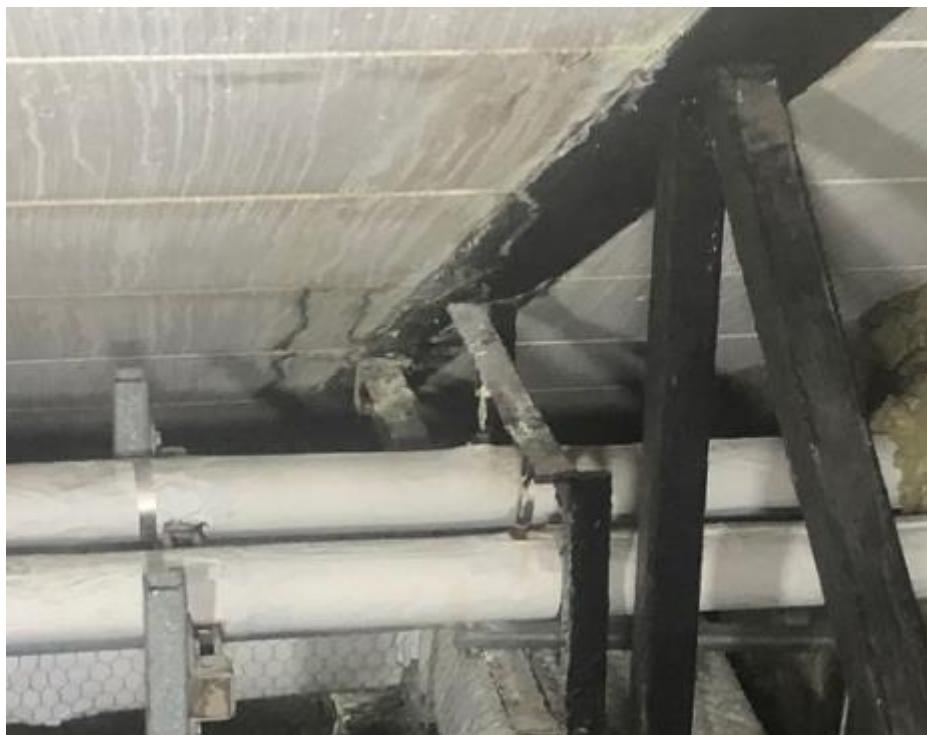
MATERIAL STAINING DUE TO ROOF LEAK

It appears that these leaks have now been addressed following roof repairs following the recommendations of revision 2 and 3 of this report.

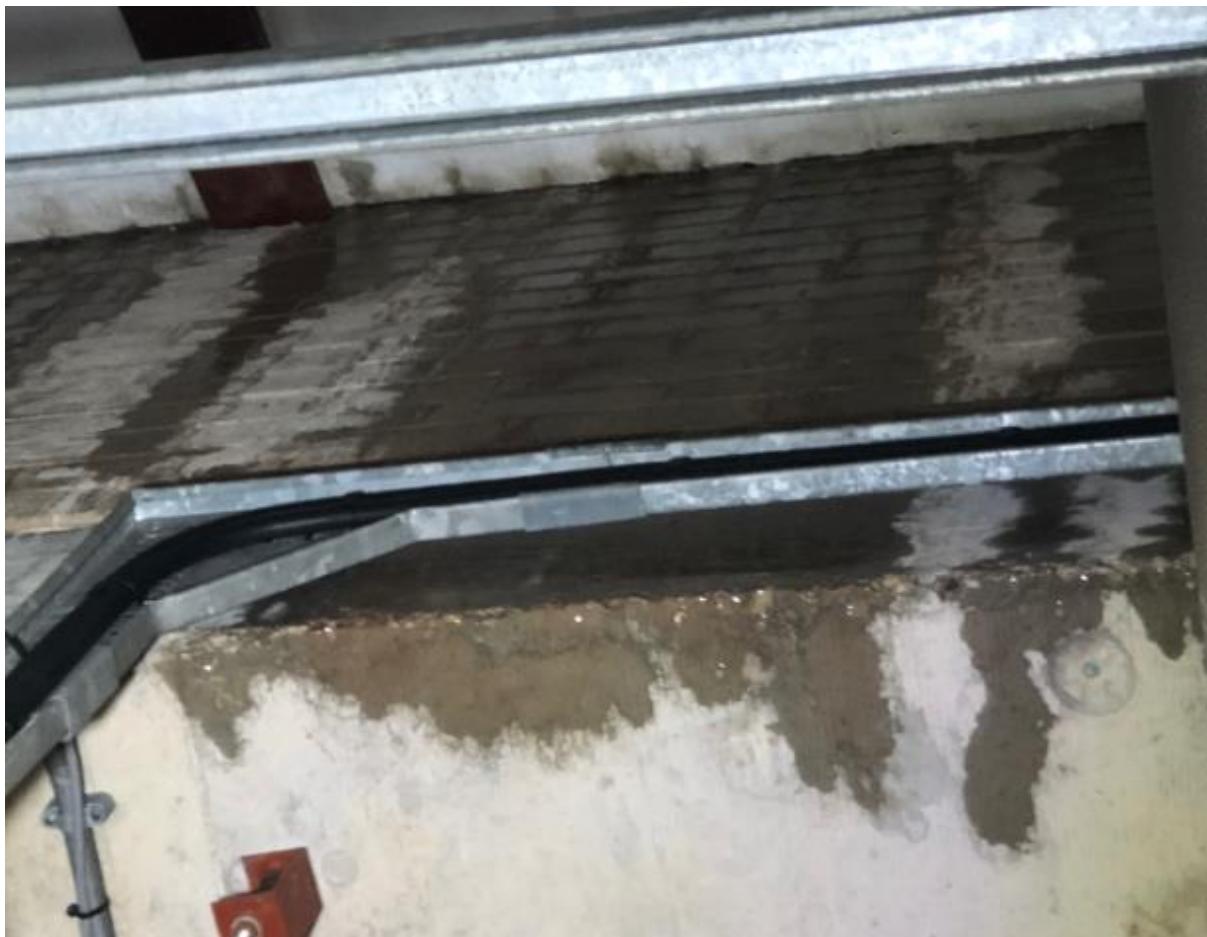
WATER INGRESS DUE TO ROOF LEAKING

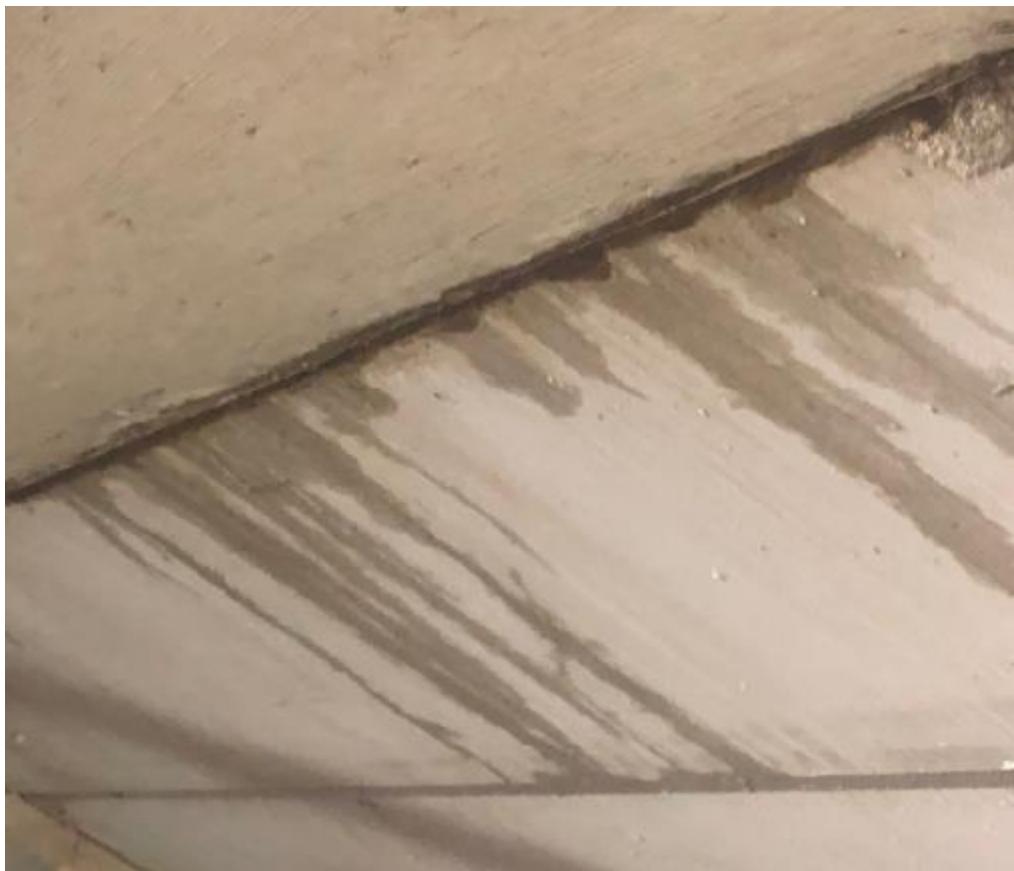
- Head of main access stair
- Above the medical records store
- Above the disused mechanical plant to the West of the main access stair

WATER INGRESS AT HEAD OF PHASE 4 STAIR

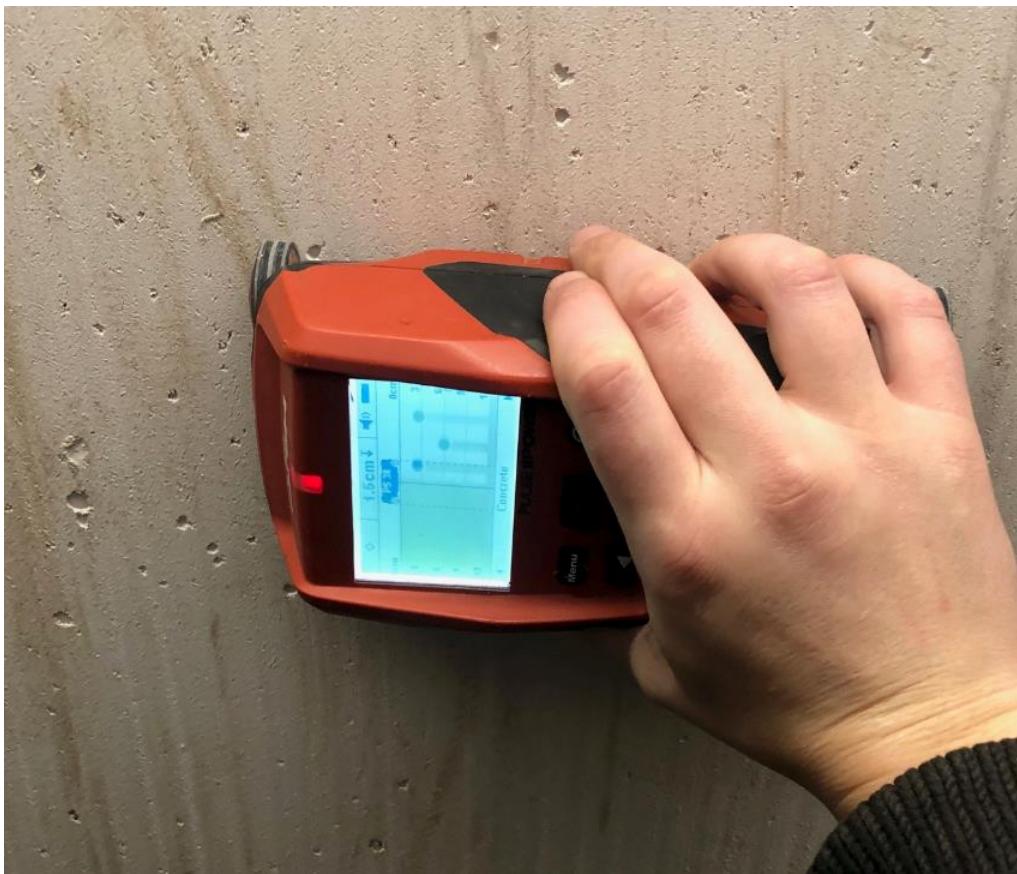
The spacing and general arrangement of the reinforcement was found to be uniform in all panels tested. Cover was measured to be a minimum of 20mm and a maximum of 30mm, typical of precast concrete and giving no cause for concern.

HILTI PS38 MULTIDETECTOR TAKING SITE MEASUREMENTS

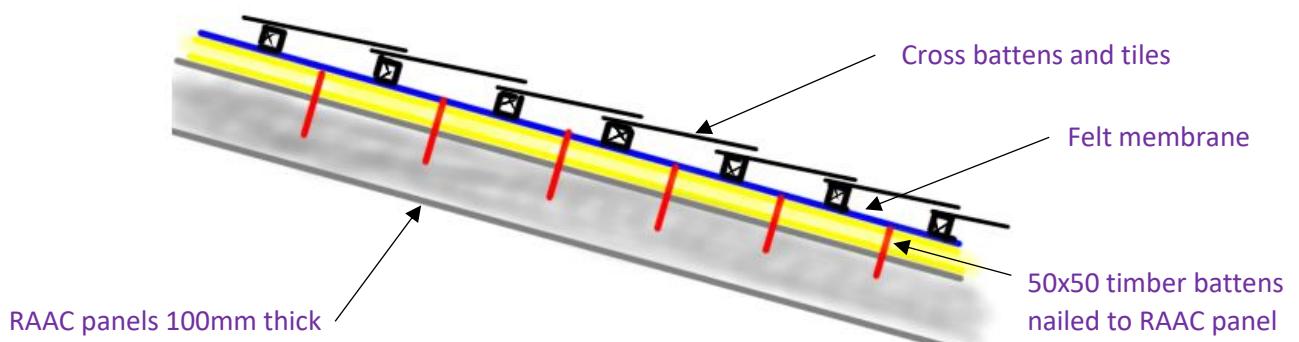
Following the erection of 2no. scaffolding towers, AJP were able to assess the panel condition from above by locally removing small sections of roof finishes to expose the RAAC surface. The build-up above the panels generally consists of 50mm deep timber battens at regular centres nailed down to the RAAC surface, these are overlain with a felt membrane and further cross battens which carry the roof tiles.

TYPICAL ROOF BUILD-UP

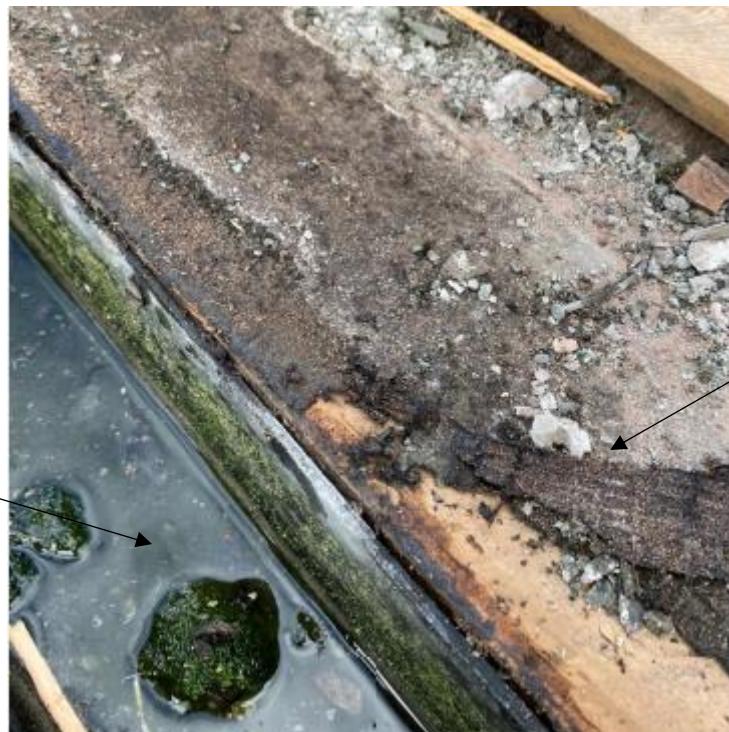
The felt and timber at the eaves was in poor condition due to water damage caused by splashback from the gutter immediately adjacent. The roofing contractor in attendance commented that the workmanship was sub-standard in the observable locations.

CONDITION OF BUILD-UP AT EAVES

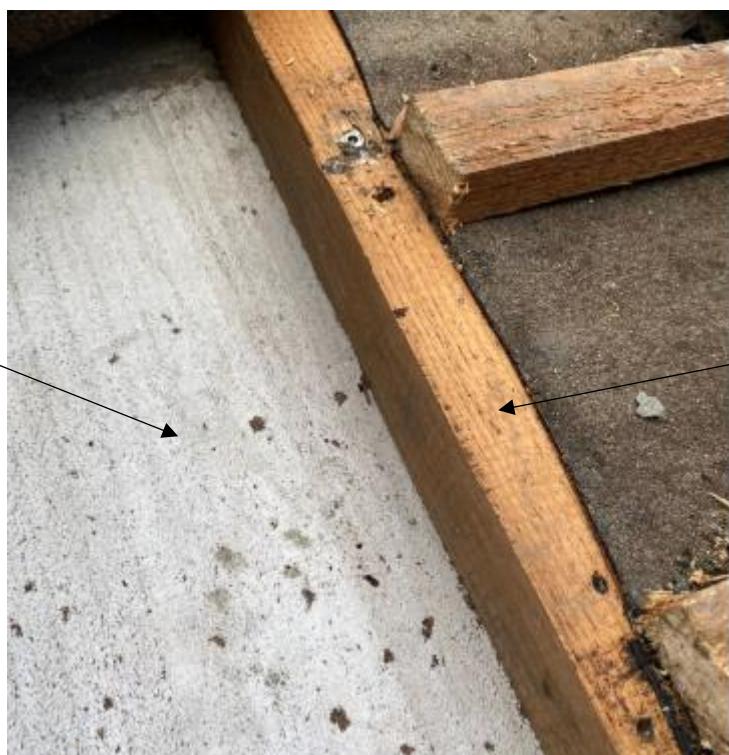
The observable RAAC panel surface was free of defects and appeared to be in good condition.

CONDITION OF RAAC PANEL

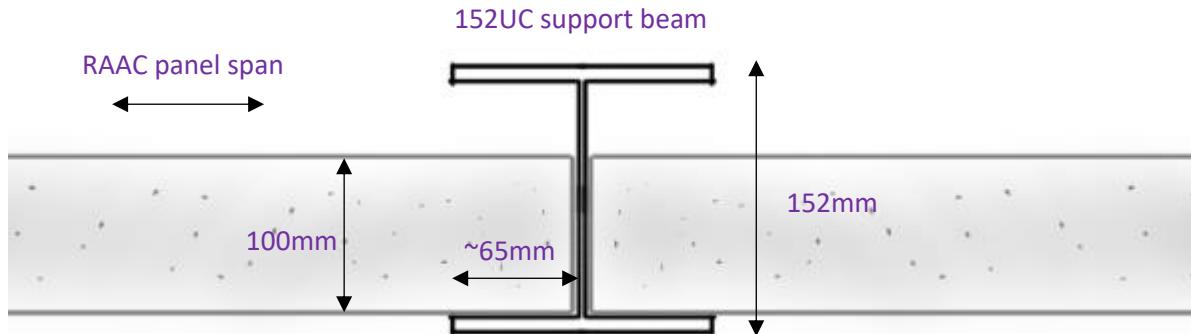
The unit was exposed at the bearing location, the support beam appears to be a steel 152UC section with the panel being supported on the bottom flanges. Investigations indicated that a bearing of at least 65mm had been achieved (greater than the 45mm acceptable minimum).

TYPICAL SUPPORT CONDITIONS FOR RAAC PANELS

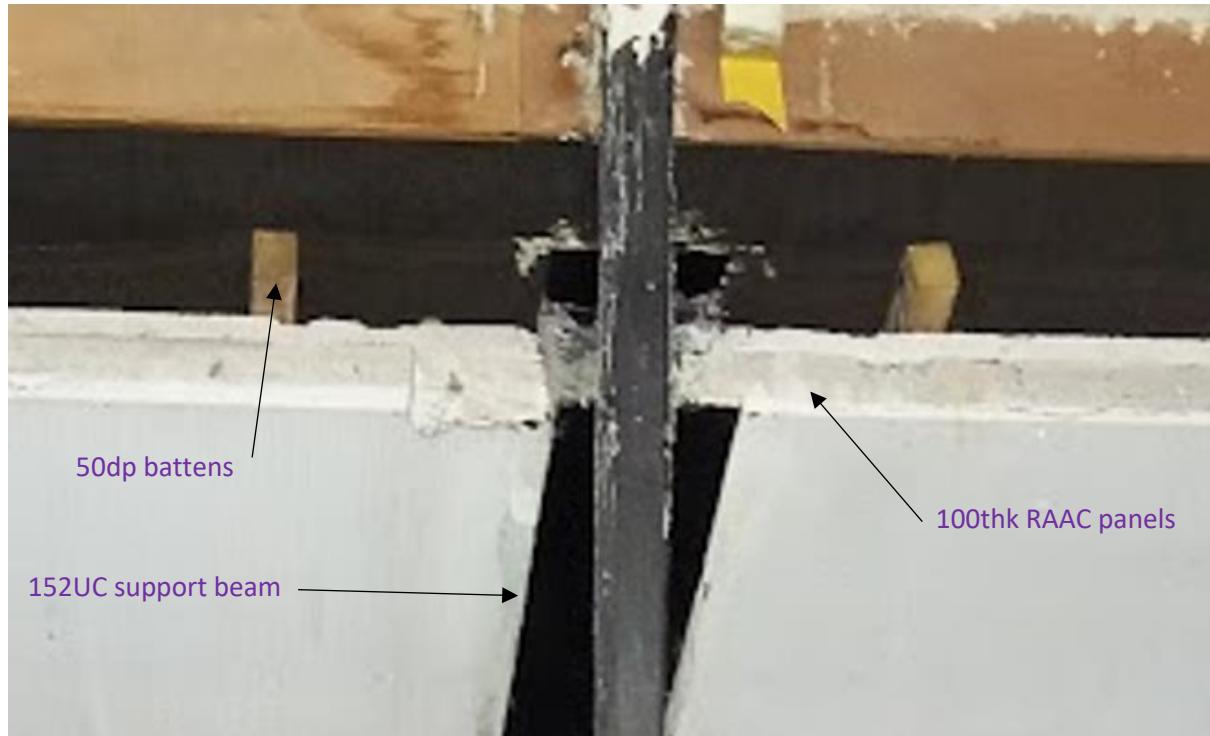
The above arrangement was also verified from within the roof void

SUPPORT CONDITIONS WITHIN THE ROOF VOID
