Ref. 219-390

STRUCTURAL INSPECTION REPORT

Blackpool Victoria Hospital, RAAC units

This document details the findings of the inspection carried out in December 2019 with regard to the Reinforced Autoclaved Aerated Concrete (RAAC) roof units in various locations

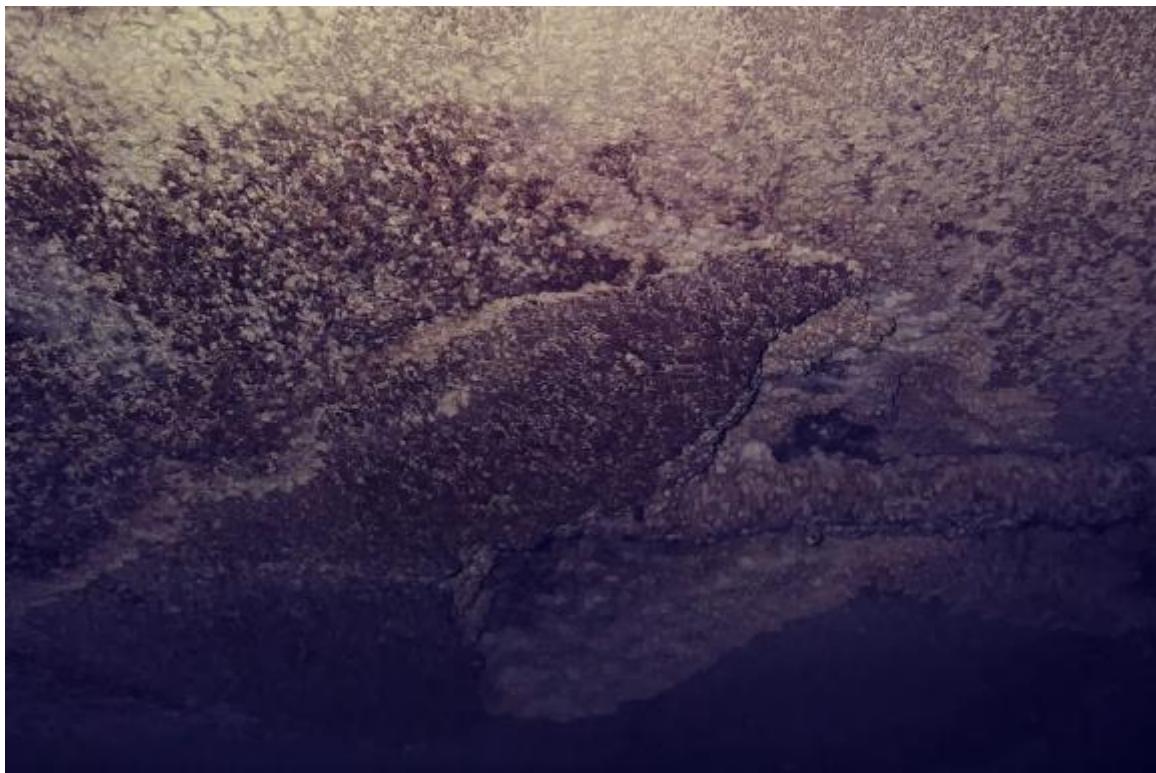
- Excessive deflection due to creep
- Discoloured and spalling concrete near to supports and roof cowl
- Broken concrete at edges and fixing locations

SPALLING OF CONCRETE NEAR ROOF COWL

It is likely that in order to maintain the use of the building, the units will require full scale replacement with an alternative construction such as structural steel metal deck. Alternatively, it may be possible to prolong the building service life with the introduction of additional steelwork to

reduce the current span of the planks by approximately 50%. The most appropriate option can be further developed once a more detailed inspection has been completed.

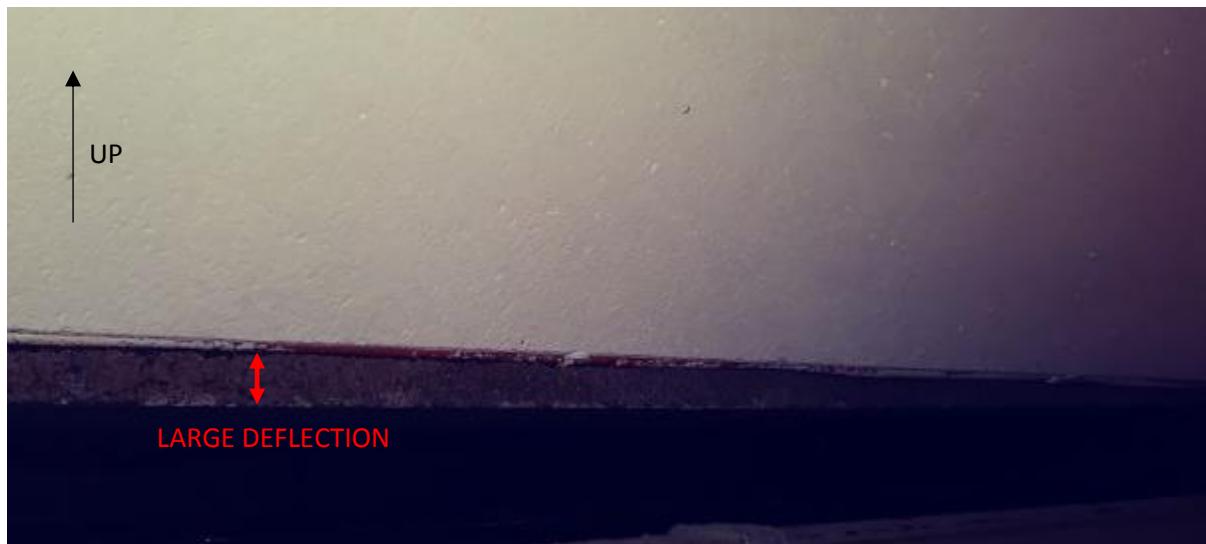
EXCESSIVE DEFLECTION

These findings suggest that many of the panels are nearing the end of their useful life, and deterioration is light/moderate. The extent of the deflection of the horizontal planks which form the valley gutters is concerning. It will be necessary to undertake a more detailed inspection following the removal of the timber panels which prevent a clear view of the RAAC units.

Until further inspections have been undertaken, based on the low risk/occupancy of the building it is recommended that evacuation is considered in certain conditions. Due to the shape of the roof there is a risk of significant snow build up in the valleys during adverse weather. We would recommend that access to the building is restricted if there is a risk of significant snow fall which could lead to a build-up of snow in the valley gutter areas. Significant loading of the units could lead to collapse if their performance is compromised. There should be no access to the roof at any time until the planks have been replaced/resupported.

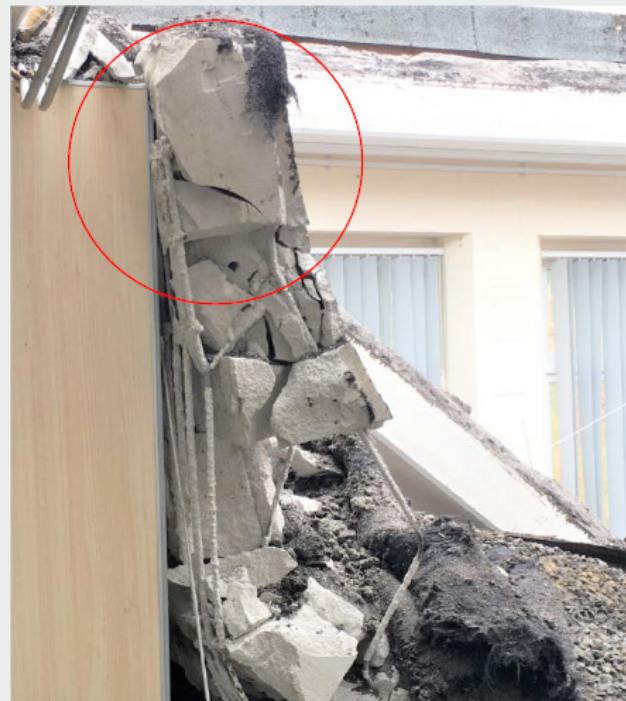
Figure 1
The 2018 roof slab collapse

In the case of the 2018 failure, there was evidence of shear cracking adjacent to a support and possible indications of tension reinforcement stopping short of the support. It was noted during investigation that the roof had been recently resurfaced. Also, the failure was at a time of hot weather, so there may have been a thermal influence.
