Ref. 219-390

STRUCTURAL INSPECTION REPORT 2021

Blackpool Victoria Hospital, Laundry and Phase 4,
RAAC units

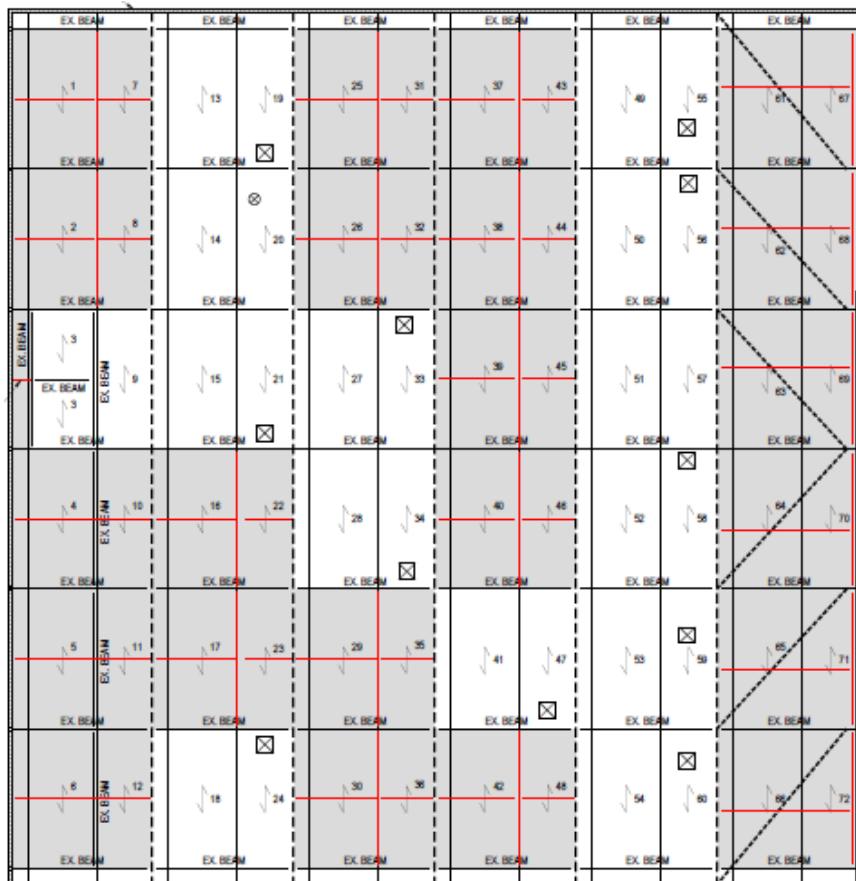
The new steelwork specified on AJP drawing S-001 has been installed correctly as per the coloured illustrated below. No further deterioration of the RAAC units has occurred since the initial inspection. Due to trimmed openings cored into various units, it was not possible to install steelwork in every bay as the existing steel caused various obstructions. Initial inspections concluded that the existing trimming steel was effectively reducing the span of the RAAC units therefore deeming them acceptable without intervention. Refer to the photograph overleaf for clarity

PLAN ON LAUNDRY ROOF HIGHLIGHTING NEWLY INSTALLED STEELWORK

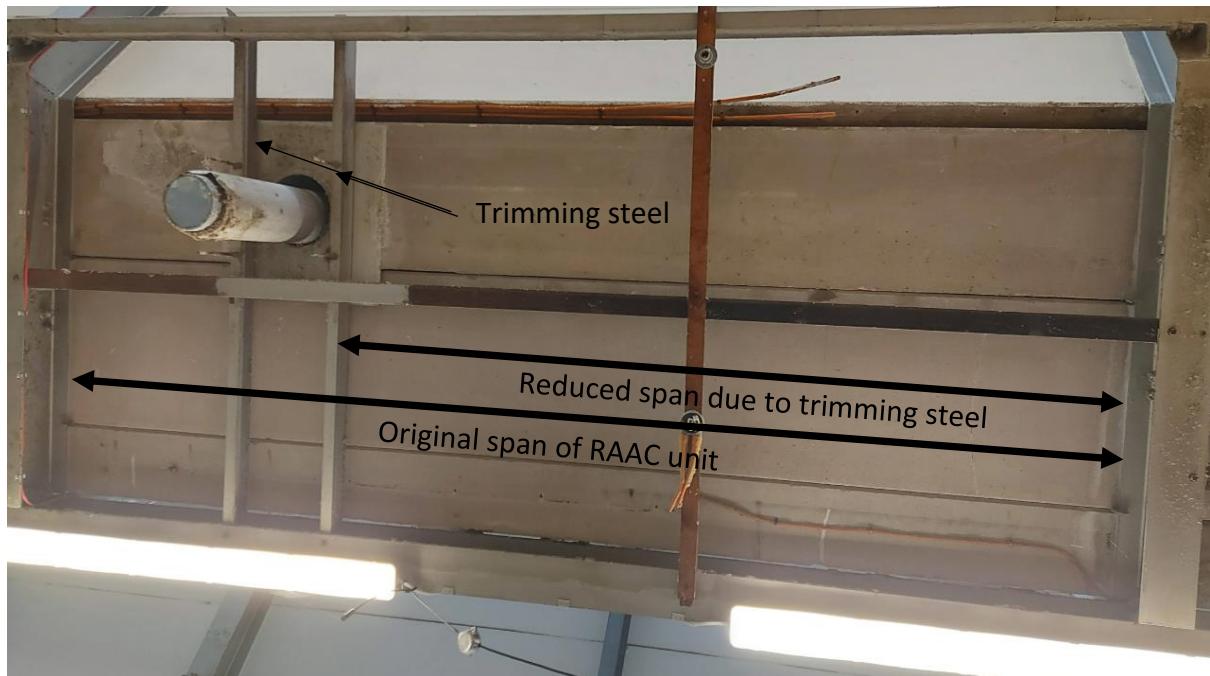
EFFECT OF EXISTING TRIMMING STEEL ON UNITS

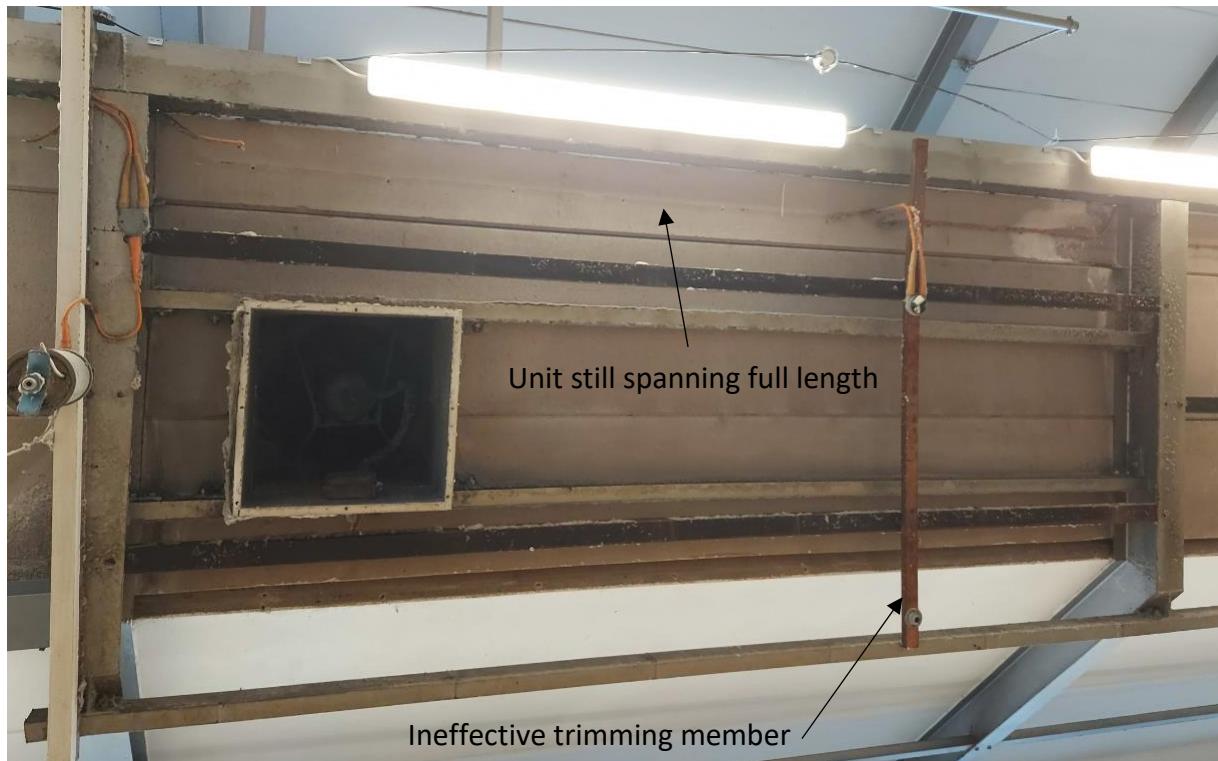
As part of the recent inspection, several units were identified as being not fully supported by this trimming steelwork as illustrated by the photograph below:

EXAMPLE OF EFFECTIVELY UNTRIMMED UNITS

Further non-urgent minor works will be needed to rectify these issues at a convenient time to suit the building's use. Typical details required as indicated below:

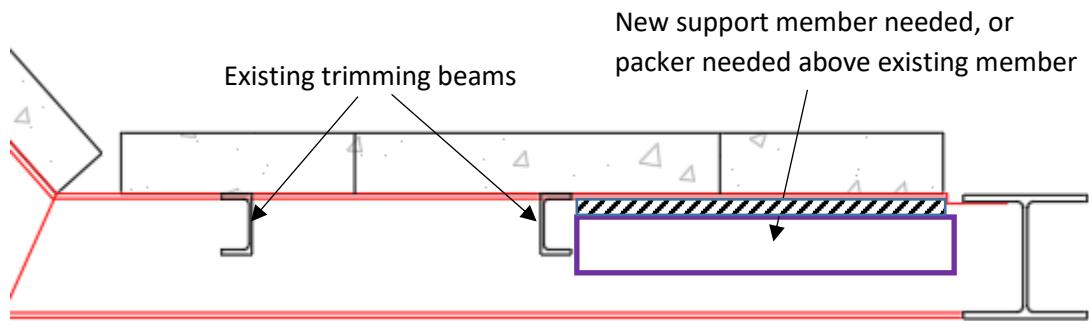
TYPICAL MINIMUM REQUIREMENTS

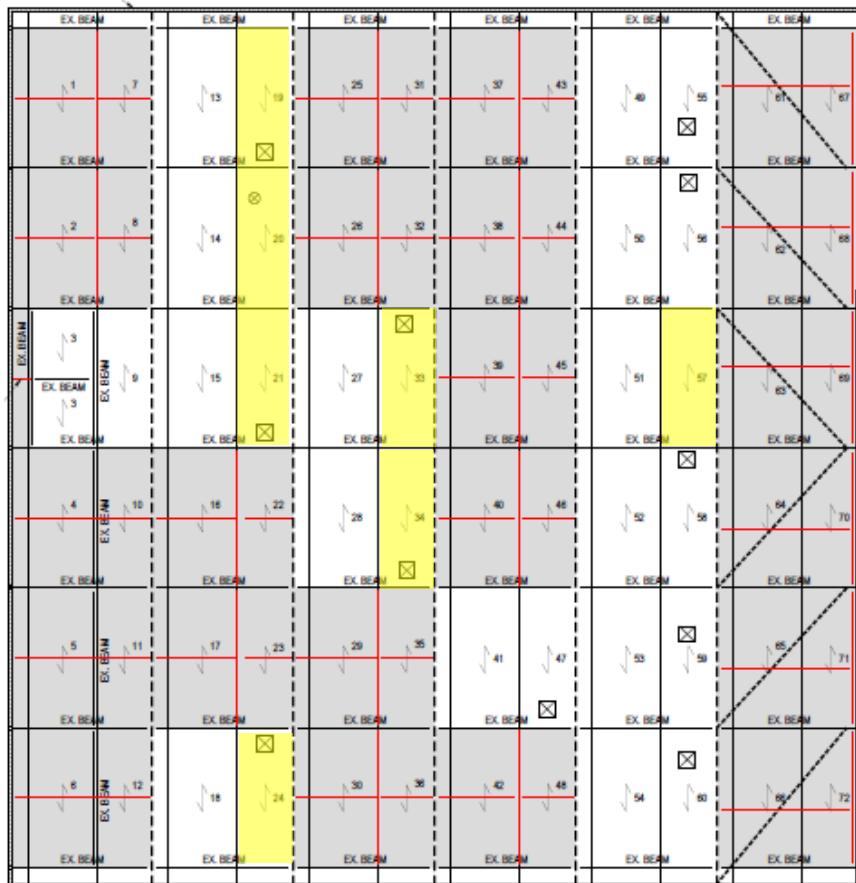
PLAN INDICATING TYPICAL BAYS REQUIRING FUTURE ATTENTION

The full scope of works for this ongoing maintenance procedure will be defined at such a time when the building ceases to be a covid-19 vaccination centre, and becomes accessible again. It may be prudent to carry out additional preventative works at the same time in anticipation of further deterioration in the coming years.

- Identify a suitable date to carry out further non-urgent roof works
- Continue to restrict access to the roof

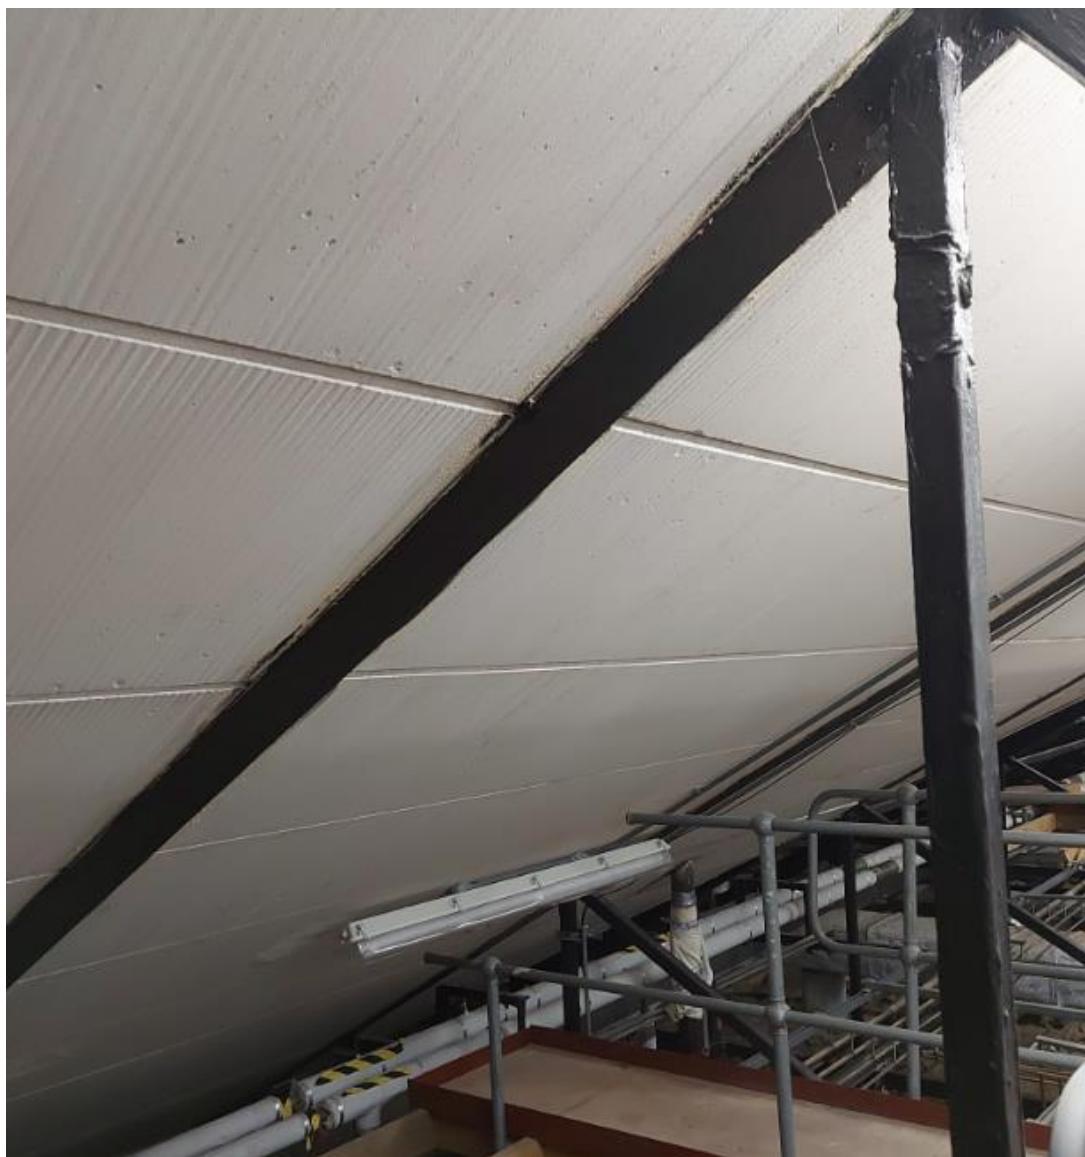
No deterioration of the RAAC units was evident, and the units appear have remained in a generally good condition.

TYPICAL RAAC UNITS IN GOOD CONDITION
