Ref. 219-390

STRUCTURAL INSPECTION REPORT

Blackpool Victoria Hospital, RAAC units

This document details the findings of the inspection carried out in December 2019 with regard to the Reinforced Autoclaved Aerated Concrete (RAAC) roof units in various locations

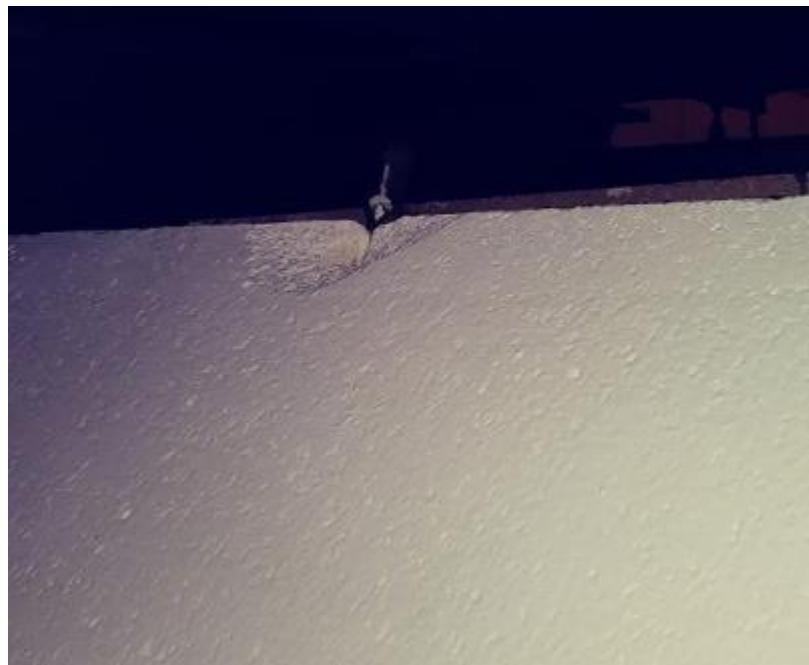
- Excessive deflection due to creep
- Discoloured and spalling concrete near to supports and roof cowl
- Broken concrete at edges and fixing locations

BROKEN CONCRETE AT FIXING LOCATION

The units may will require full scale replacement with an alternative construction such as structural steel metal deck. Alternatively, it may be possible to prolong the building service life with the introduction of additional steelwork to reduce the current span of the planks by approximately 50%.

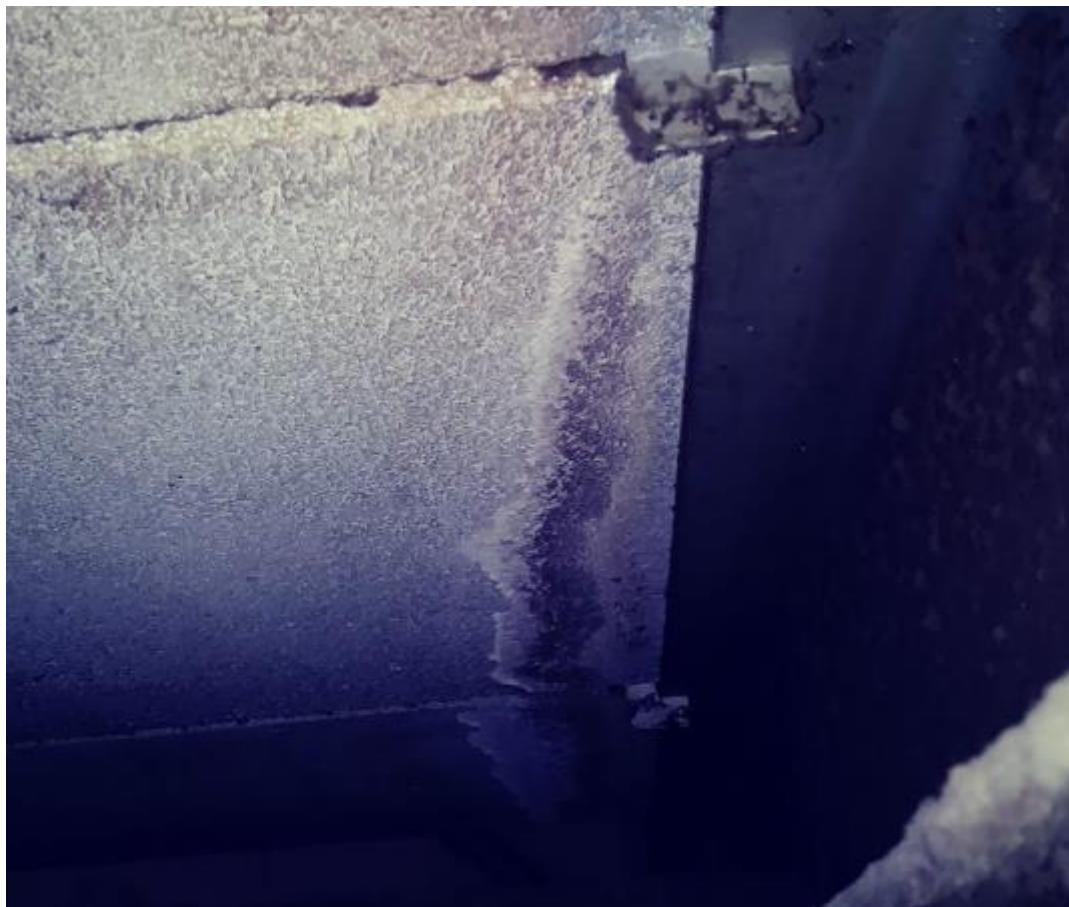
SPALLING CONCRETE AT SUPPORT

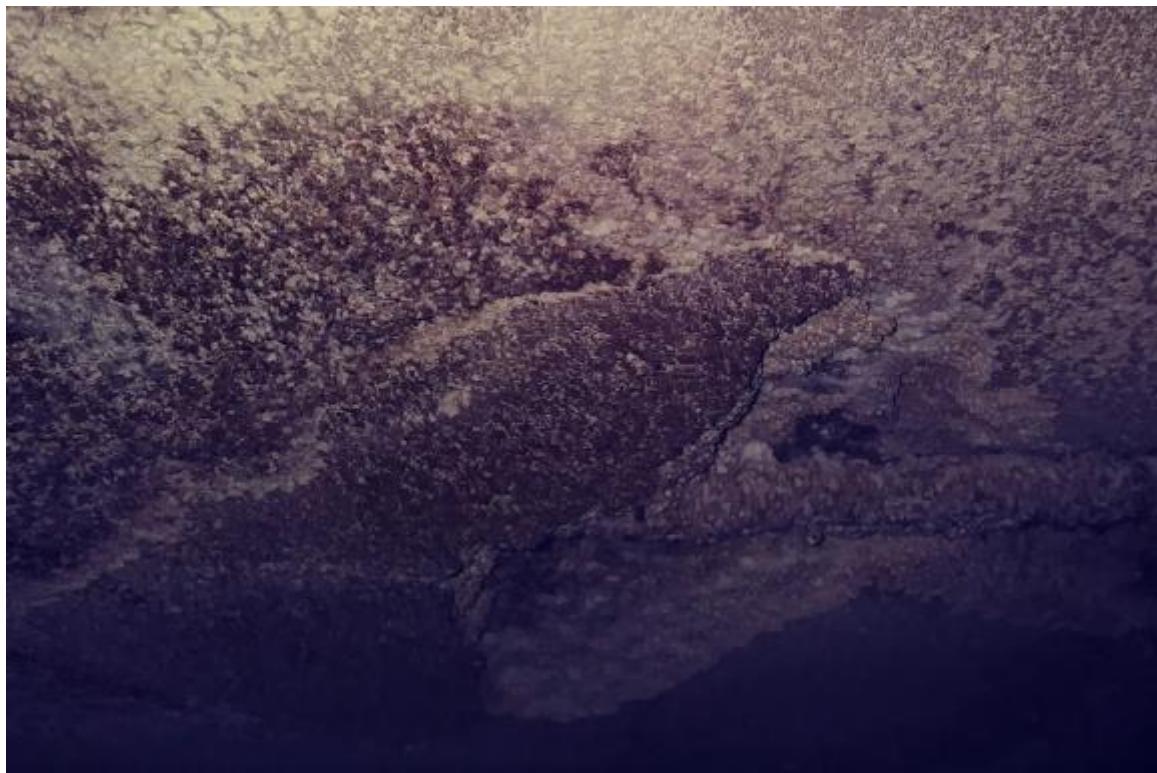
SPALLING OF CONCRETE NEAR ROOF COWL

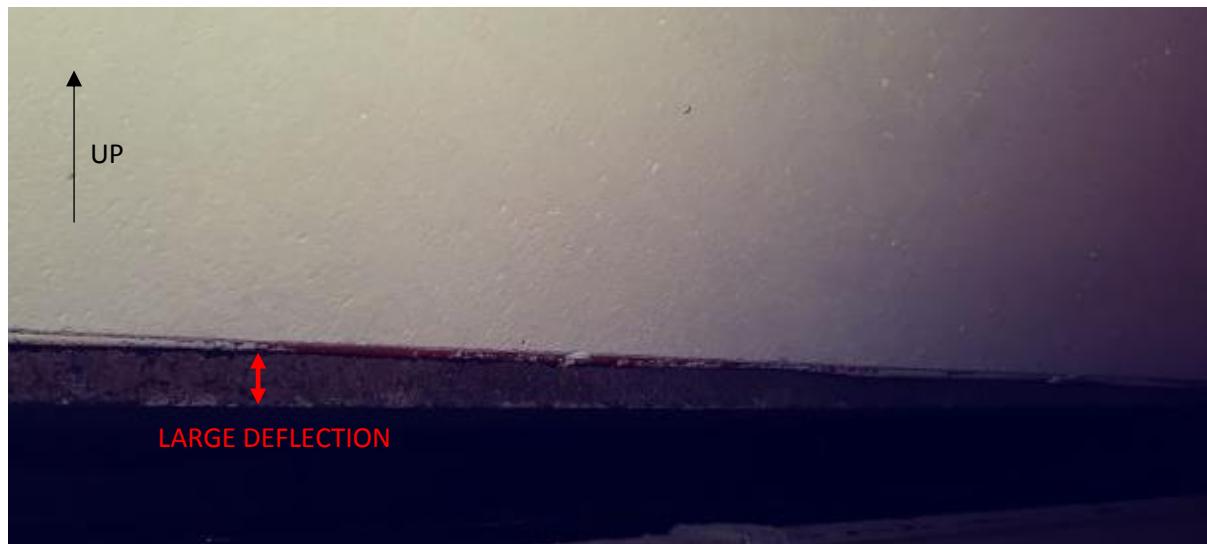
EXCESSIVE DEFLECTION

These findings suggest that many of the panels are nearing the end of their useful life, and deterioration is light/moderate. The extent of the deflection of the horizontal planks which form the valley gutters is concerning. It will be necessary to undertake a more detailed inspection following the removal of the timber panels which prevent a clear view of the RAAC units.

Until further inspections have been undertaken, based on the low risk/occupancy of the building it is recommended that evacuation is considered in certain conditions. Due to the shape of the roof there is a risk of significant snow build up in the valleys during adverse weather. We would recommend that access to the building is restricted if there is a risk of significant snow fall which could lead to a build-up of snow in the valley gutter areas. Significant loading of the units could lead to collapse if their performance is compromised. There should be no access to the roof at any time until the planks have been replaced/resupported.

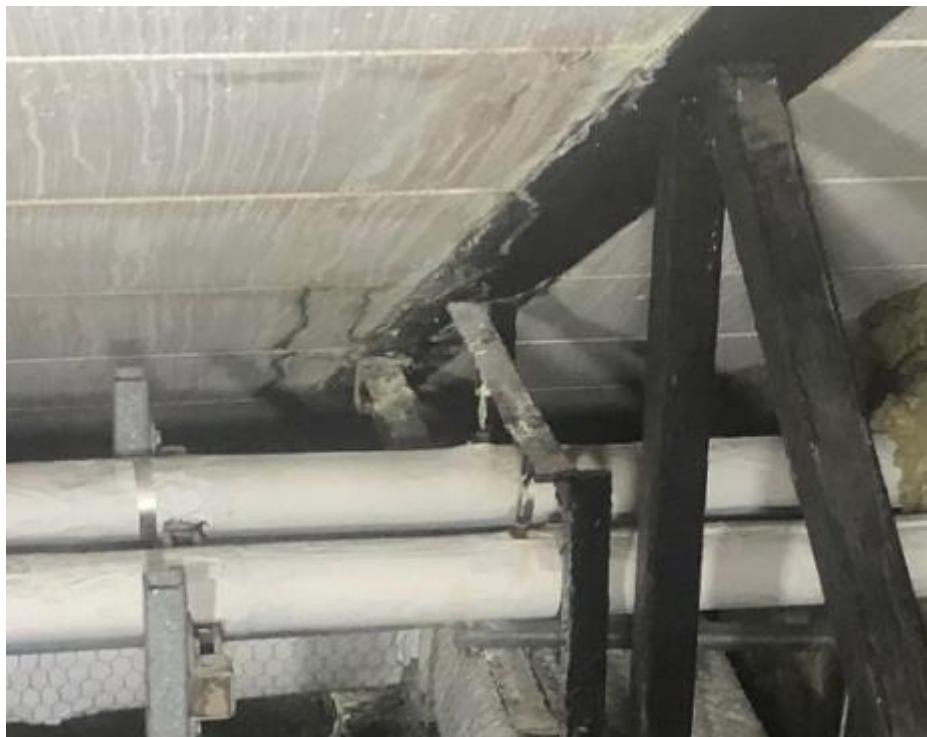
The roof in this area is pitched in all areas and finished with tiles. AJP were able to readily access the roof space and assess each RAAC unit without hindrance. The apparent signs of deterioration were very limited, none giving rise for concern. It is important to note that the tiled roof and associated waterproofing have failed in several key areas as follows:

MATERIAL STAINING DUE TO ROOF LEAK

It is recommended that these leaks are repaired as a matter of urgency to prevent water related damage.

- Urgently repair the leaks occurring in the areas described previously
- Repair/replace any water damaged material (namely timber/boarding)

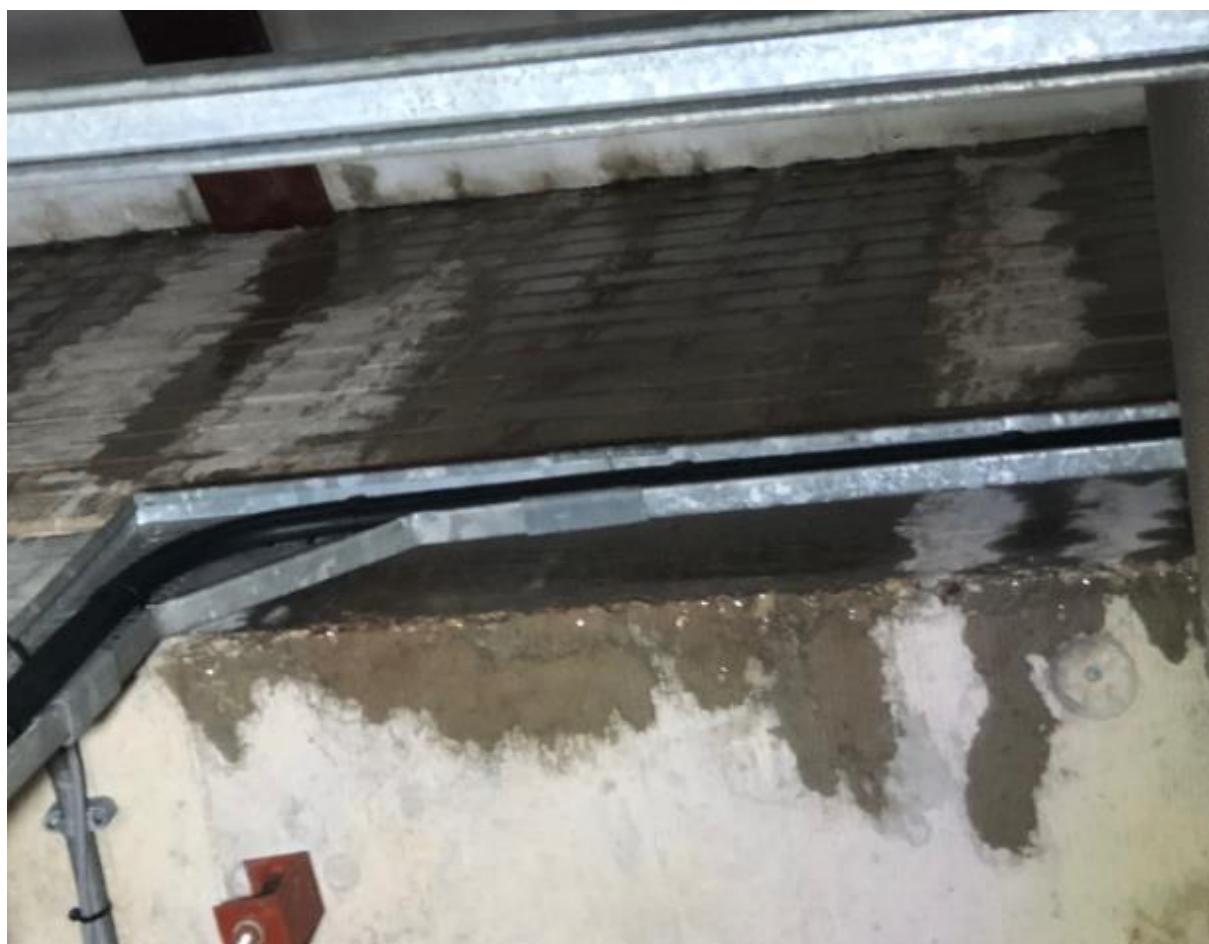
WATER INGRESS DUE TO ROOF LEAKING

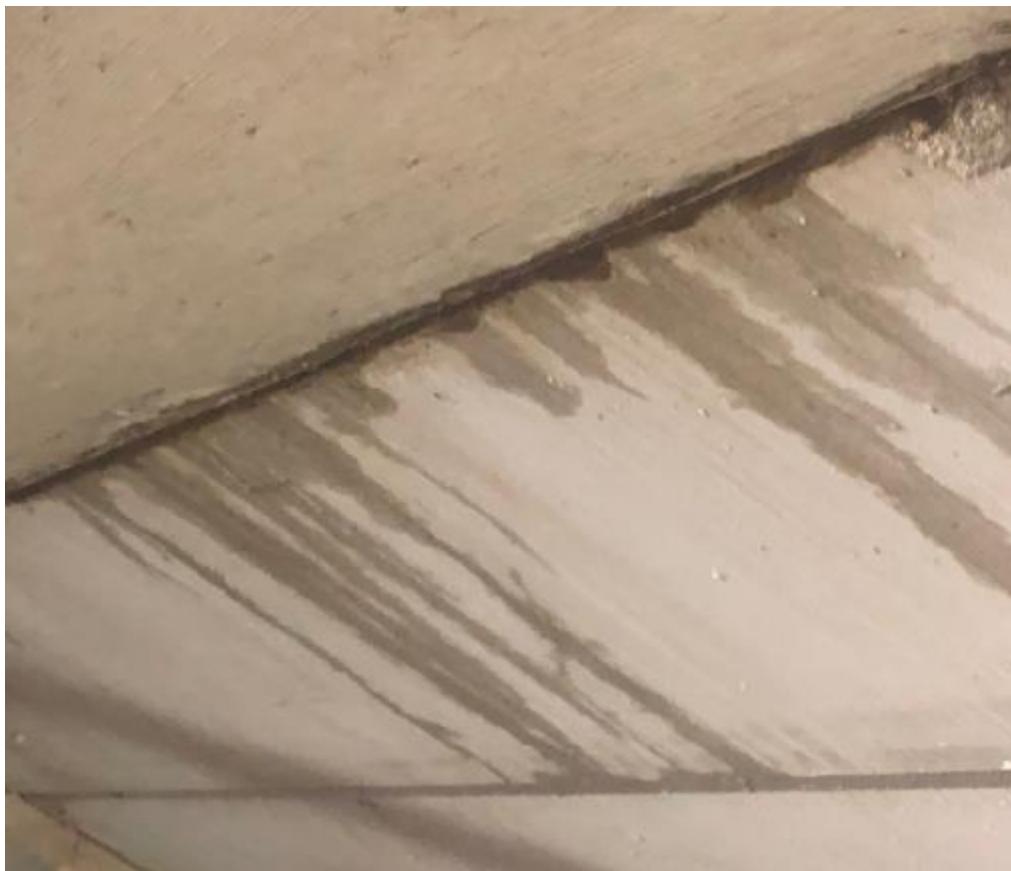
- Head of main access stair
- Above the medical records store
- Above the disused mechanical plant to the West of the main access stair

WATER INGRESS AT HEAD OF PHASE 4 STAIR
