BASSETLAW HOSPITAL, PHASE 1

STRUCTURAL INSPECTION REPORT

22nd October 2021

RAAC PLANK INSPECTION

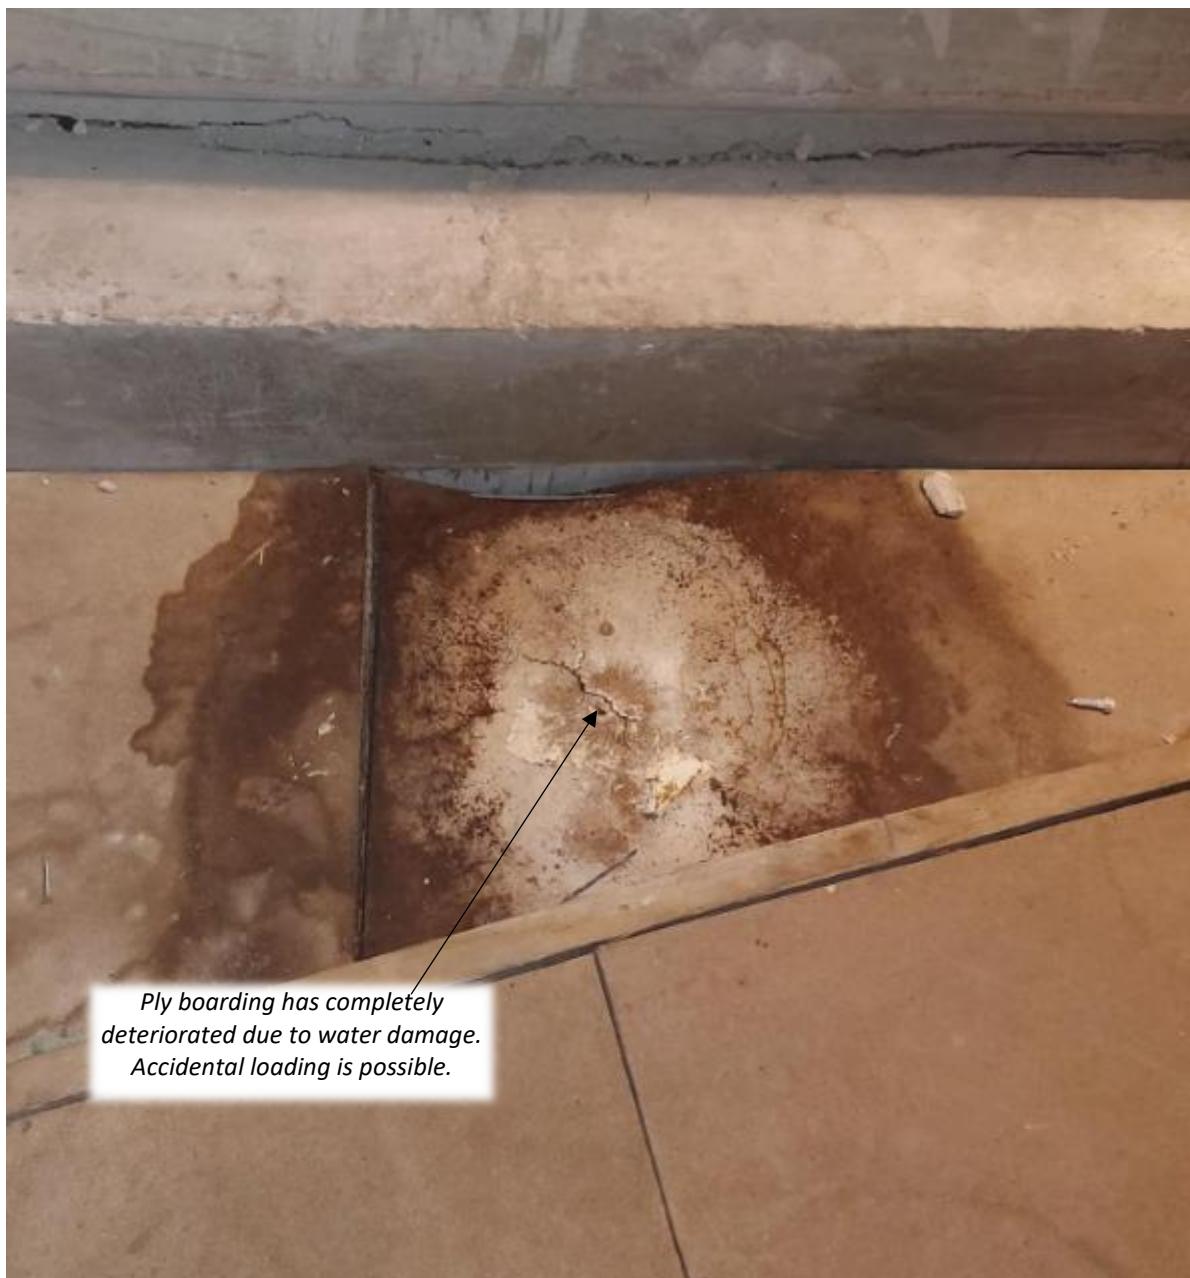
- Severe water damaged ply boarding forming the floor due to water ingress, this occurs immediately adjacent to the steel plant room door (photo 1)
- Saw cut holes, plank 15 (photo 2)
- Loose and structurally inadequate barriers preventing access onto ventilation units, occurs above theatres 6, 5 and 4 (photo 3)

PHOTO 1 – SEVERE WATER DAMAGED PLY BOARDING

Based on the building age and survey findings, it is suggested that the RAAC planks are nearing the end of their useful life (50 years). Although the planks appear to be in reasonable condition and are not displaying any indications of overstress (cracking or deflecting) it is not possible to identify defects which lie beneath the observable surfaces, and a very small number of recent failures in the UK have occurred suddenly without warning. It is recommended that plank 15 is re-supported to account for the significant cut which appears to coincide with reinforcement. This may involve a timber beam arrangement fixed between the trusses. AJP are to advise further on the re-support detail upon receipt of NHS trust comments. Any visibly exposed unpainted/untreated reinforcement should be thoroughly wire brushed and protected. The damaged ply flooring has a very reduced lifespan and it should be replaced at the earliest suitable opportunity.

- Demarcation of areas with loose barriers (see photo 3)
- Installation of a barrier to prevent fall from height (see photo 9)
- Patch repair of roof leaks where ponding has occurred if planks retained
- Refit missing gulley caps at roof level if planks retained
- Inspect the gullies during heavy rain to check they drain freely if planks retained
- Re-support of plank 15 if planks are to be retained
- Treatment and protection of exposed/corroding reinforcement if planks retained
- GPR ferro-scanning from above if planks are to be retained
- Repair of damaged ply flooring (see photo 1 and 8B)

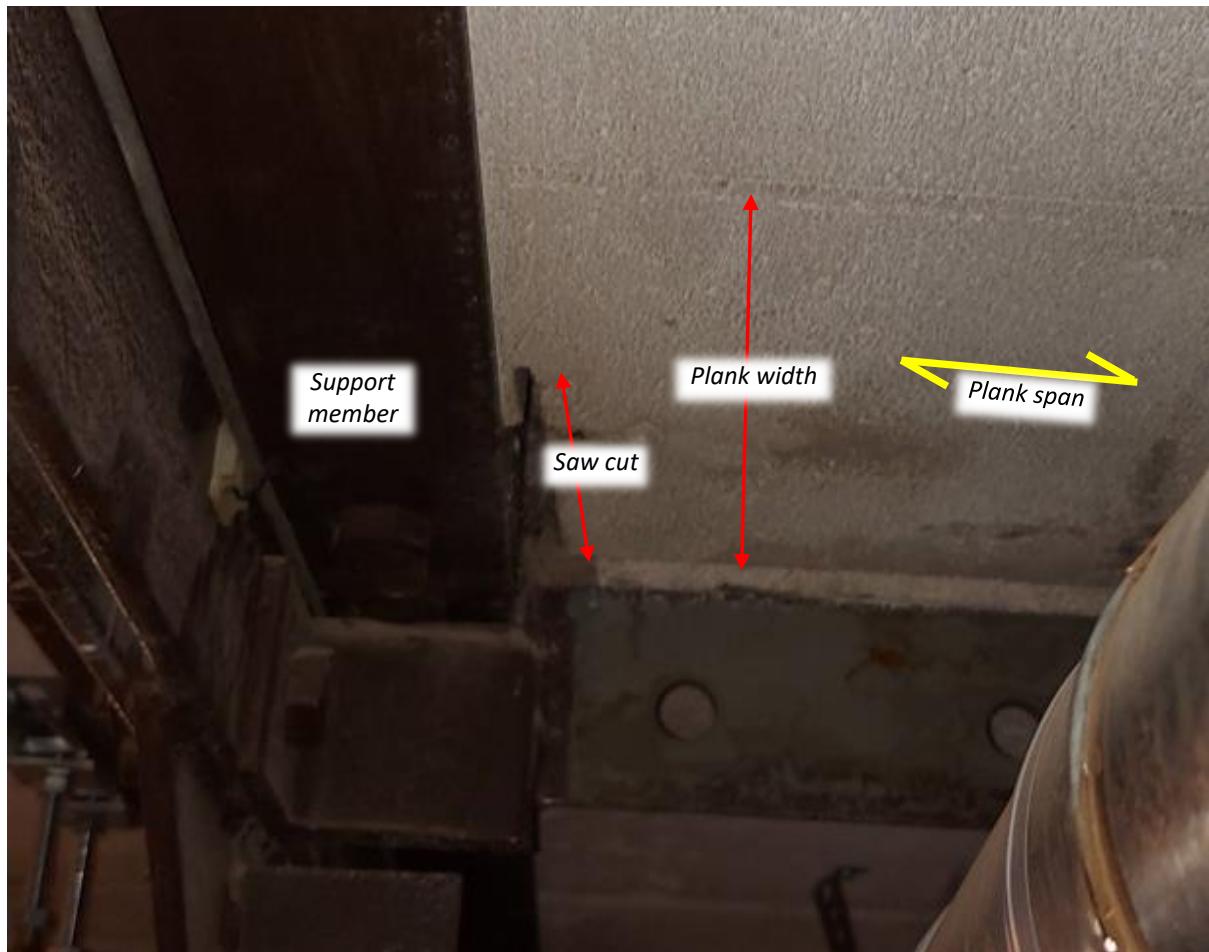
PHOTO 2 – RAAC PANEL CUT AT SUPPORT LOCATION

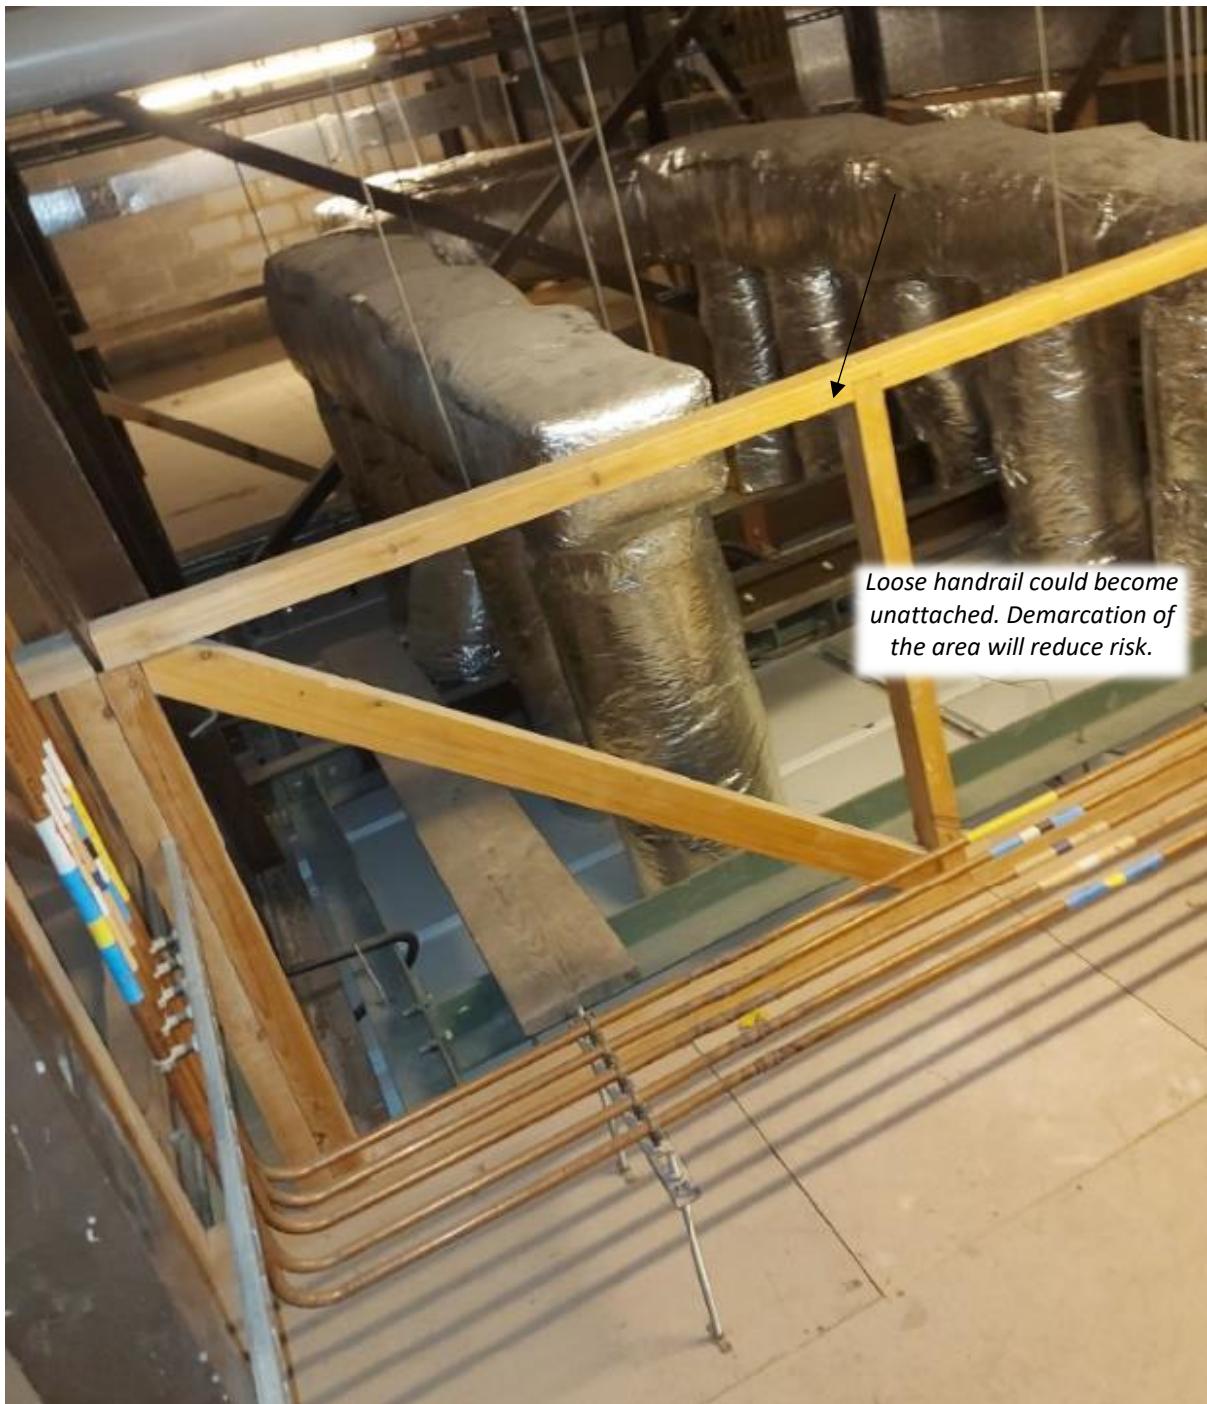
PHOTO 3 – LOOSE HANDRAILS

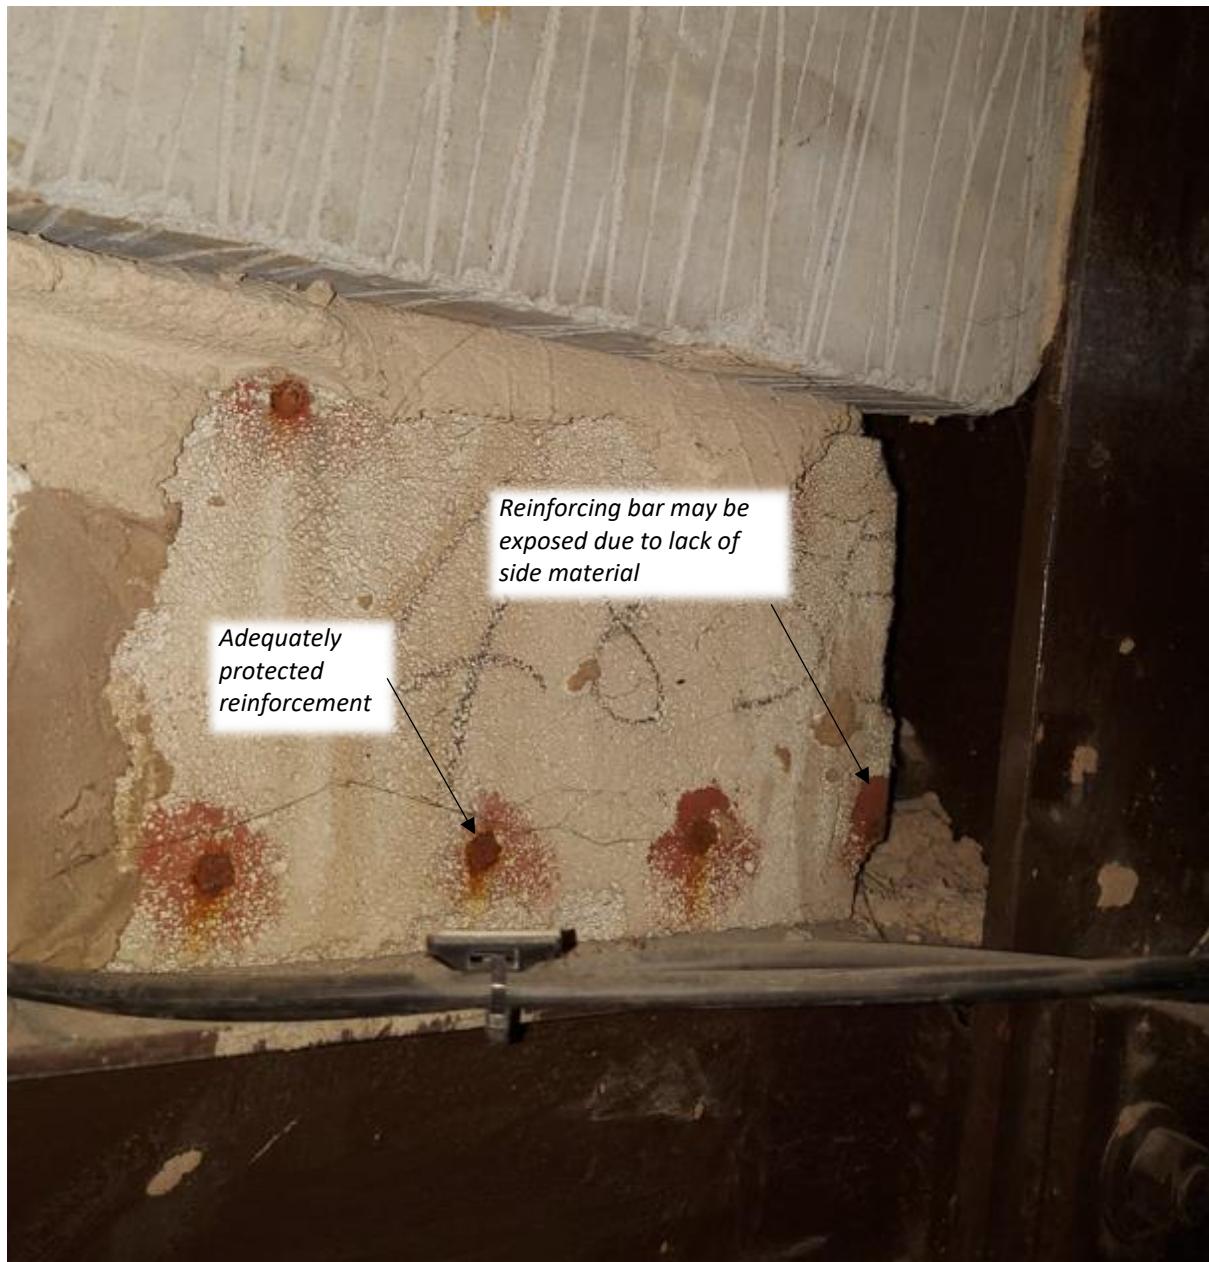
- Roughly cut units exposing reinforcement, planks 102, 111, 143, 166, 199, 222 and 245 (photo 4)
- Untreated exposed reinforcement, plank 15 (photo 5)
- Loosely fitting and missing holding down clips (photo 6)
- Long term ponding of water at roof level (photo 7A and 7B)
- Water ingress through roof build-up, plank staining and moderate floor damage particularly above theatre 4 (photo 8A and 8B)
- Unprotected falls from height, occurs where roof ladder is positioned (photo 9)

PHOTO 4 – ROUGHLY CUT RAAC PLANK

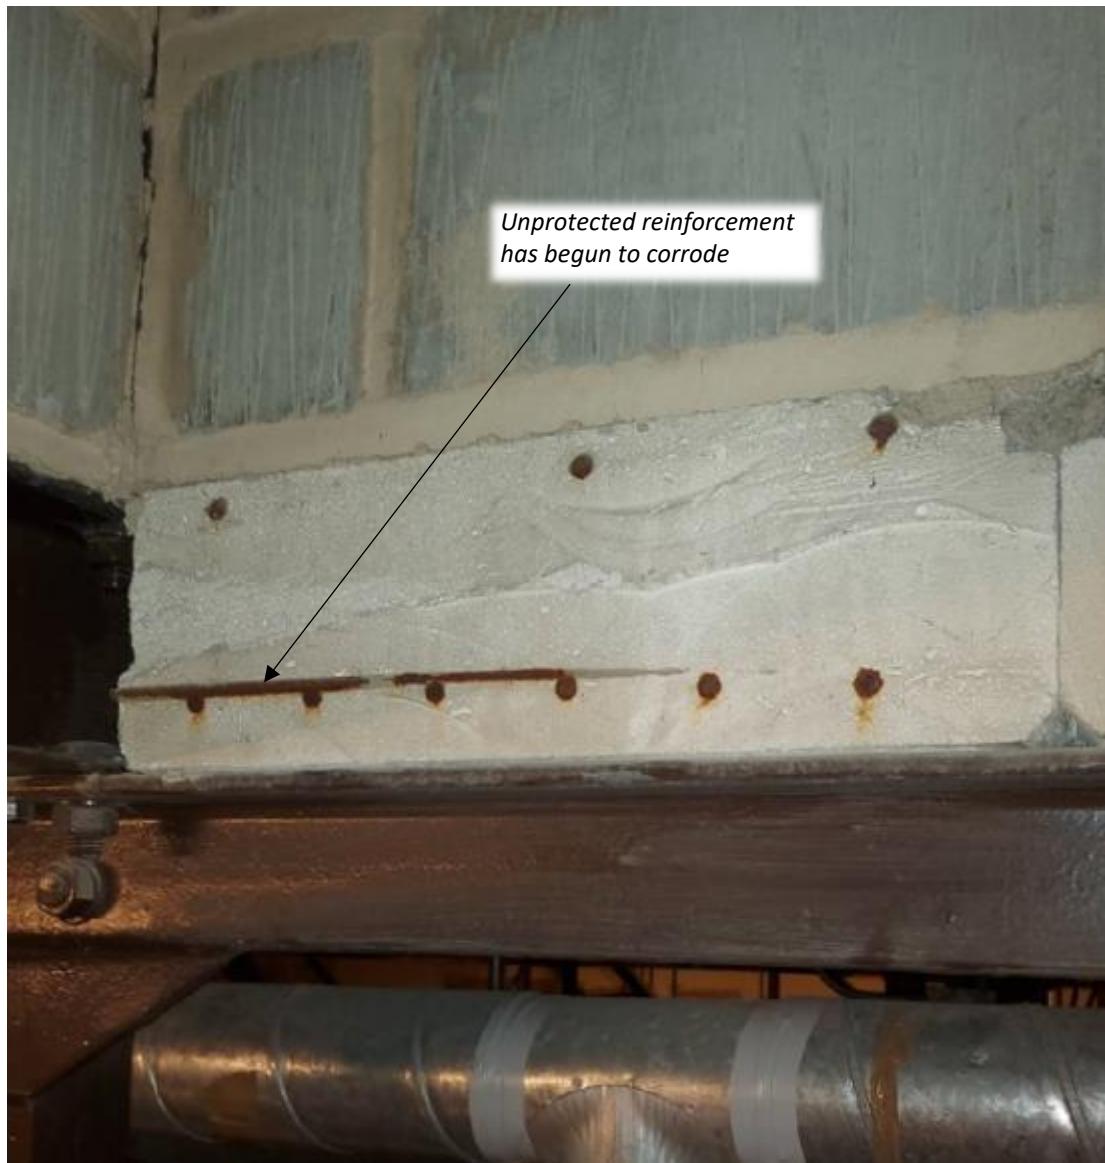
PHOTO 5 – CORROSION OF UNPROTECTED REINFORCEMENT

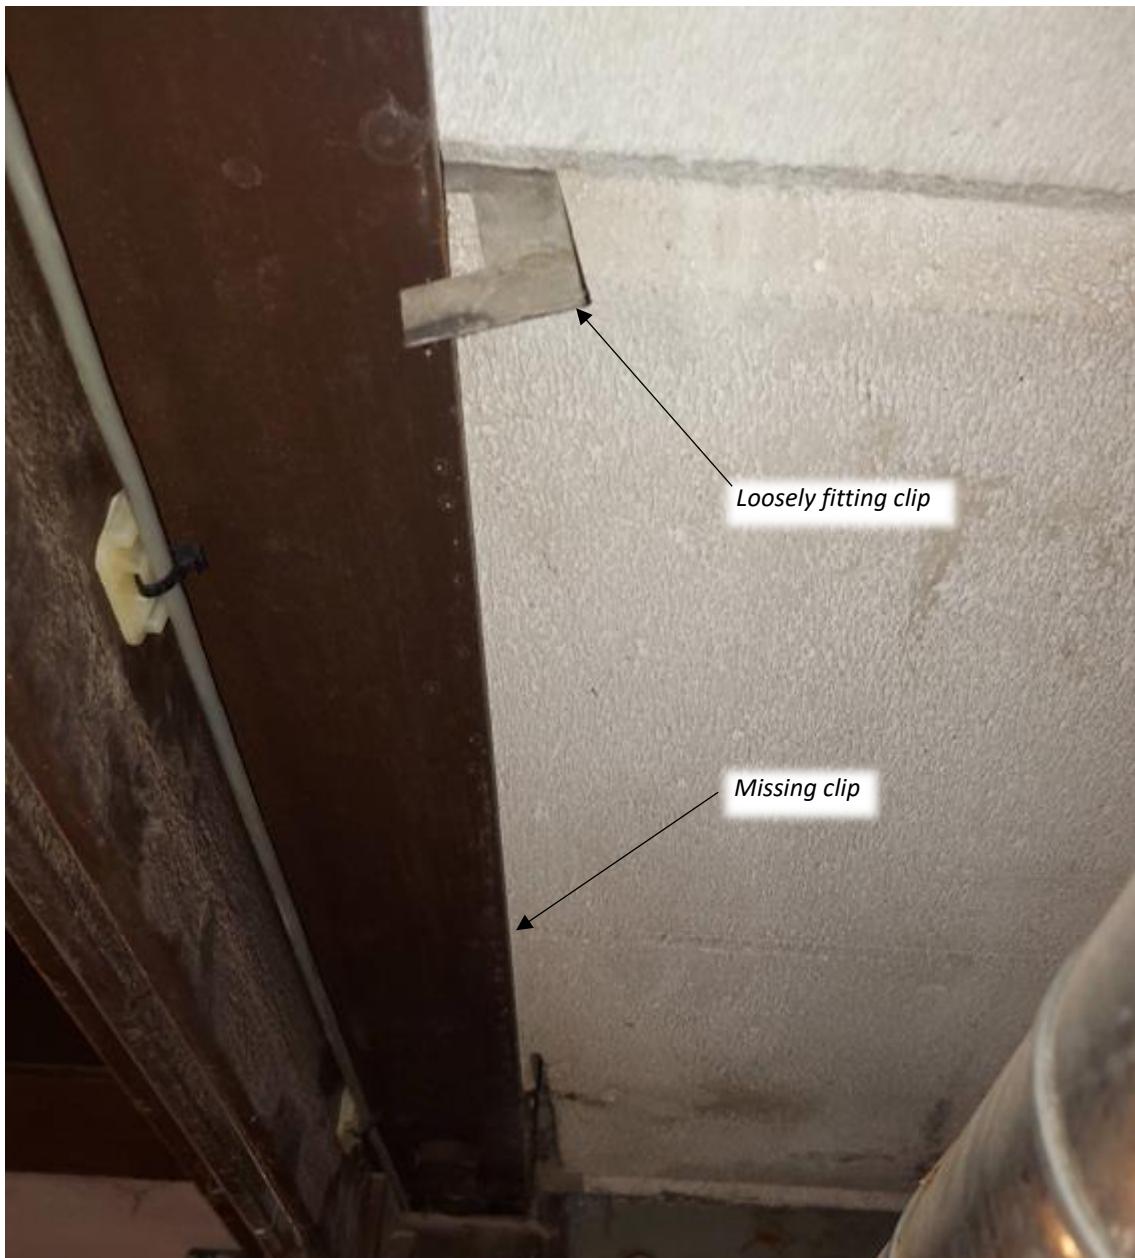
PHOTO 6 – MISSING PLANK CLIPS FOR HOLDING DOWN

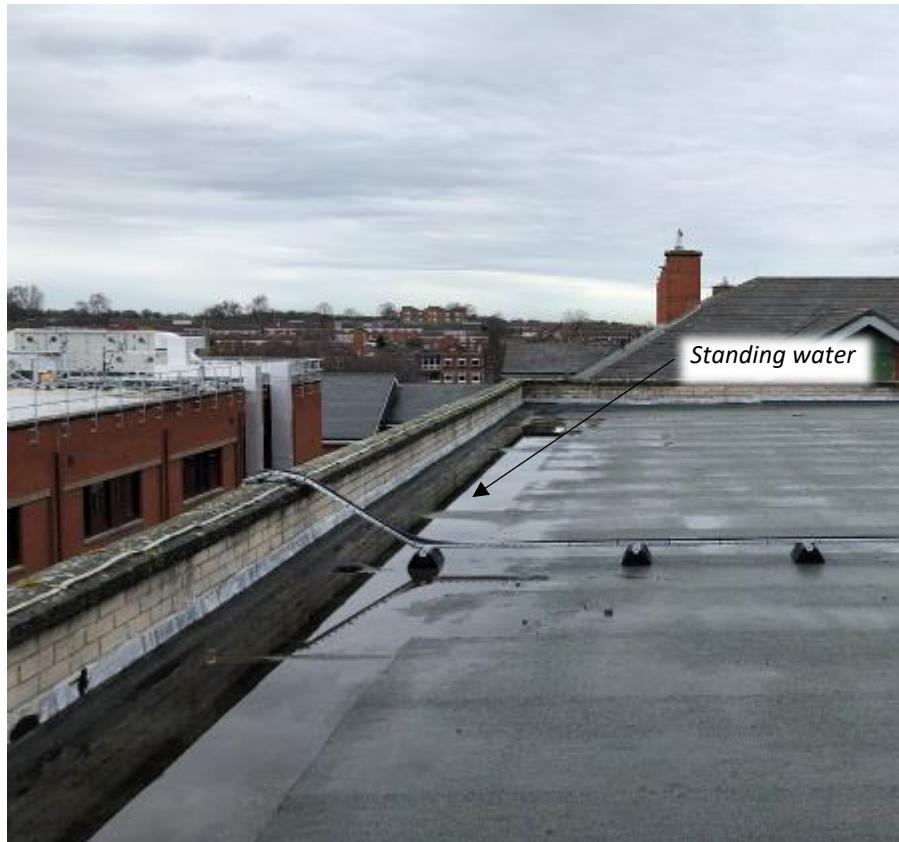
PHOTO 7A – PONDING, PHOTOGRAPH FEBRUARY 2021

It is recommended the gullies at roof level are inspected by estates during periods of heavy rain to ensure they are draining freely. Several gullies were missing caps which prevent blockages, these should be re-fitted if possible. Consideration should be given to identifying any surface damage where water is able to penetrate, and sealing with a synthetic rubber patching system. Unless the roof is re-surfaced with tapered insulation or similar to achieve a minimum fall it will be challenging to fully address the standing water issue.

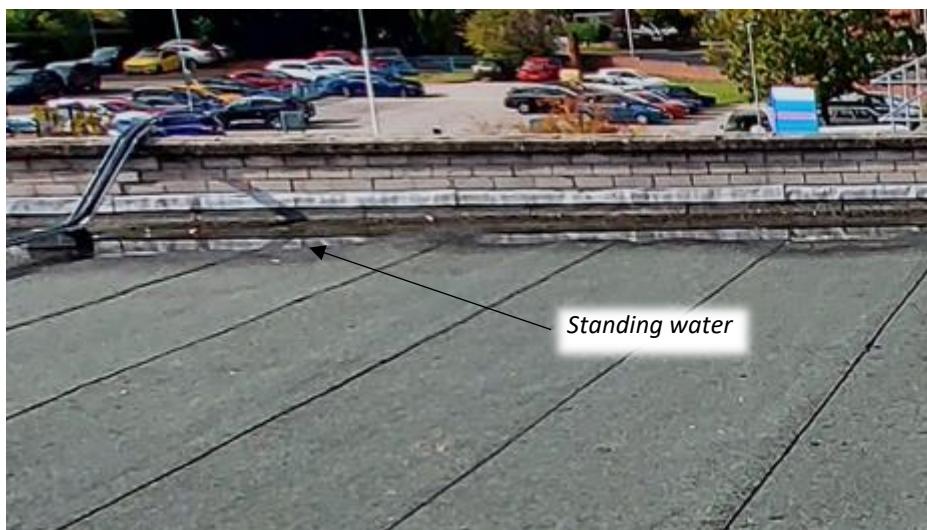
PHOTO 7B – PONDING, PHOTOGRAPH OCTOBER 2021

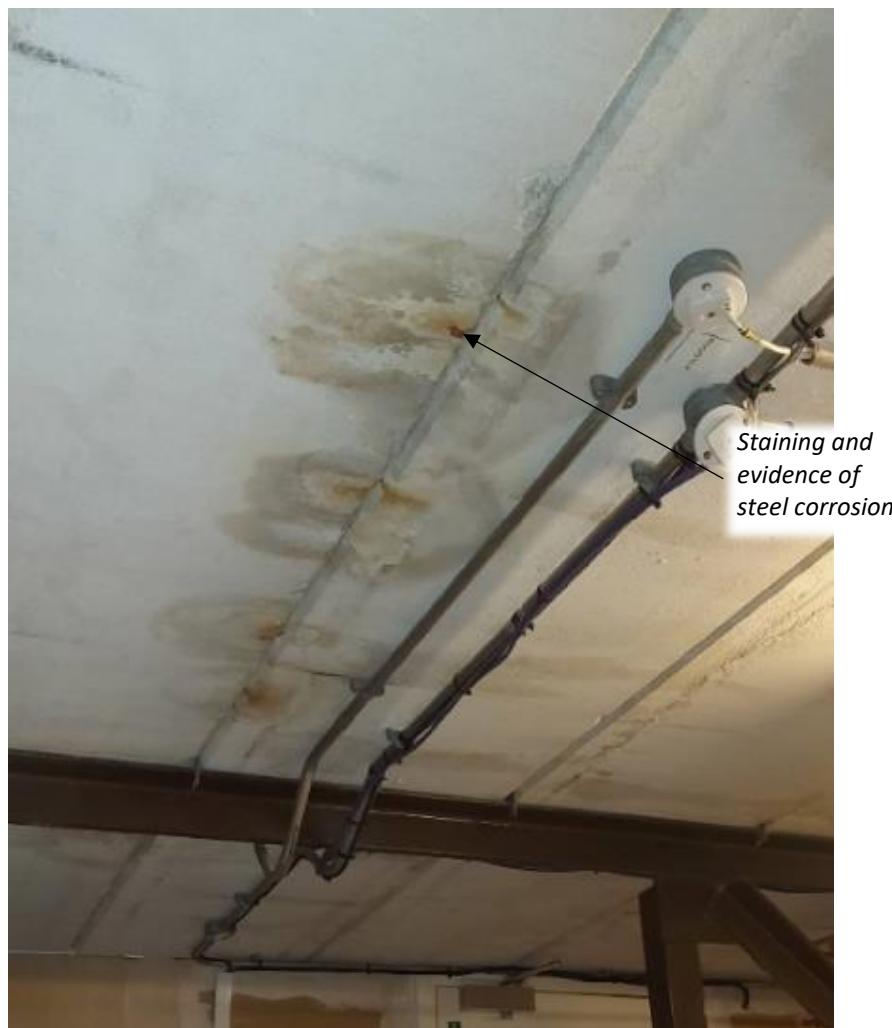
PHOTO 8A – WATER INGRESS AND STAINING OF PLANKS

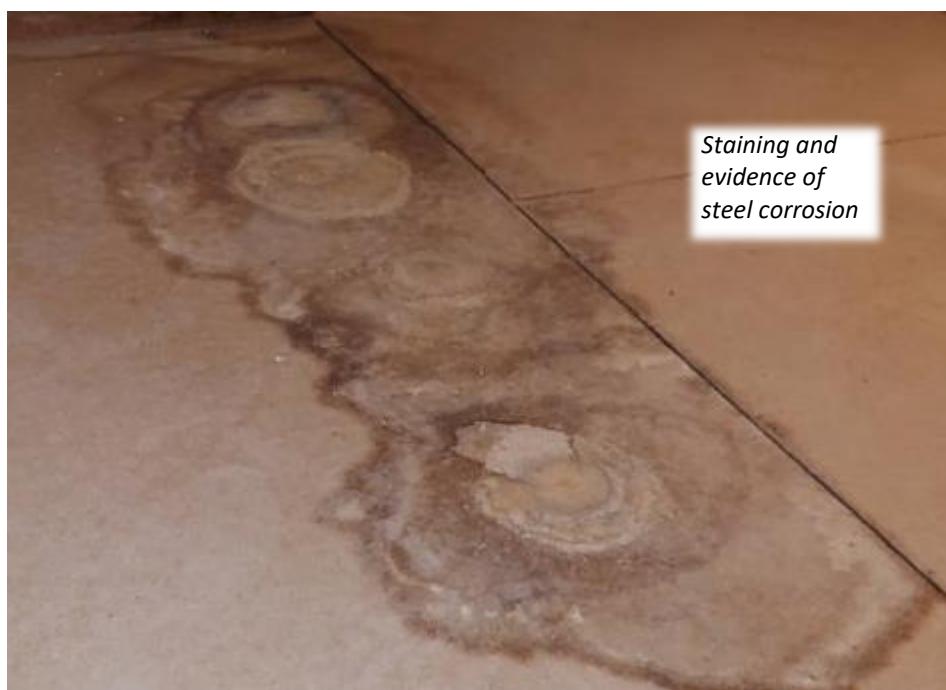
PHOTO 8B – MODERATE WATER DAMAGE BELOW WATER INGRESS LOCATIONS

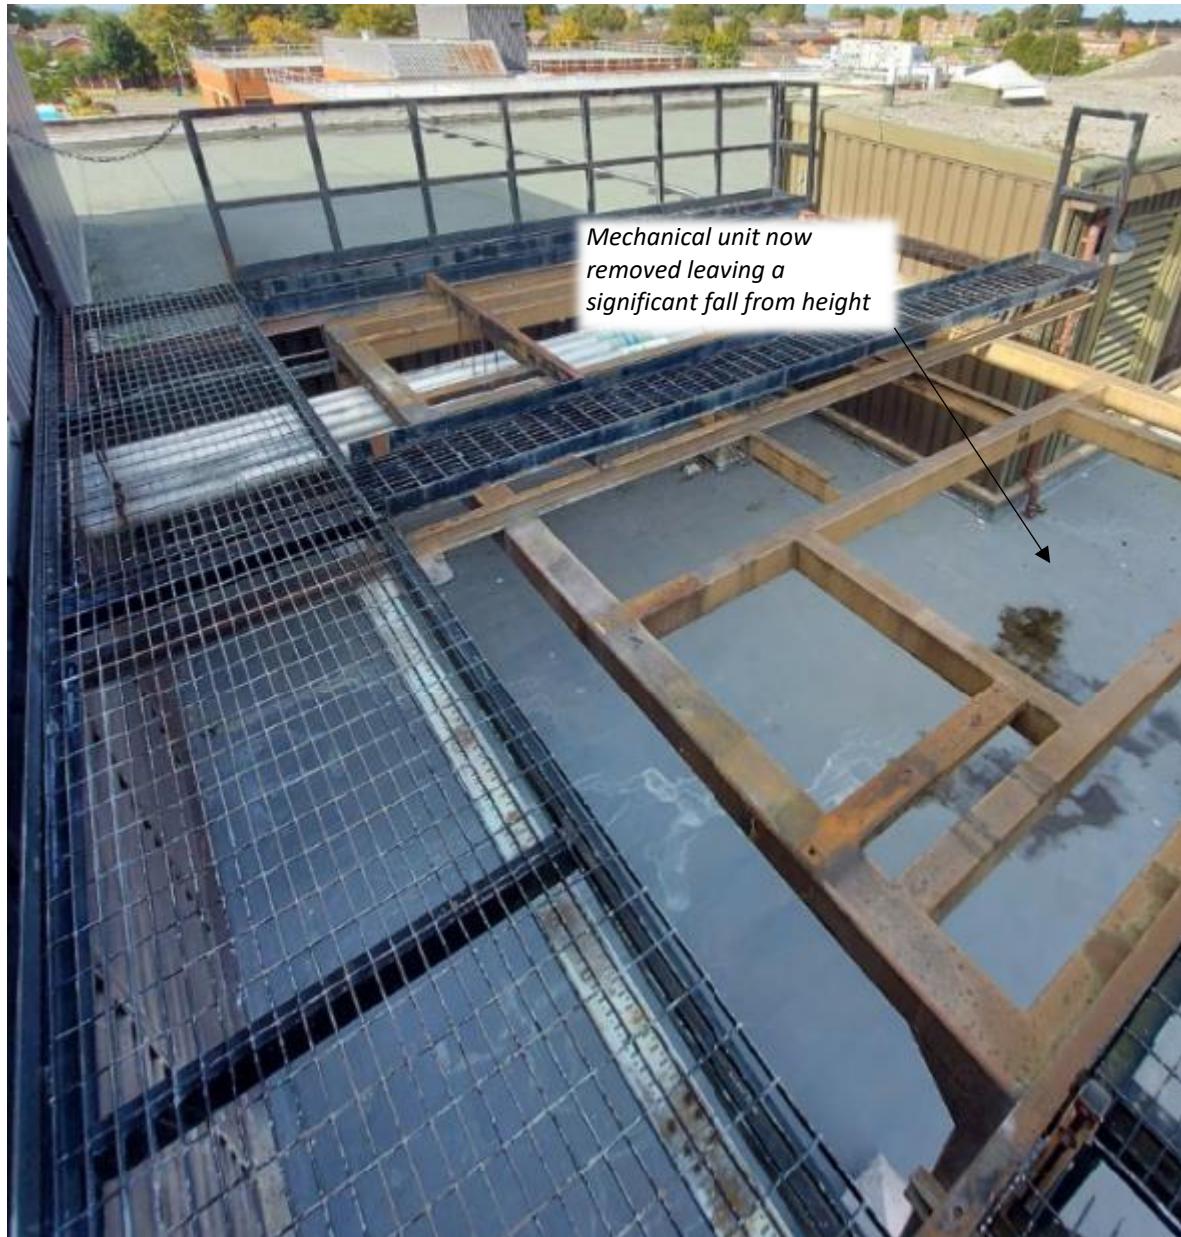
PHOTO 9 – UNPROTECTED FALLS FROM HEIGHT

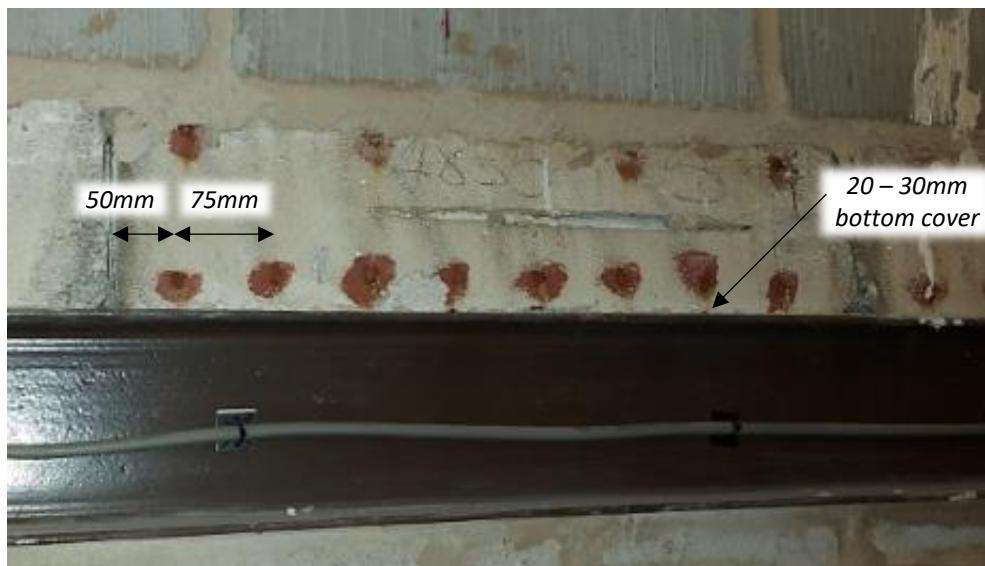
Generally, bearing lengths appeared to be in excess of 80mm and reinforcement cover was found to be 20mm to 30mm. Main tension reinforcement in the bottom of each plank was consistently found to be at 75mm centres. Refer to photo 10 for a visual aid. Span/depth ratios are around Span/22. None of these geometric values are cause for concern.

PHOTO 10 – REINFORCEMENT ARRANGEMENT
