Structural Appraisal Report for RAAC Roof Planks at Haywood Hospital, Stoke-On-Trent

Prepared for Midlands Partnership NHS Foundation Trust

28/01/2020

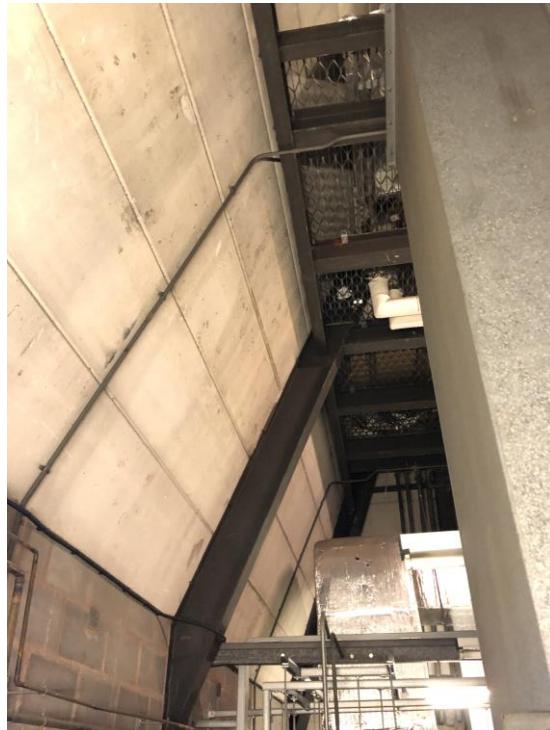
Planks in this area appear to be in reasonable condition with no visible sign of any significant defects, this is shown in Photos 1 to 3. Minor abrasions to the underside of planks are visible in certain locations, these are likely to have been caused during the erection process of the structure, shown in Photo 4.

Photo 1 Plant Room 1 Mansard Planks

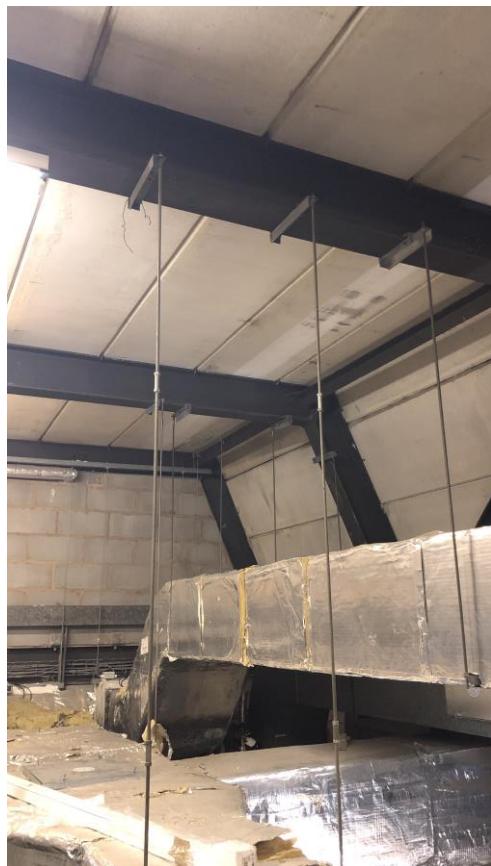
Photo 2 Plant Room 1 Roof Planks

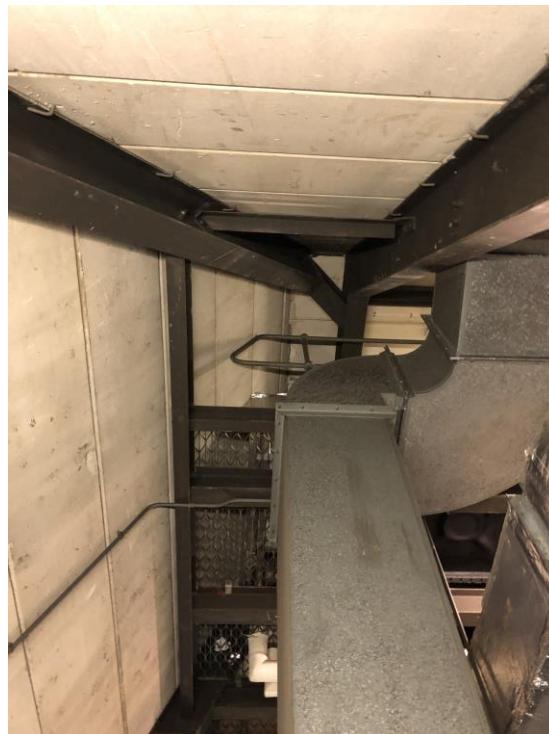
Photo 3 Plant Room 1 Planks

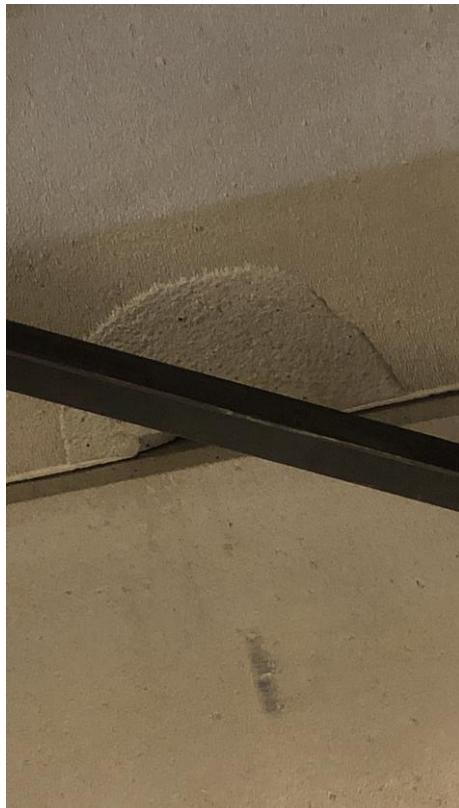
Photo 4 Plant Room 1 Planks - Minor Abrasions

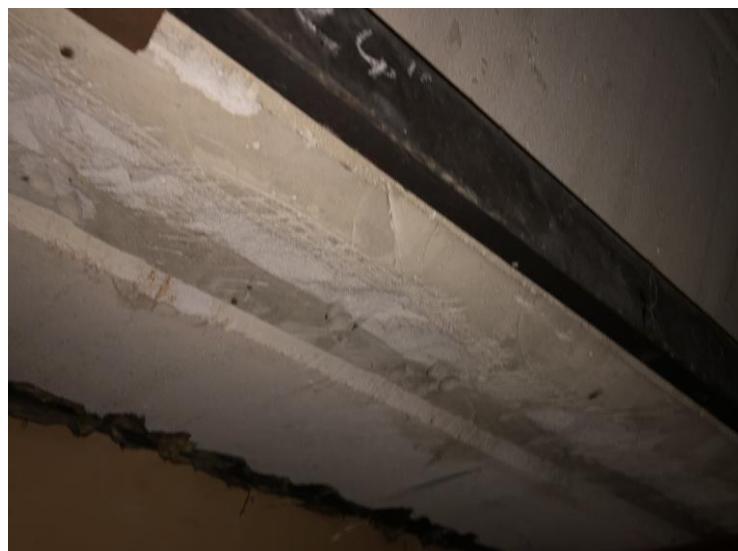
There appeared to be an alteration made to a mansard plank above the louvred door on the western side of the plantroom. This is shown in Photo 5. As this is to a mansard roof plank, it is likely that this alteration was carried out to remove a protruding 'tongue' section of the plank which would typically be utilised in the interlocking action between adjacent planks. It is assumed this was carried out so that not to clash with the angle bracing below. As a result of this, the transverse reinforcement has been exposed and left untreated. Refer to Photo 6.

Noted alterations include the mansard plank located above the louvred door in plant room 2. This plank appears to have had the interlocking section of plank removed so that not to clash with the angle bracing below (as noted under 3.2). In addition to this, due to being the face of the plank that is on show, the transverse reinforcement is visible and left exposed. As the plank is located in an unheated space which is susceptible to moisture, we would recommend that the exposed reinforcement should be manually cleaned with a wire brush to remove any surface corrosion and primed to provide protection against corrosion using an approved remedial steelwork primer such as Fosroc Nitoprime Zincrich. At this stage the alteration does not appear to have resulted in any deterioration to the plank itself, nor is it considered to be a cause for structural concern at this stage. However, it could be a point of weakness susceptible to cracking if corrosion to the reinforcement is to occur in the future. Therefore, it would be recommended that this area is monitored for any signs of deterioration in the future.

Photo 5 Plant Room 2 - Alteration to mansard plank

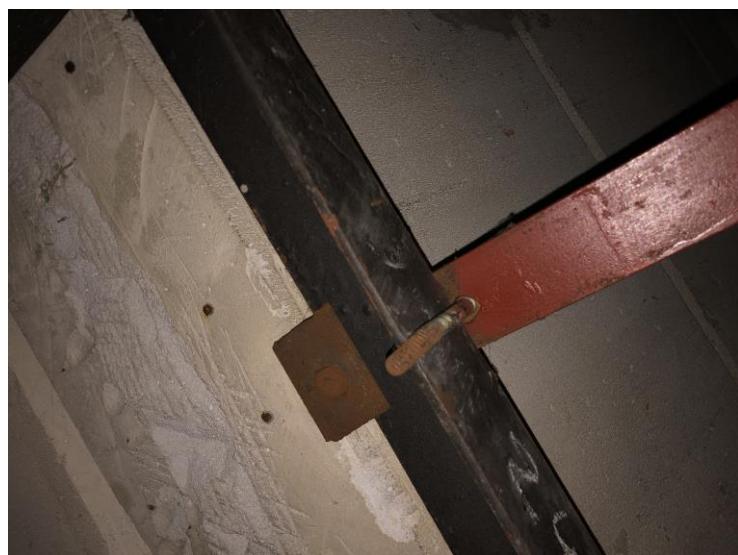
Photo 6 5 Plant Room 2 - Exposed Rebar

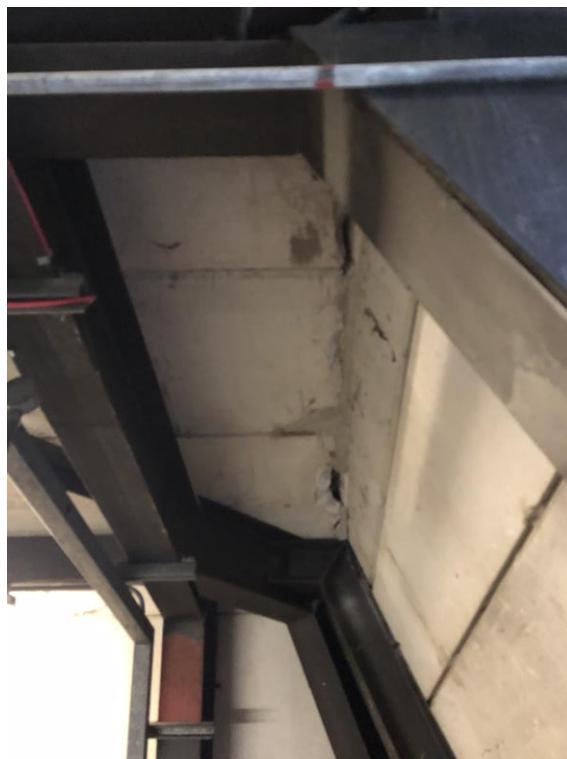
Photo 7 indicates signs of historic alterations to the ends of the roof planks where they have been altered to suit the intersection and slope of the mansard planks. It is likely that over time the grouting to this area has come loose and fallen, resulting in a gap between planks.

Additionally, in this plant room the ends of the roof planks have appeared to have been altered to suit the pitch of the incoming mansard. These areas had previously been grouted which appears to have fallen out at some point likely due to expected thermal movement of the planks. As this section of the plank is cantilevered from the main structural support, it is unlikely that this alteration has affected the structural integrity of the plank. However, it would be recommended that this area be re-grouted to eliminate the risk of moisture ingress in the future. Further to this, it would also be recommended to restrict access on the small portion of the roof where these alterations have been made, i.e. the outer 0.5m to the perimeter of the roof.

Photo 7 Plant Room 2 - Plank end alterations

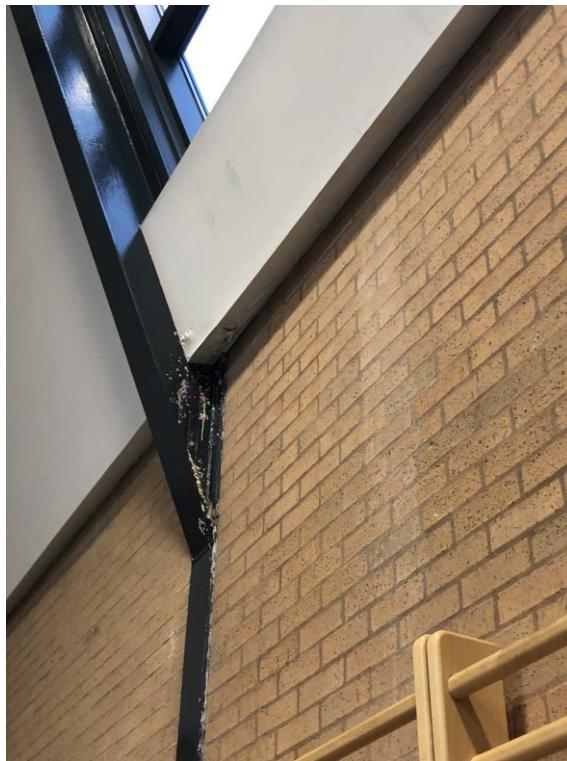
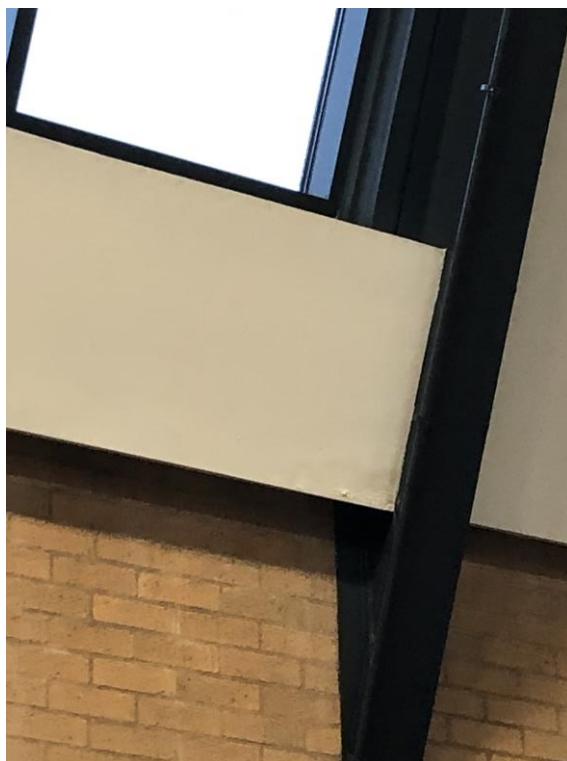
There is staining to the finishes in the mansard section below the windows to the northern and southern elevations, as shown in Photos 8 and 9 respectively, suggesting moisture ingress. Externally there is a large gap between the window cill and mansard tiling, allowing moisture ingress below external finishes. This is shown in Photo 10. The water ingress is considered to occur under rainfall events which is evident to occur from the standing water on the cill

In the gymnasium it is evident that moisture ingress has occurred around the windows in the mansard roof on the north and south elevations. This is potentially due to a lack of sealant around the windows allowing moisture to ingress behind the external finishes. The staining to the internal finishes and columns suggests that the planks have potentially been affected by this moisture ingress. In these locations we would recommend works are undertaken to strip off the finishes and expose the planks so that these can be visually inspected. The source of the moisture ingress will also need to be addressed to prevent future ingress.

Photo 8 Gym - Moisture Ingress

Photo 9 Gym - Moisture Ingress

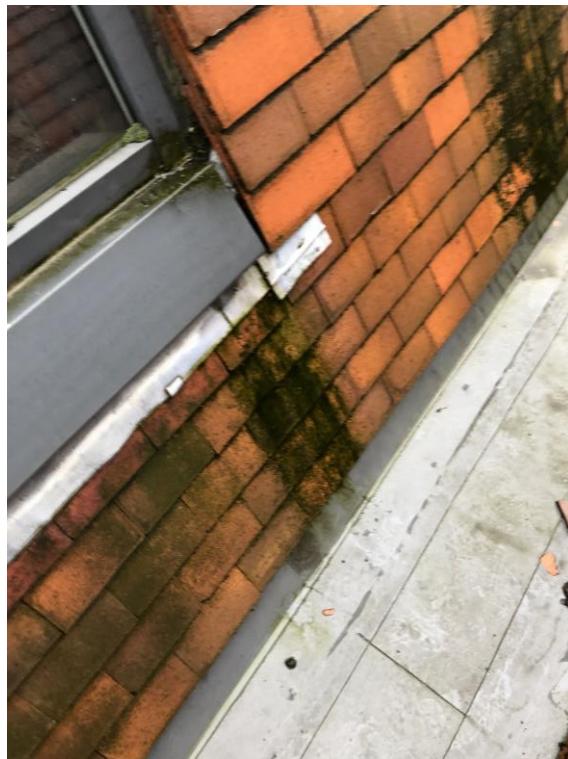
Photo 10 Gym - Moisture Ingress

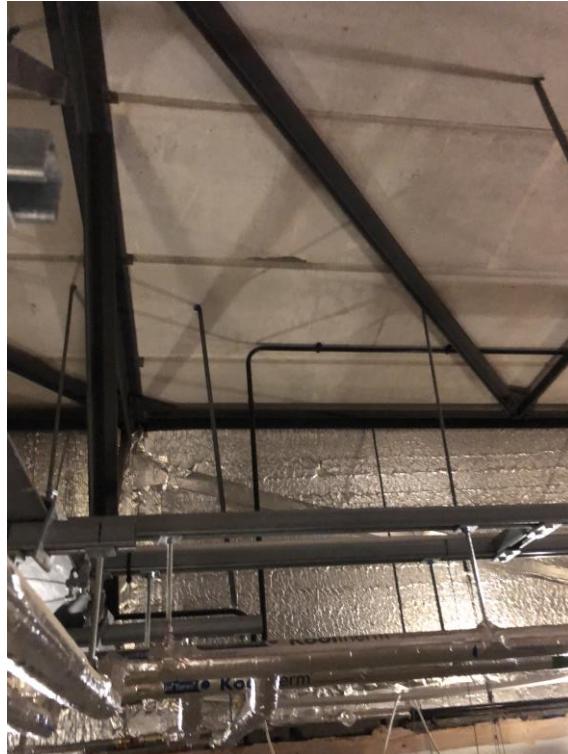
Shown in Photo 11, there are a lot of fixings to the underside of the planks supporting the ceiling and mechanical equipment. This results in applying additional load to the planks. We would consider that the location of fixings for the original mechanical equipment was agreed between the Mechanical and Electrical and Structural consultants at the time of installation.

It is evident throughout the building that there are a vast number of fixings to the underside of the roof planks, which are typically supporting mechanical and electrical equipment along with secondary ceiling finishes. Whilst these are adding additional load to the roof planks, there is a greater likelihood that pullout of these fixings could occur if not of an approved fixing specification. This could result in localised break outs of the concrete planks which could in turn affect the structural integrity of the planks. It is therefore recommended that during any maintenance to rooms that all fixings are removed from the planks. All equipment, that is currently supported from these fixings would then be required to be transferred to a Unistrut frame spanning between main structural steel members supporting the roof.

Photo 11 Fixings to roof planks

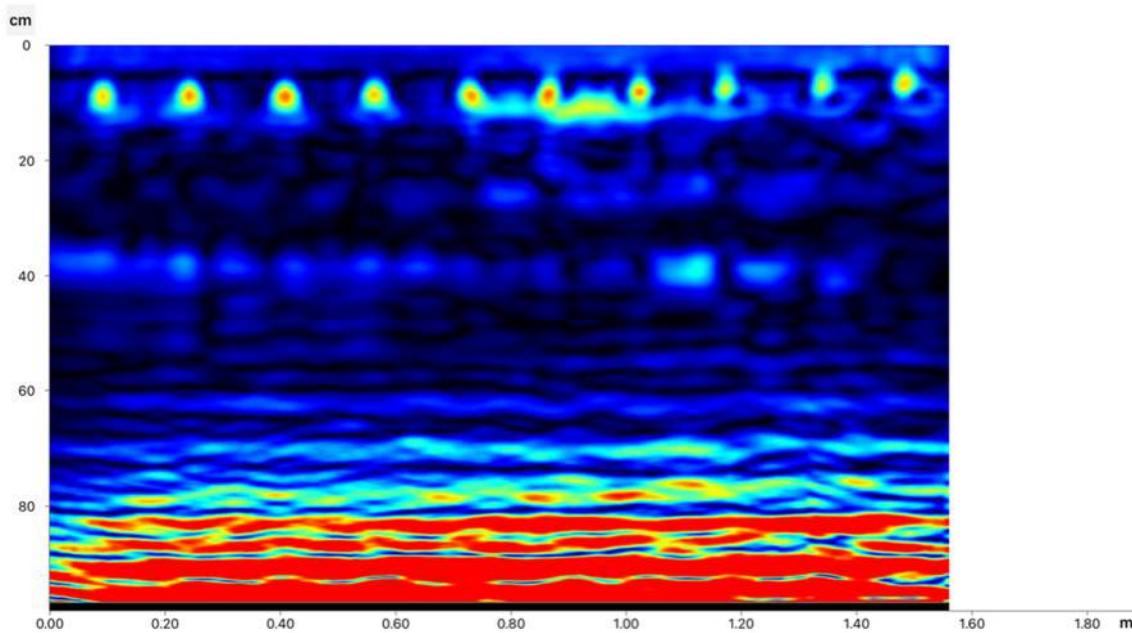
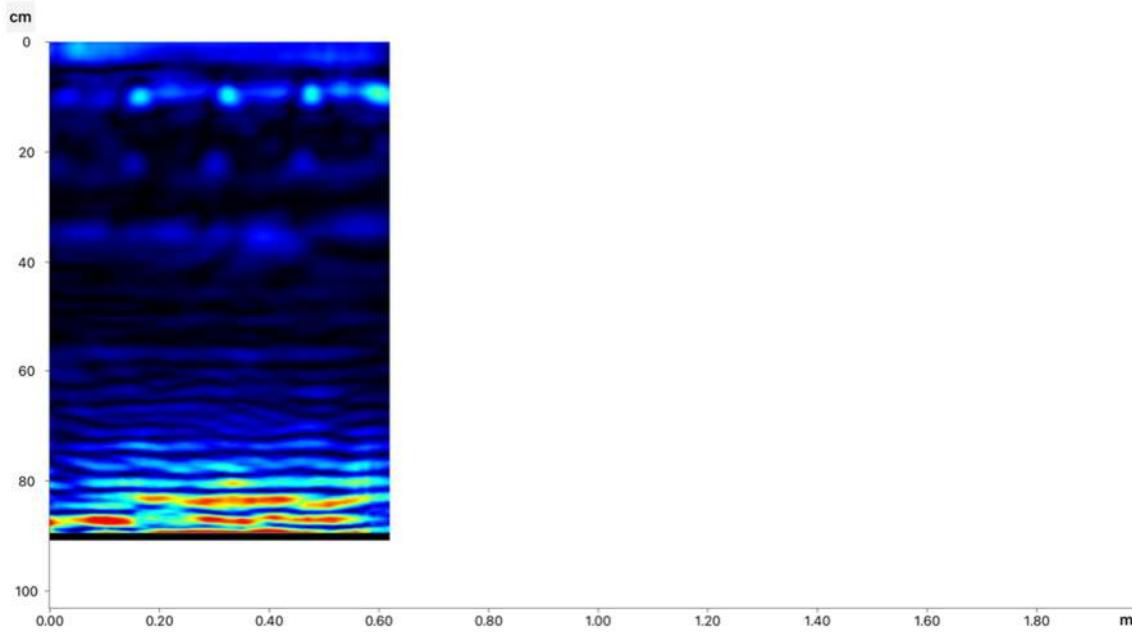
GPR scan along face of wall showing vertical bars and thickness of wall (including finishes)

GPR scan up face of wall showing horizontal bars and thickness of wall (including finishes)

- Uniform in construction – RC wall.
- 300mm thick plus finishes.
- Two layers of uniform reinforcement. Horizontal and vertical bars at 150mm centres to both layers.
- Bars were detected as 8-10mm in diameter.

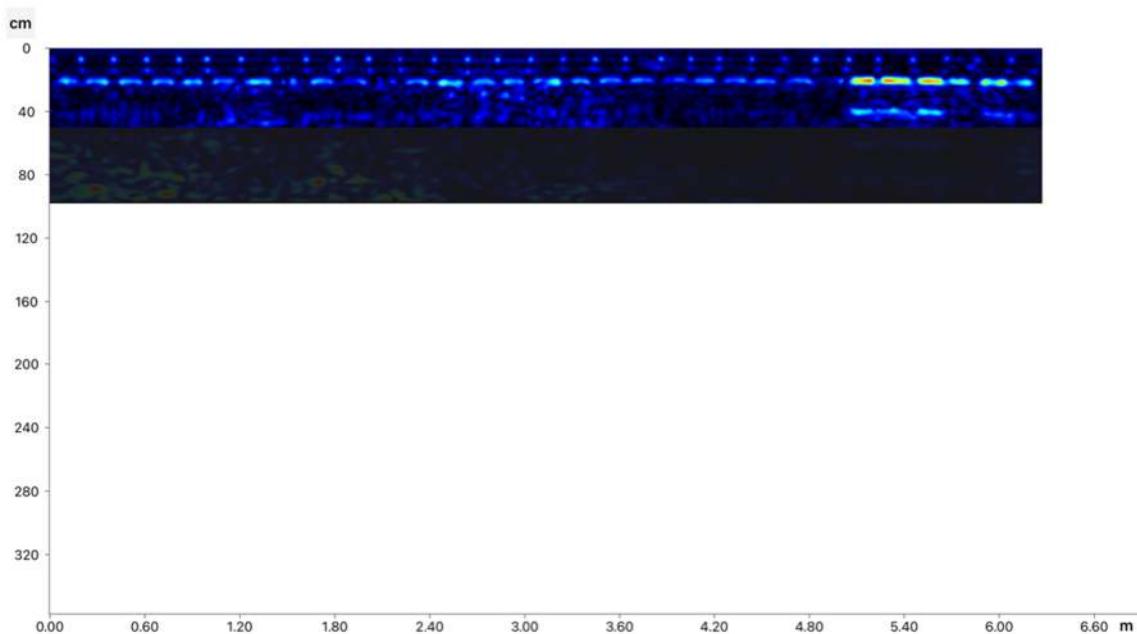
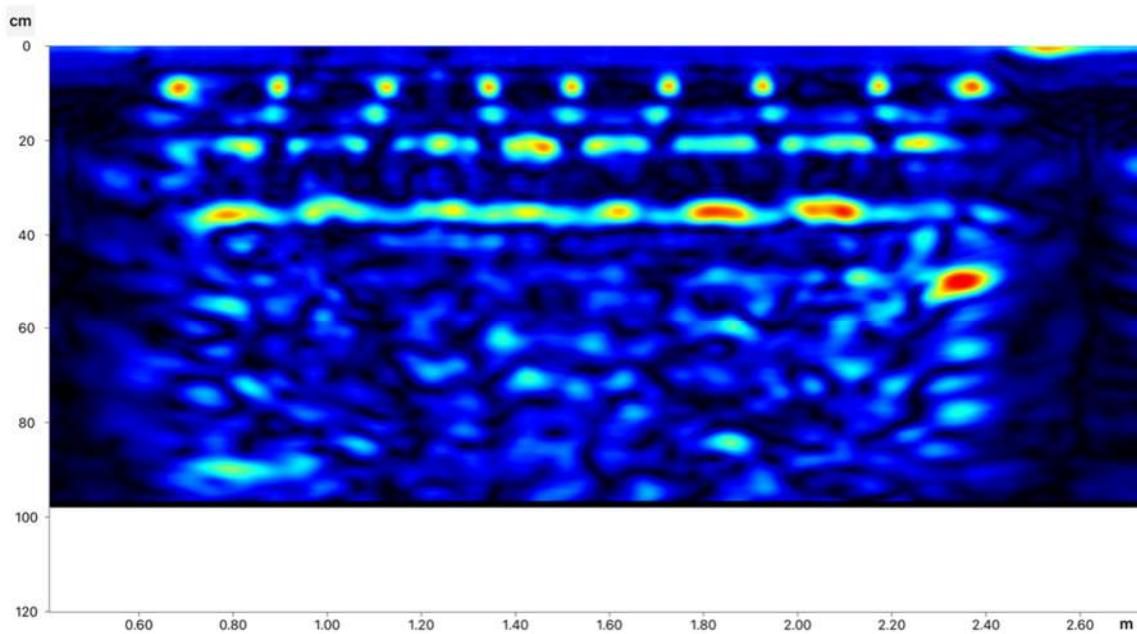
GPR scan to soffit of hydrotherapy room showing bars in X direction

GPR scan to soffit of hydrotherapy room showing bars in Y direction

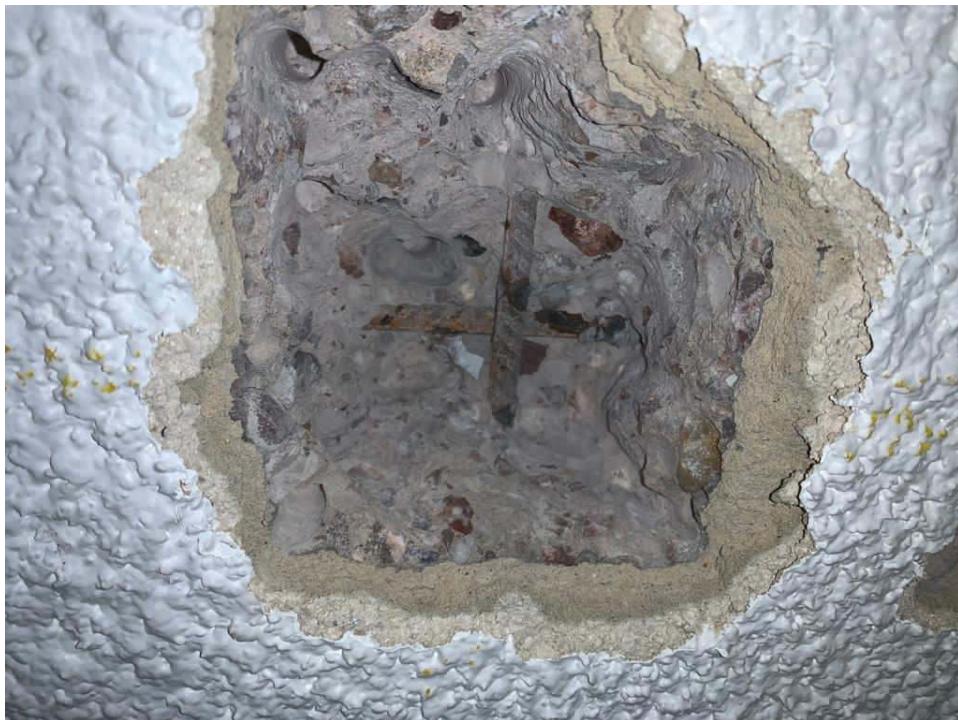
Photograph 004 – Breakout to soffit of hydrotherapy room

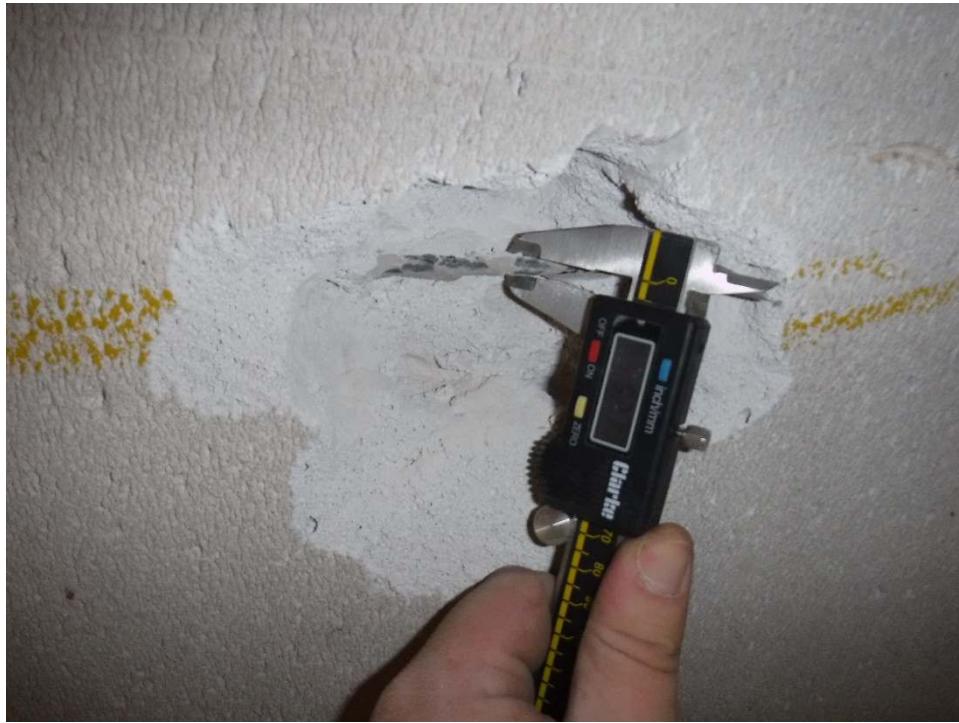
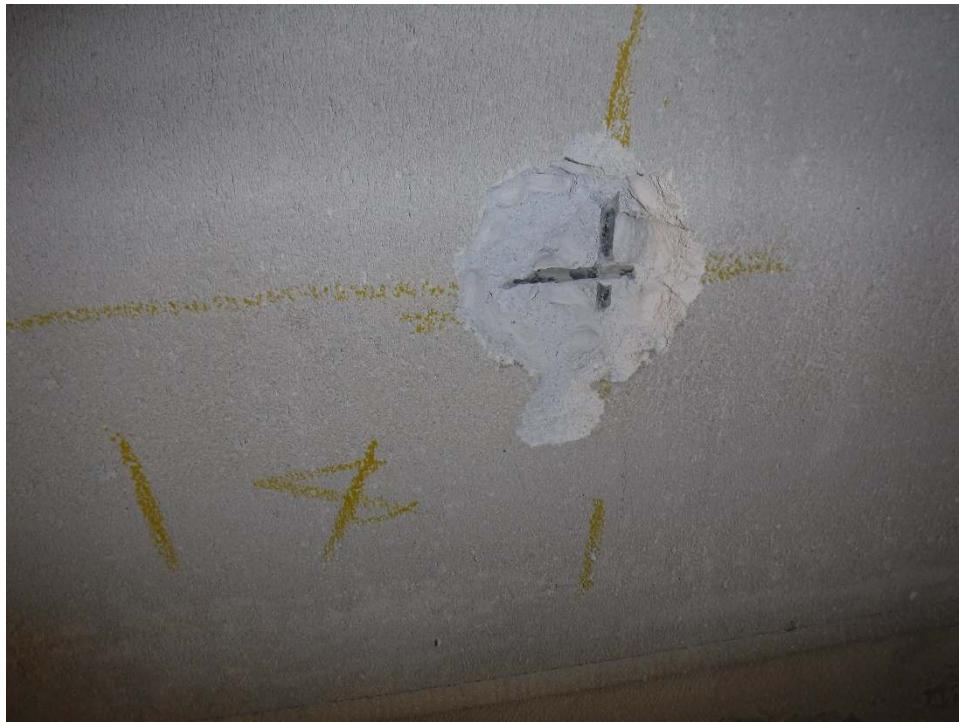
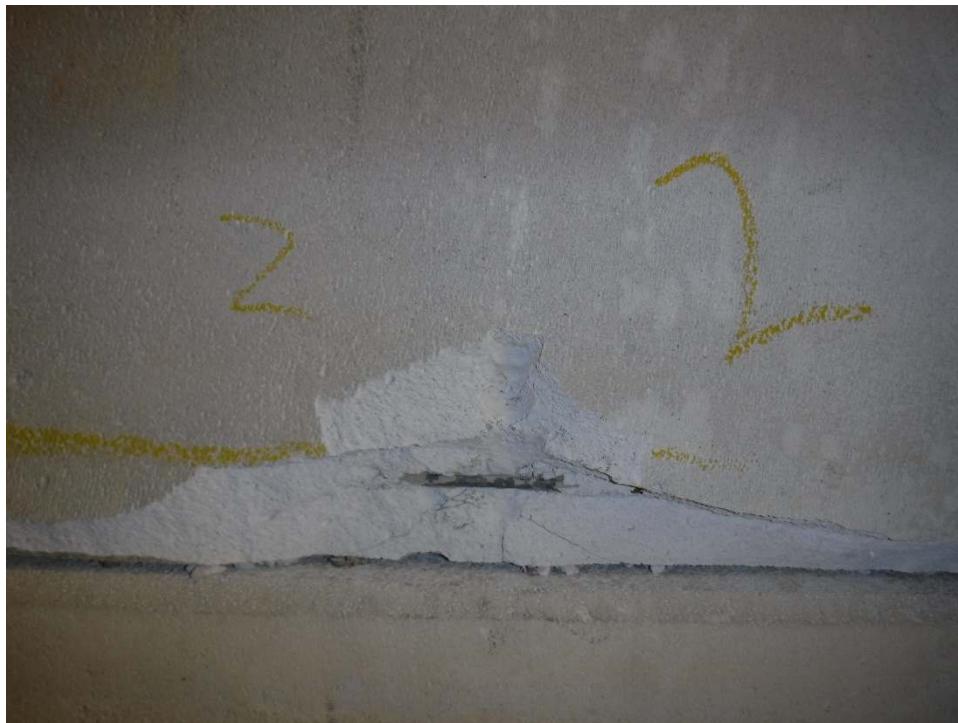
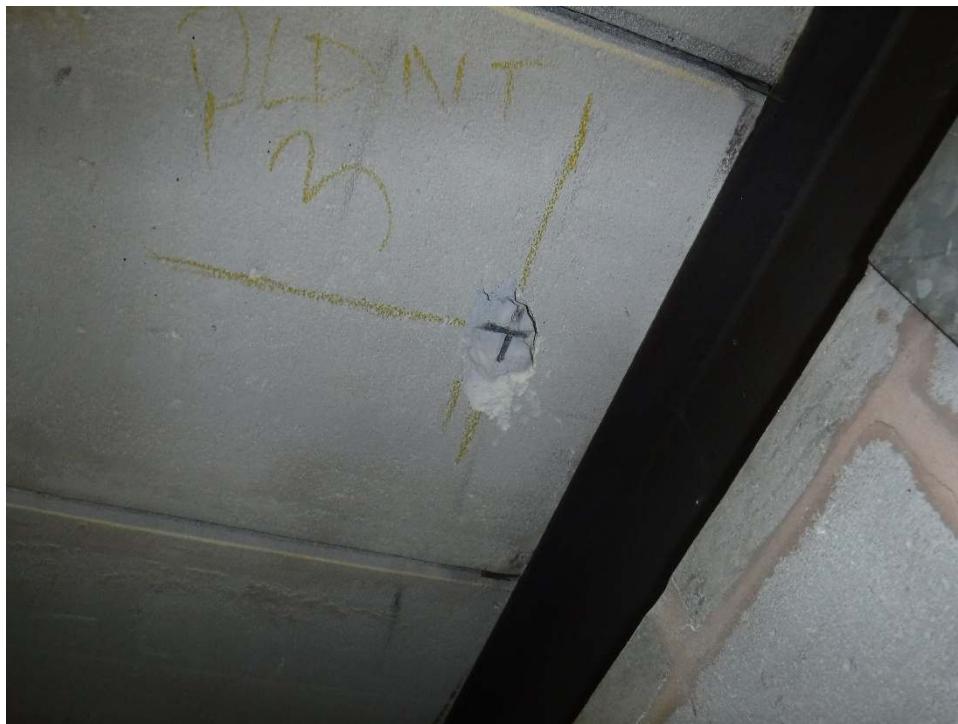
Photograph 006 – Breakout to RAAC planks above plant area

Photograph 007 – Breakout to RAAC planks above plant area

Photograph 008 – Breakout to RAAC planks above plant area

Photograph 009 – Breakout to RAAC planks above plant area

- Reinforcement broken out in good condition with no signs of corrosion or rust staining.

- Reinforcement broken out was all 5-6mm diameter in both directions, smooth round bars.
- Scans showed that longitudinal reinforcement carried on towards end of plank (impossible to scan end of plank to confirm as bearing on steel beams) so likely reinforcement extends into bearing areas at ends of planks.
- Planks contain two layers (top and bottom) longitudinal bars at 250mm centres within the planks. Cover to these bars was low, but typically around 25mm from top and bottom). Each plank was approximately 600mm wide and contained 3 no. longitudinal bars per layer.
- Transverse bars were 900mm centres, two layers (top and bottom at these points) with low cover of 20-25mm.
- Planks were 200mm thick with finishes to roof above on top. Finishes were an additional 100-120mm thick.

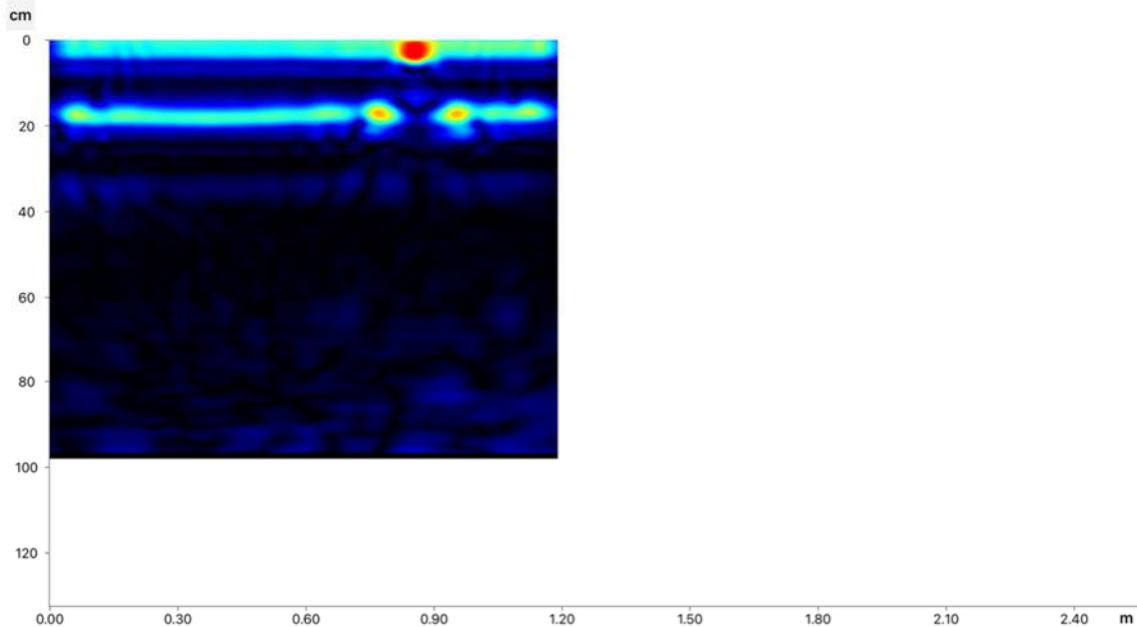
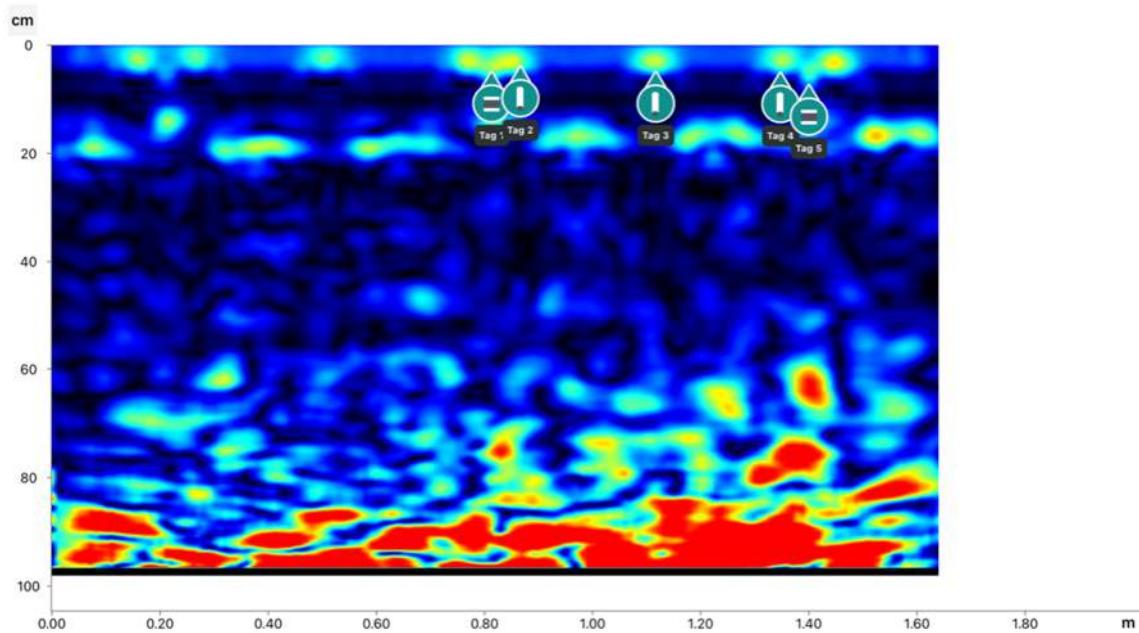
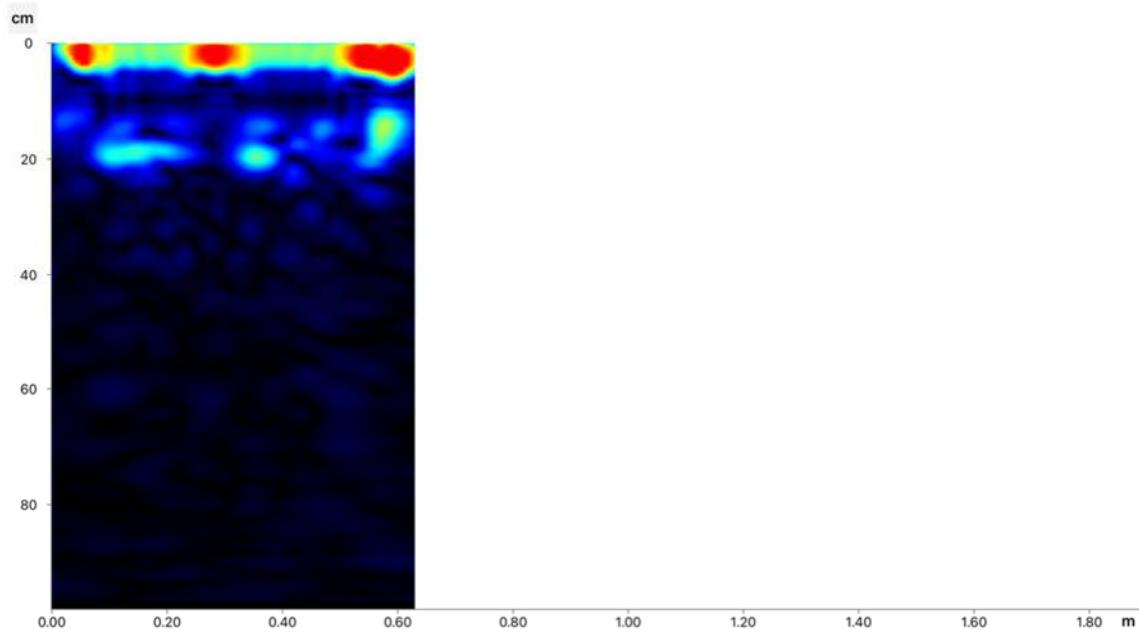
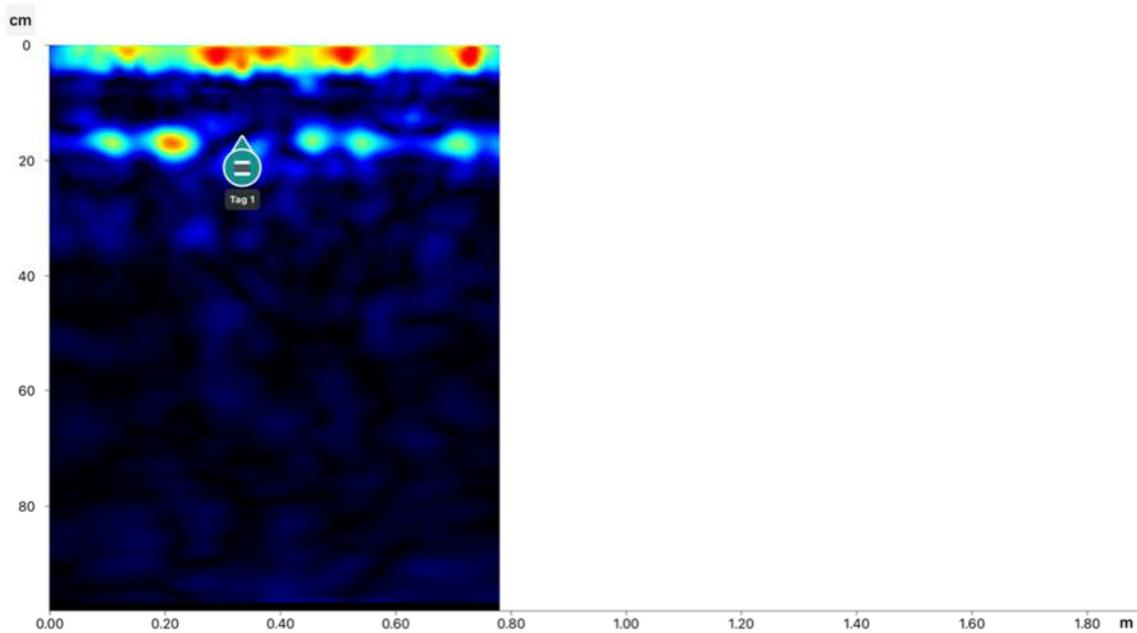
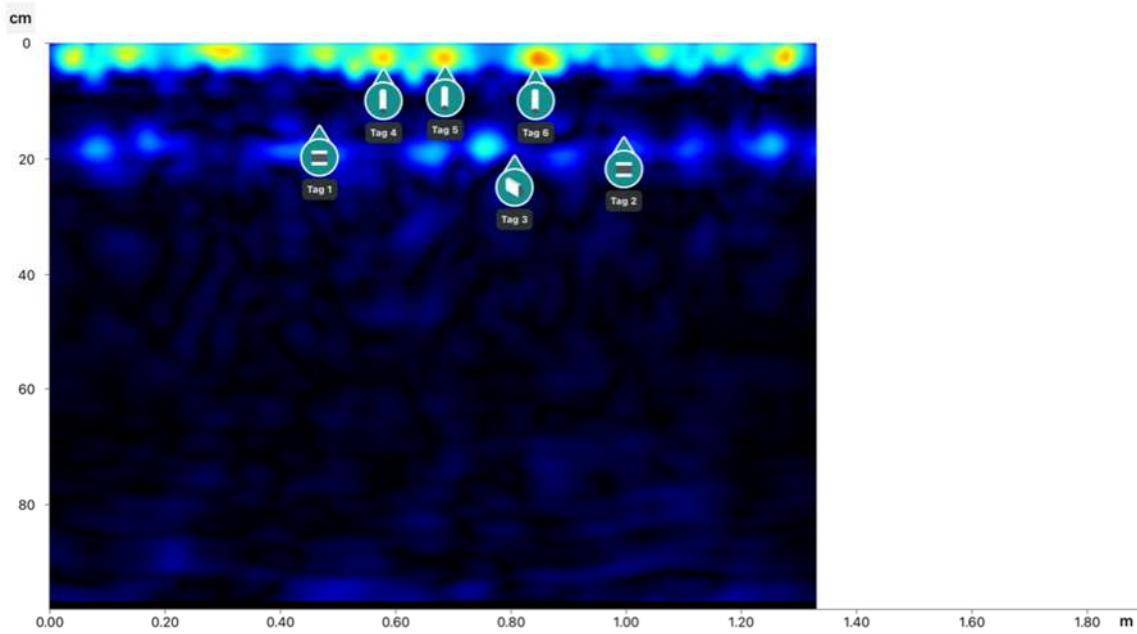
Typical GPR scan along plank showing transverse reinforcement at 900mm centres (top and bottom)

Typical GPR scan across soffit of planks showing longitudinal bars (plank edges and bottom layer of bars marked) at mid-span

Typical GPR scan across plank at end showing reinforcement continuing towards bearing zone at end of plank

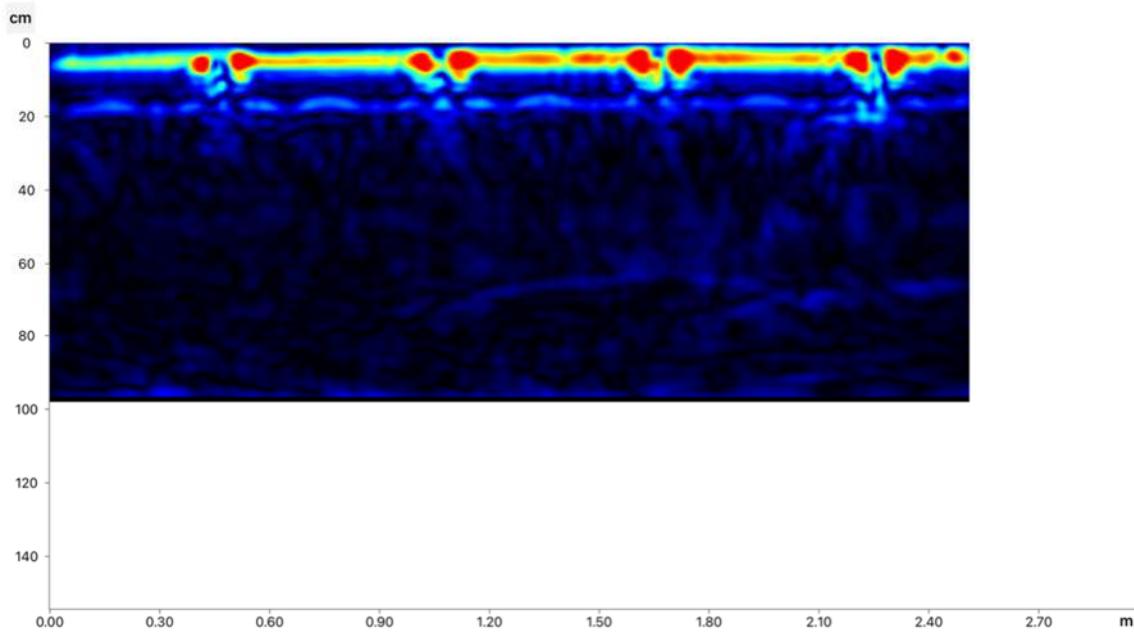
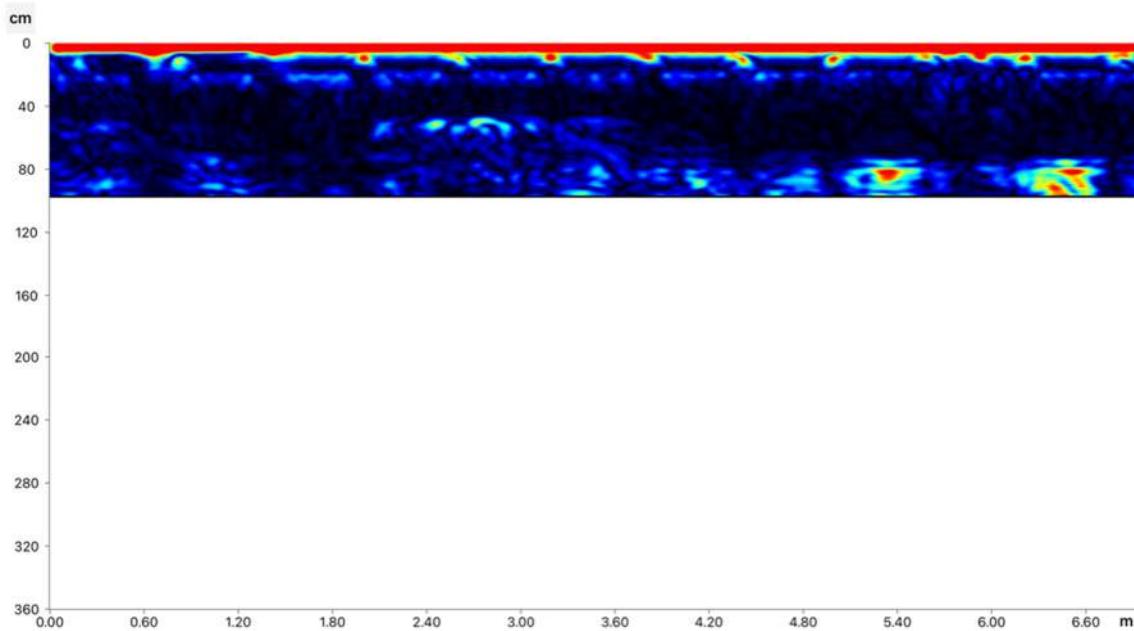
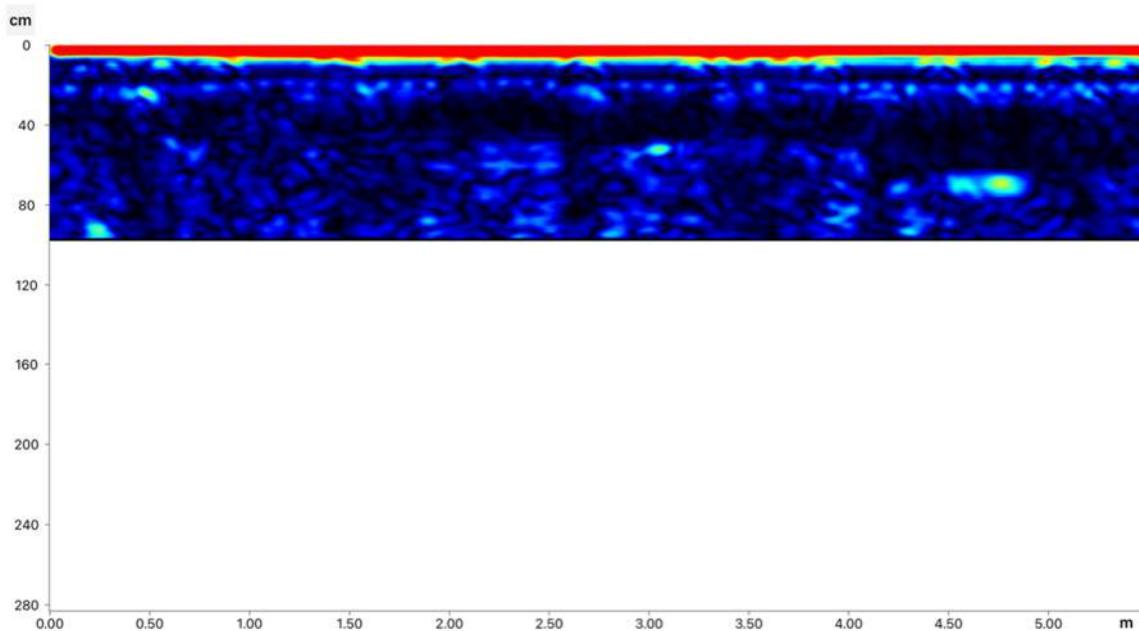
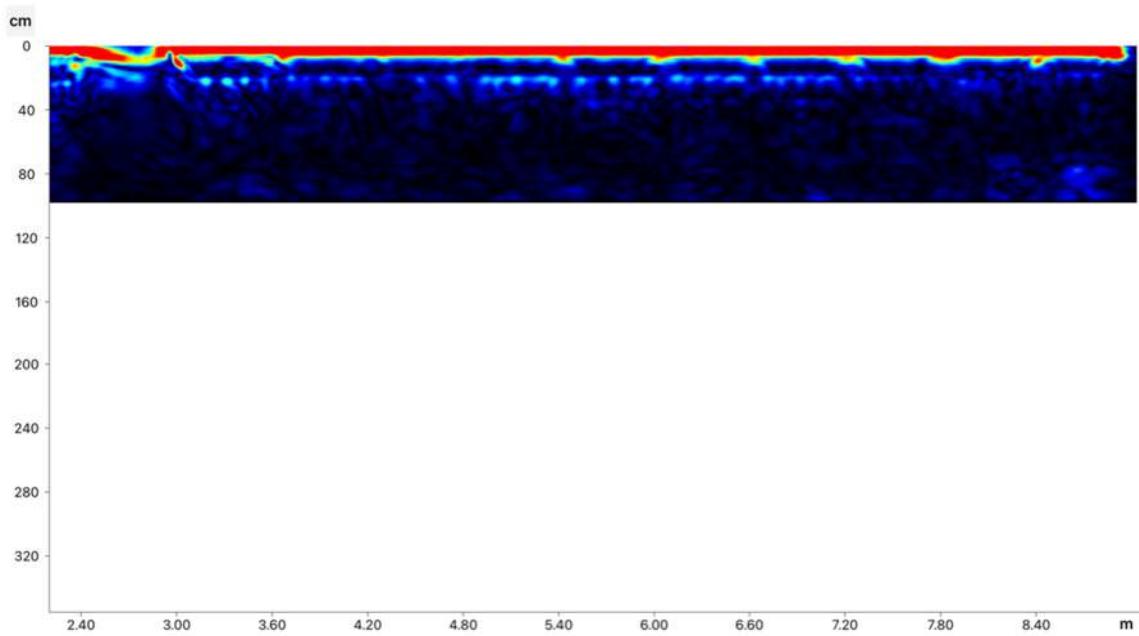
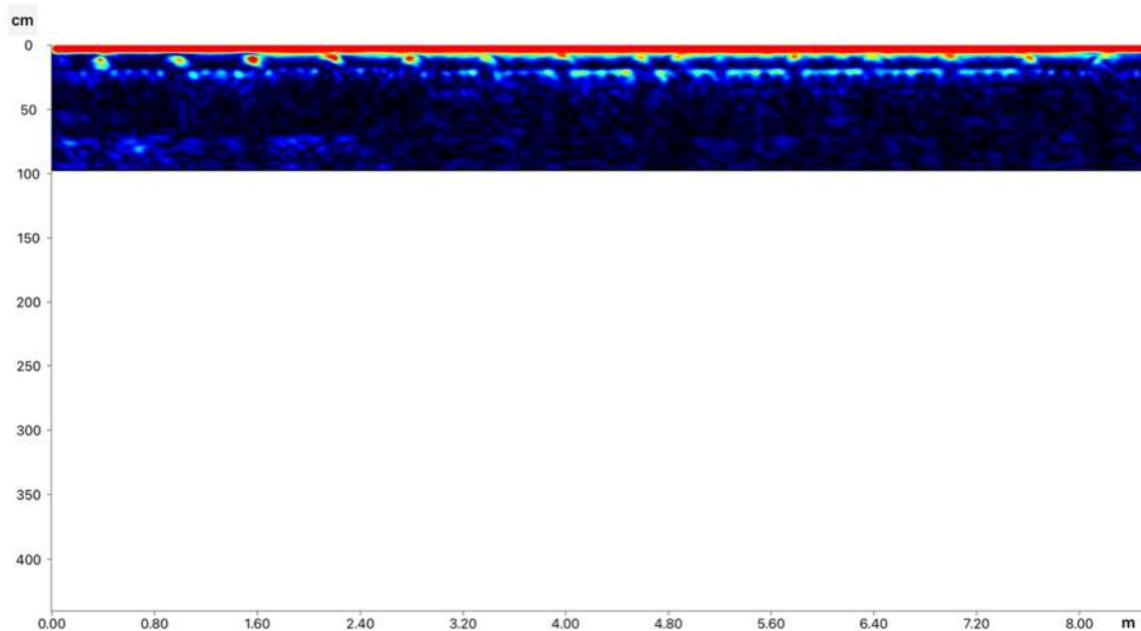
The GPR scans from above showed evidence of uniform construction with the findings from the RAAC planks below.

R001 – Showing cross section of RAAC planks beneath

R002 – Showing cross section of RAAC planks beneath

R003 – Showing cross section of RAAC planks beneath

R004 – Showing cross section of RAAC planks beneath

R005 – Showing cross section of RAAC planks beneath
