The Royal Oldham Hospital

STRUCTURAL SURVEY REPORT

RAAC PANELS

Ref. 222-013

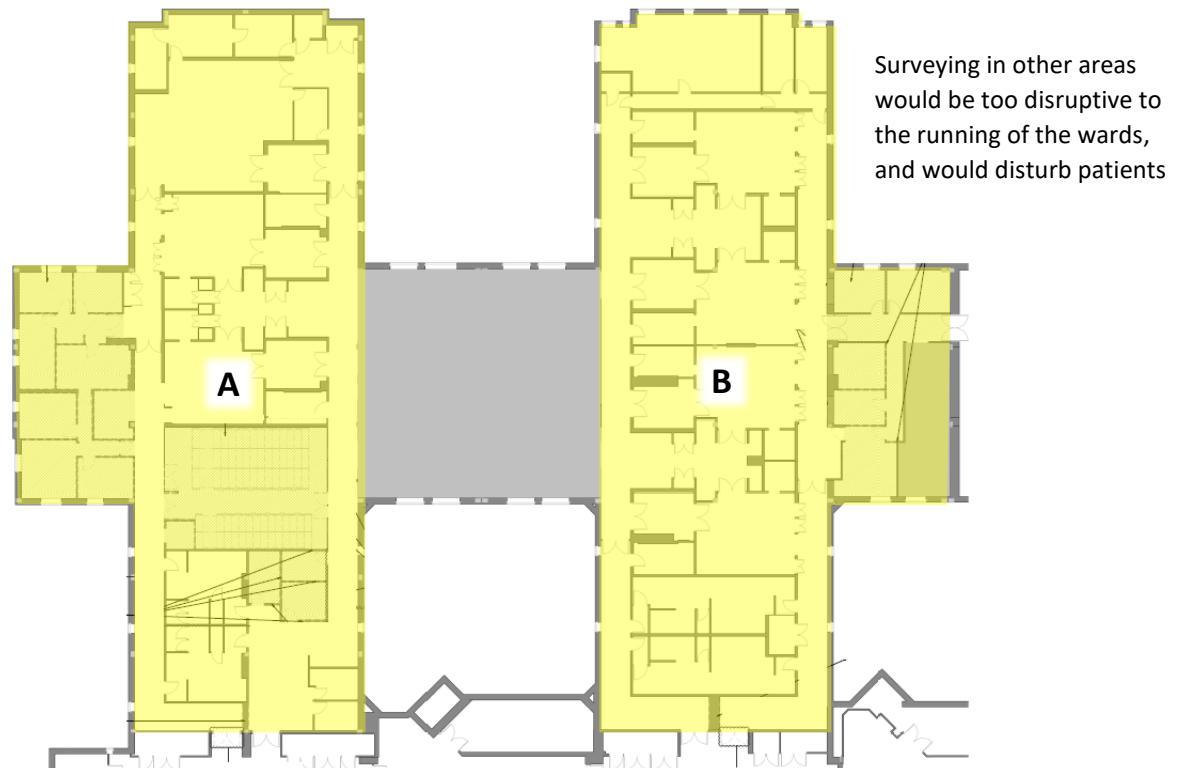
FIGURE 2: AREAS SUCCESSFULLY SURVEYED

6. A large quantity of panels could not be observed in blocks C and D due to the wards being in constant use with patient sensitive zones.

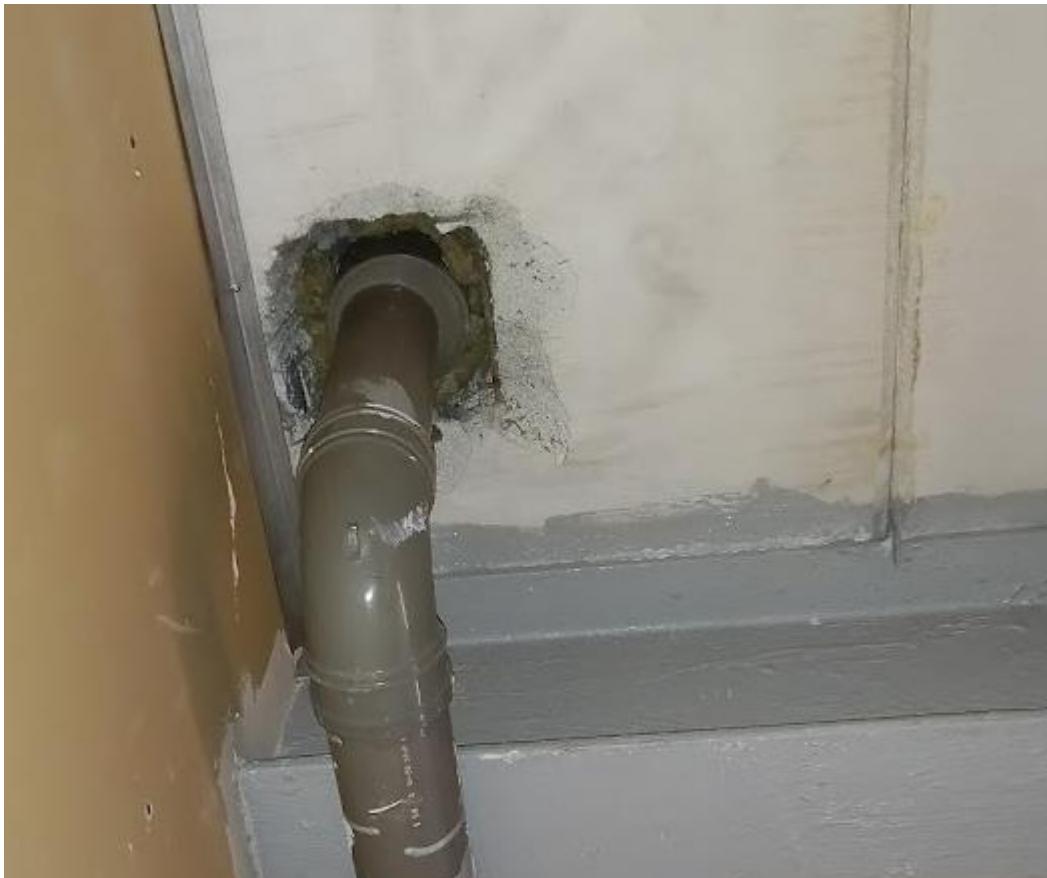
5. Where necessary for practicality, units have been roughly cored to allow rainwater pipes to pass through. In some instances, this not been trimmed or re-supported. Very little/no corrosion is visible on the exposed bars.

PHOTOGRAPH 1 – CORED UNIT

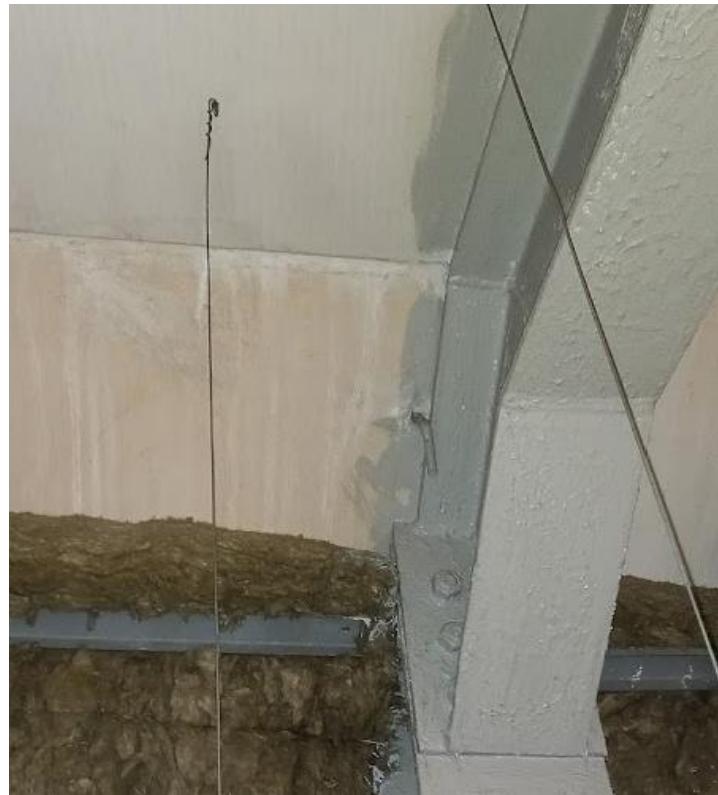
PHOTOGRAPH 2 – EXAMPLE OF UNIT OBSCURED BY INSULATION

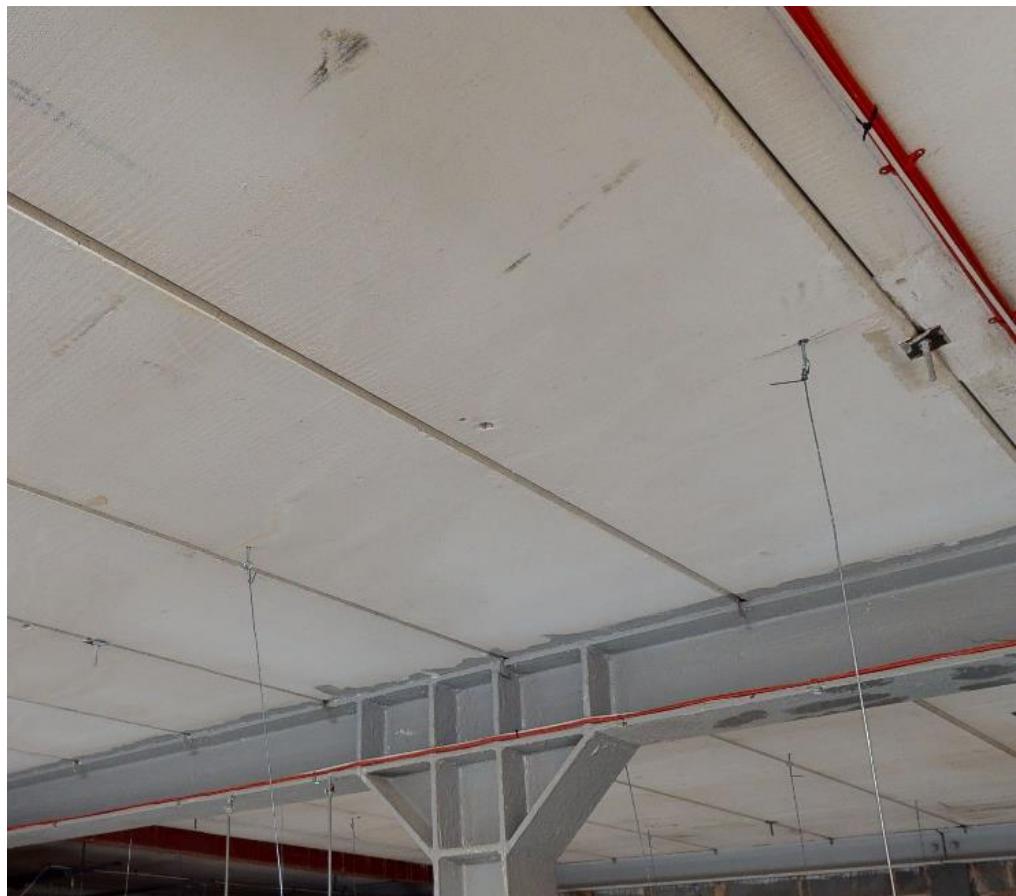
PHOTOGRAPH 3 – TYPICAL SOFFIT OF UNITS
