**Structural Report:
Block A - Kidderminster Hospital & Treatment Centre**

For: Worcester Hospitals Acute NHS Trust

August 2021
Reference: C7993

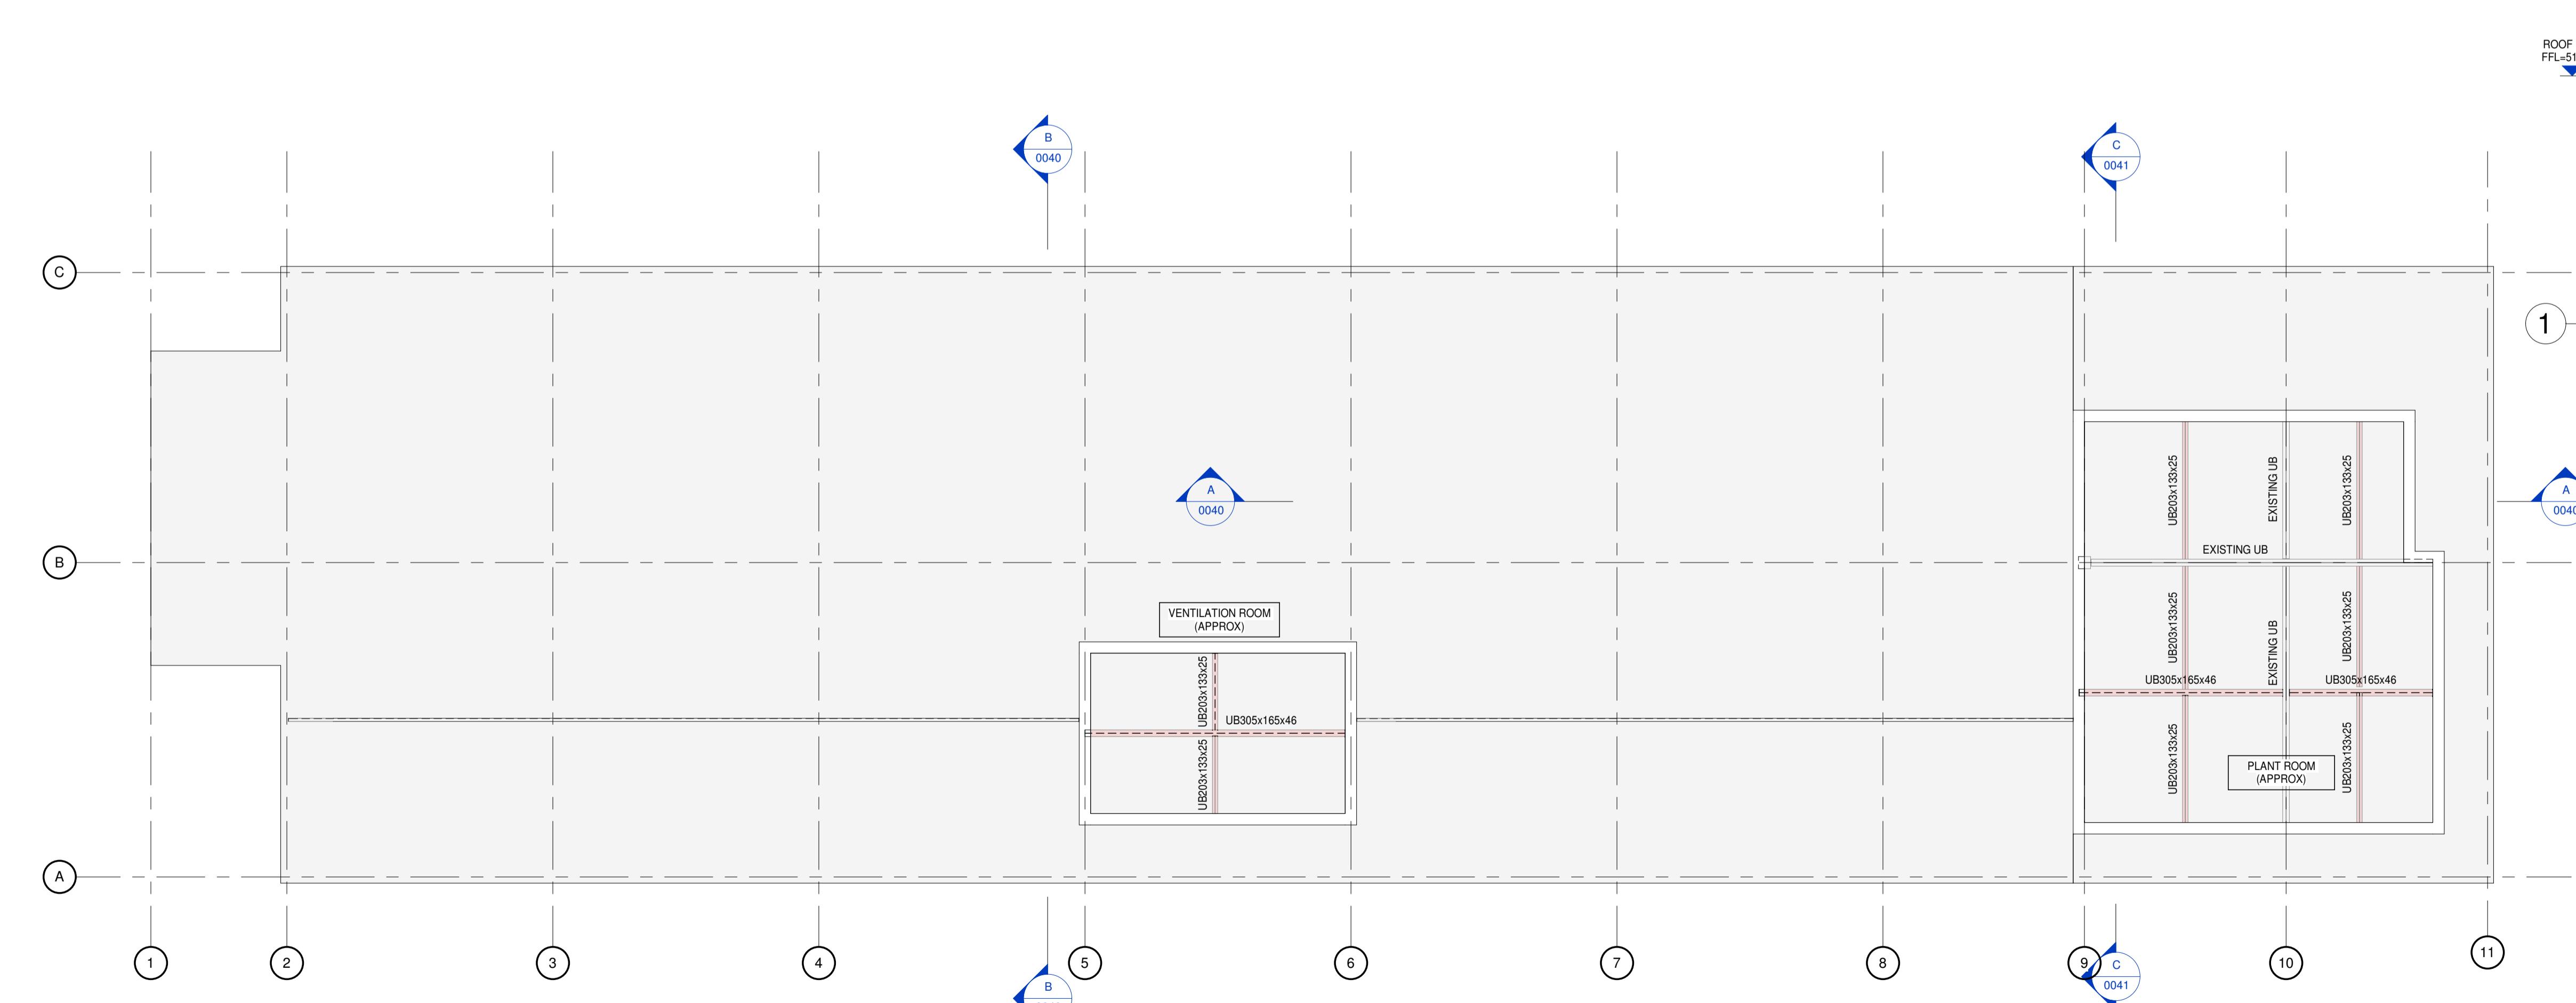
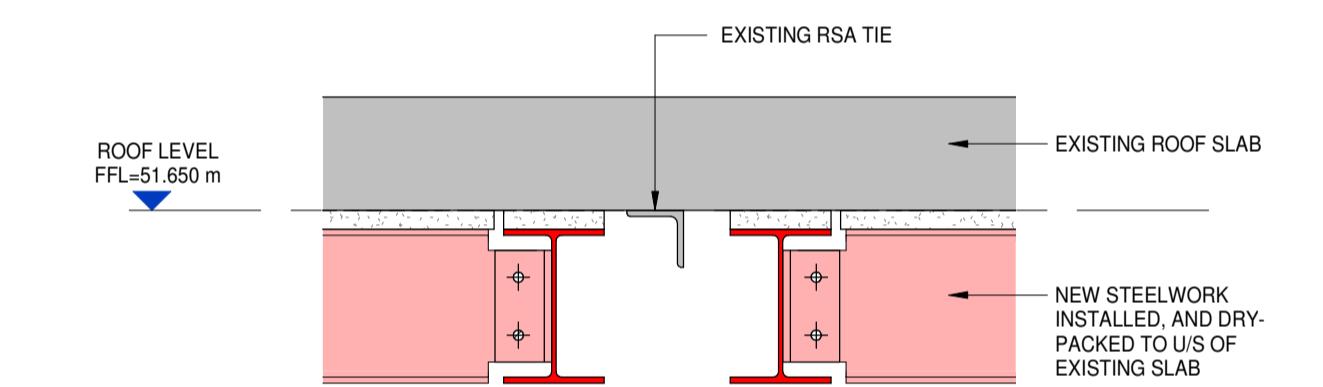
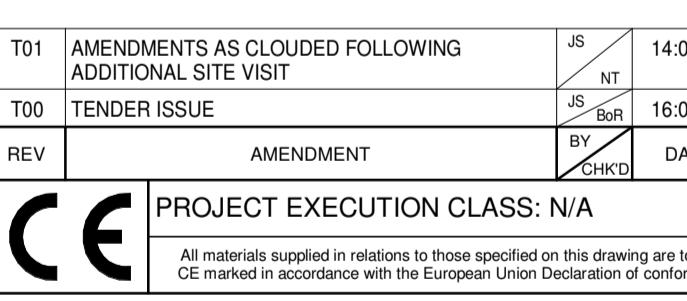
ROOF LEVEL GA - OPTION 3

Residual Risk – The RAAC planks will have there span halved and consequently the significant structural stress in the RAAC planks will be reduced by 75%. The RAAC planks will still be in place and the aerated concrete is still prone to structural issues due to historic water ingress through the roof and inherent issues with the material itself.

The introduction of the strengthening steelwork to a degree mitigates the risk but importantly does not eliminate the risk. This option is not a long-term solution and ultimately the RAAC plank will require replacing at a future date.

Method: A grillage of new supporting steelwork (refer to drawing 7993-CCE-XX- RF-DR-S-0032-T00 in the appendix) is introduced to support the RAAC planks. The new steelwork would be connected to the existing steelwork frame. In addition to the new steelwork the rooftop must receive the necessary repairs to ensure that it is watertight.

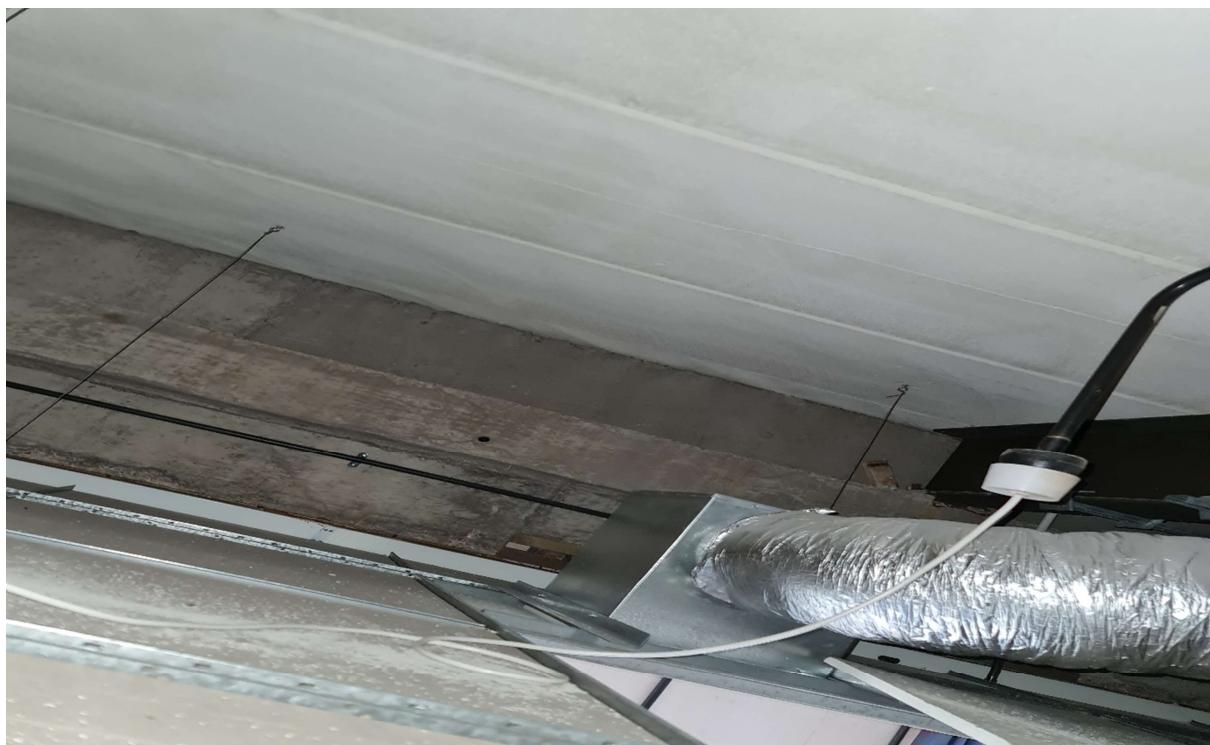
1. Existing crack repair

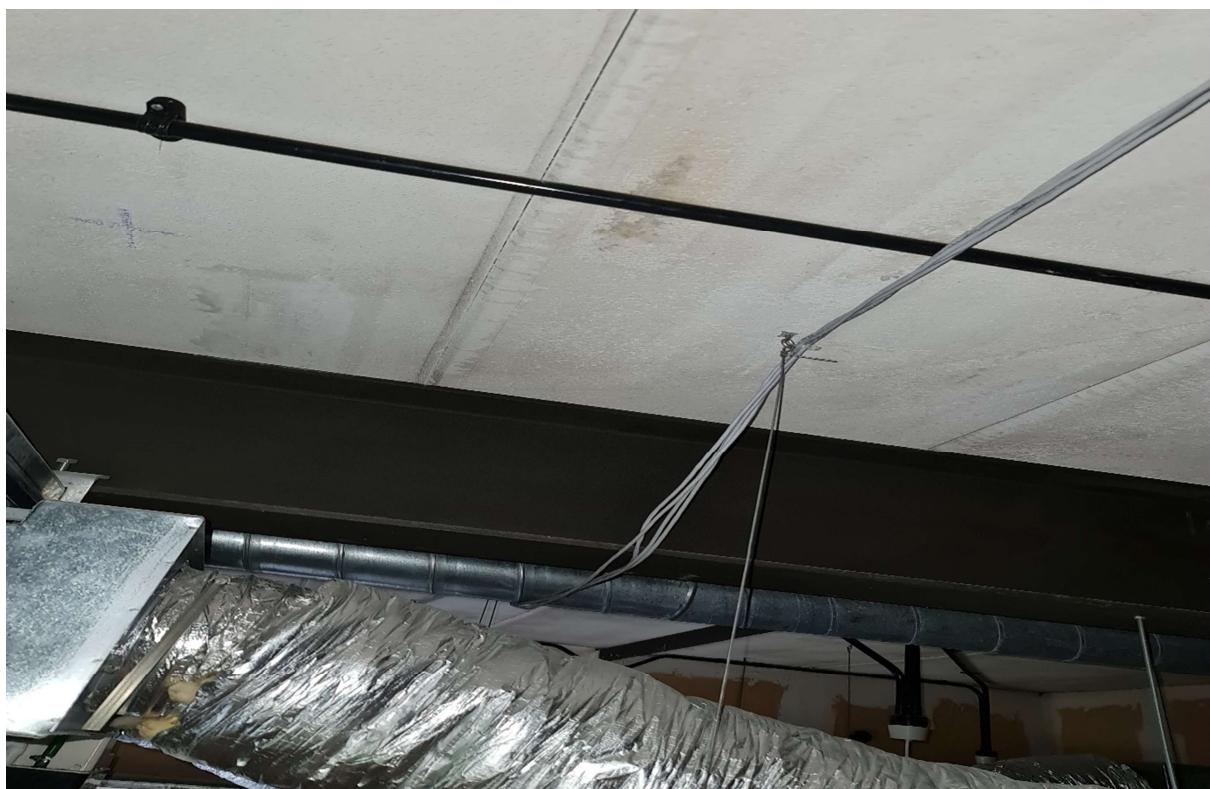
2. Minor localised pitting to soffit

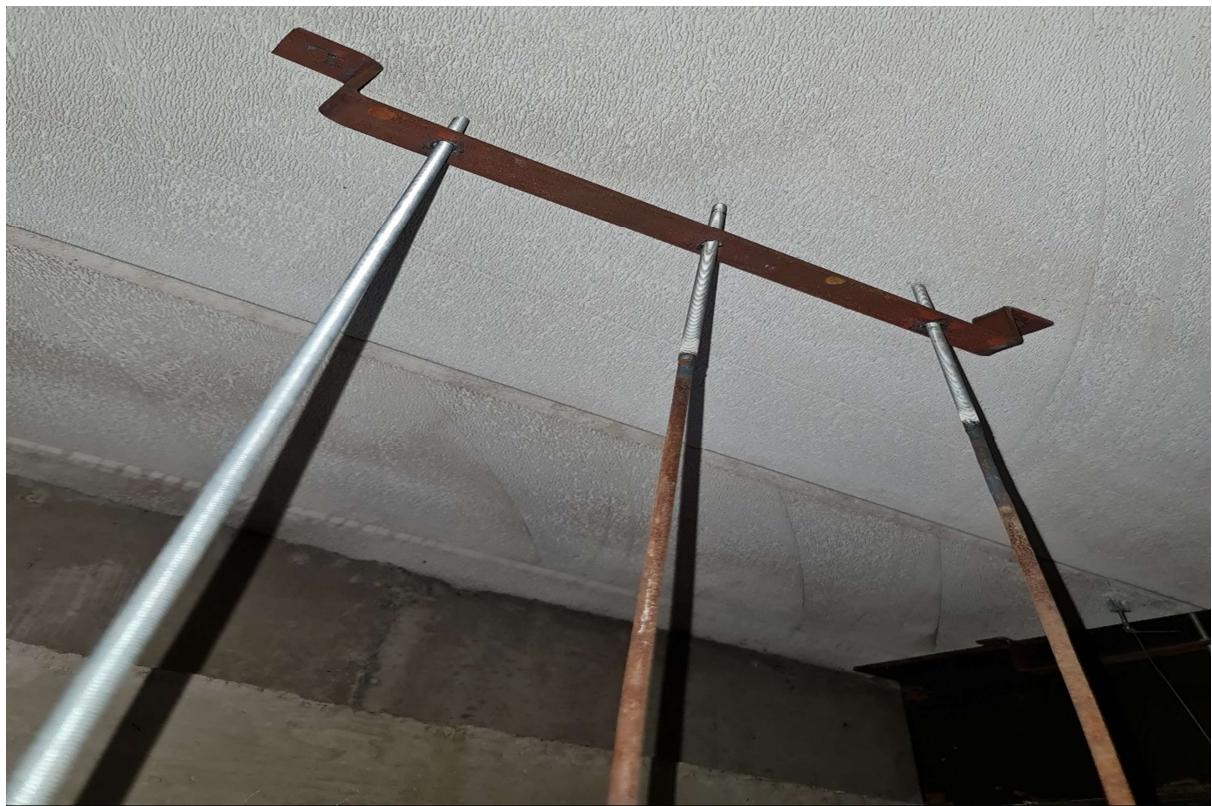
3. Minor long indent to slab soffit

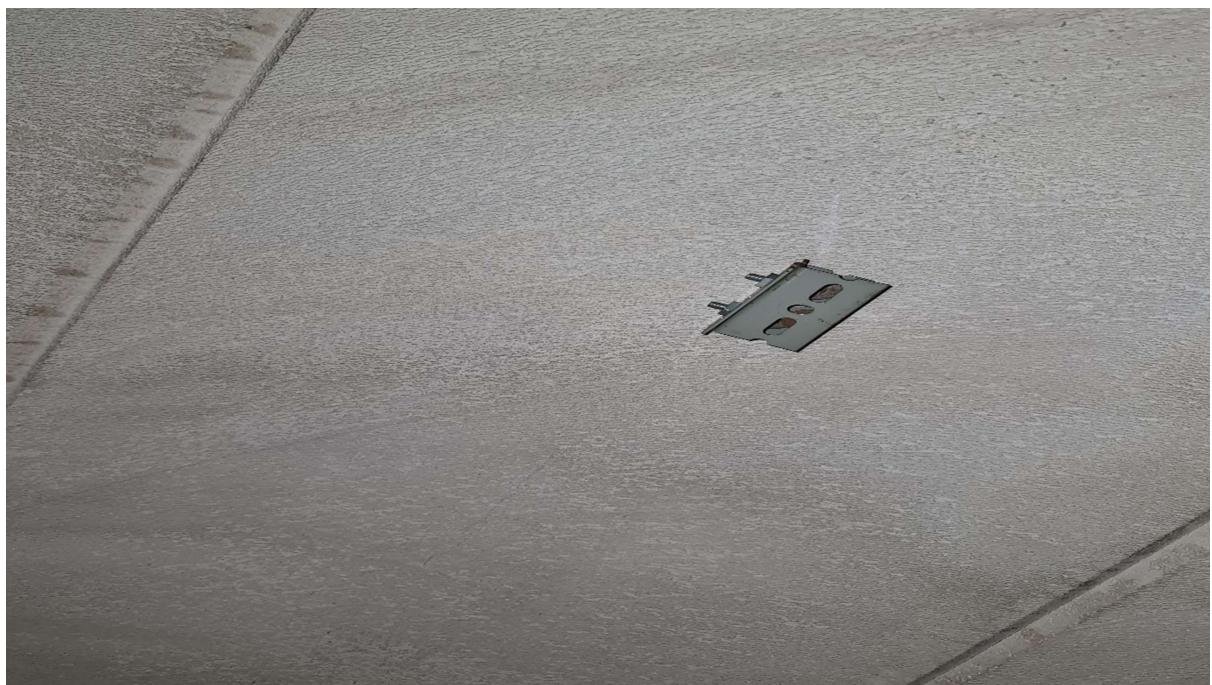
4. Minor hairline crack

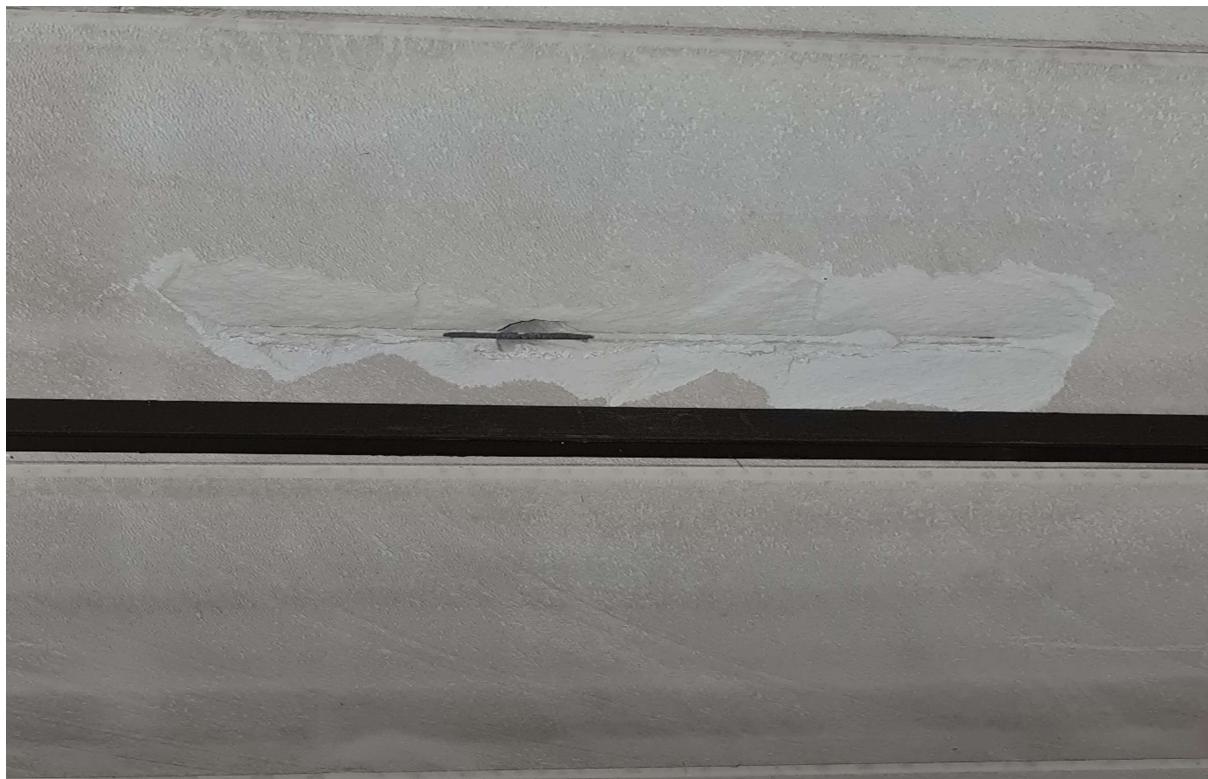
There is however a single plank above room references A1-19 & A1-44 which has an area of exposed reinforcement due to the spalling of concrete.

5. Exposed length of the exposed reinforcement

Immediate remedial works are required for this defect, and we would recommend the following:

Step 1: Remove any loose concrete around the defect.

Step 2: Apply a zinc rich protective coating (e.g., Fosroc Nitoprime Zincrich) to the exposed reinforcement.

Step 3 – Apply a Cementous protective coating and levelling mortar to replace the spalled concrete (e.g., Fosroc Renderoc ST 05)

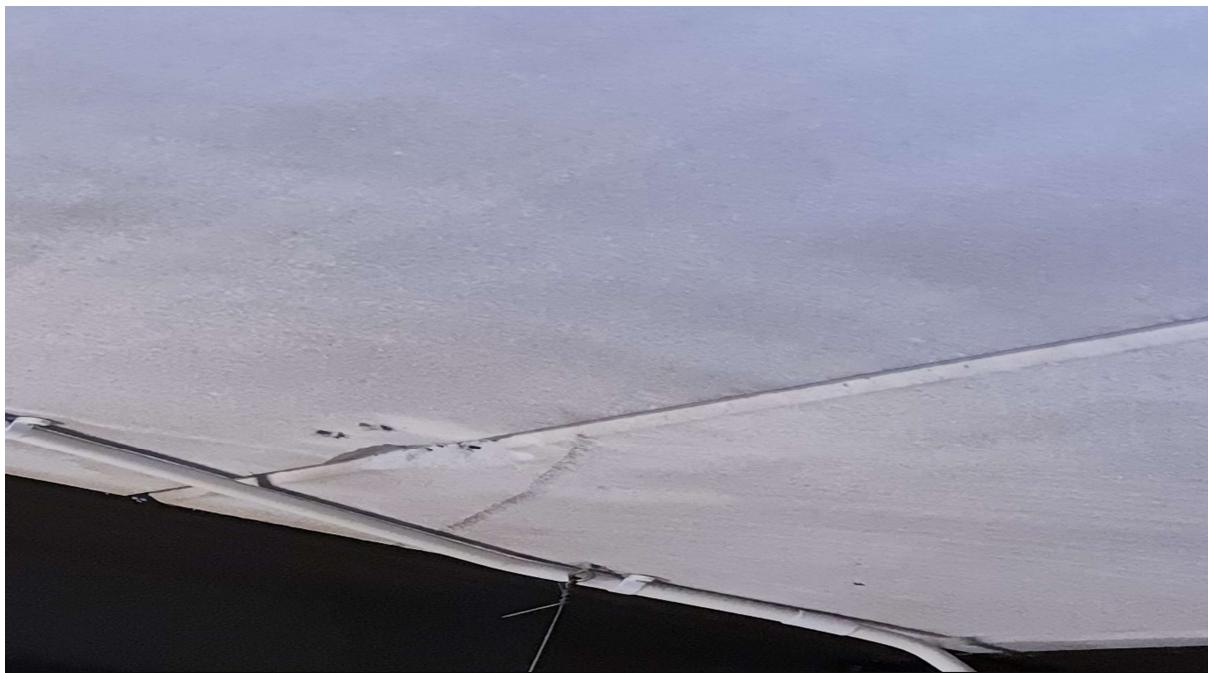
6. Damage to slab edge

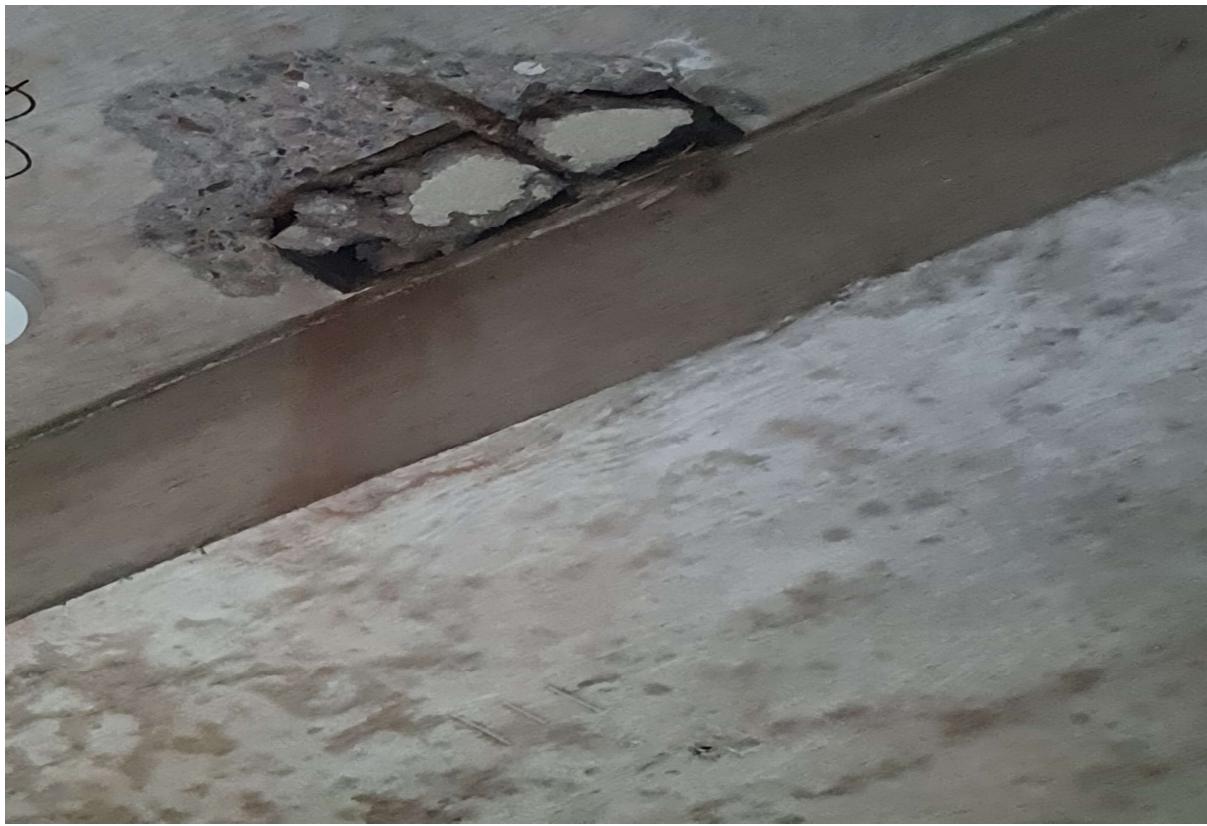
7. Damage adjacent side bearing

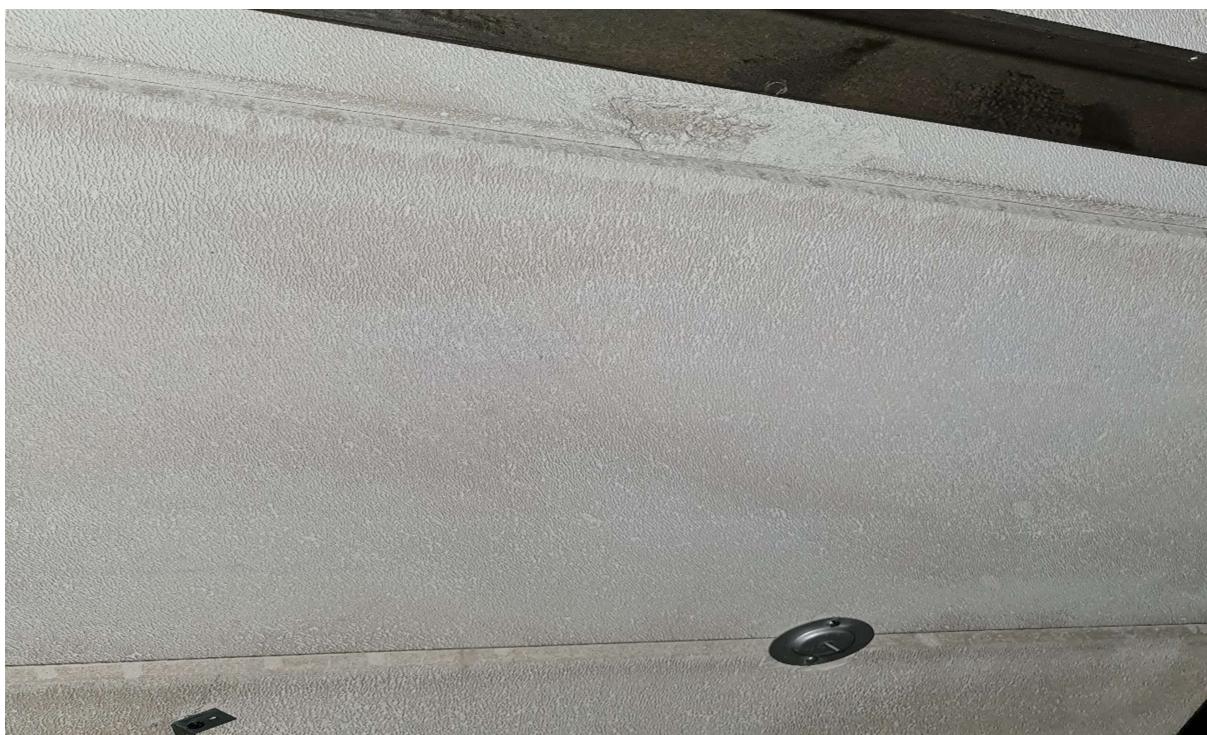
8. Minor damage to soffit

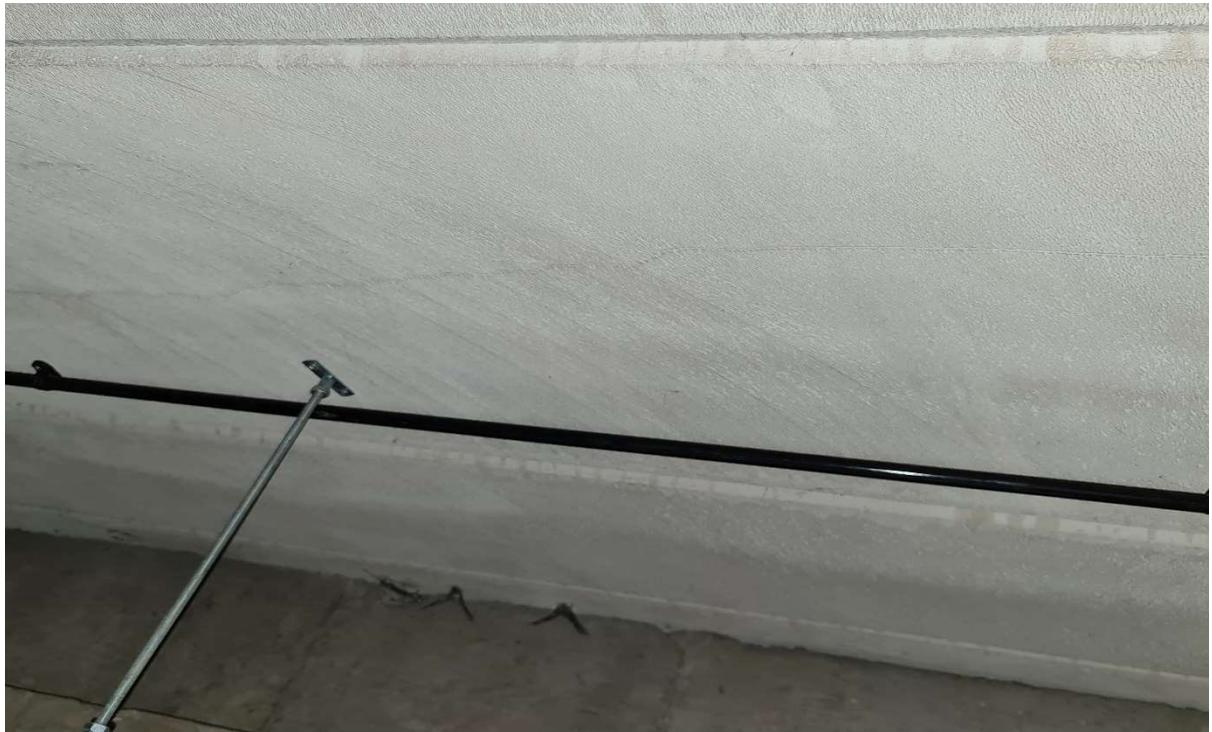
9. Long hairline crack

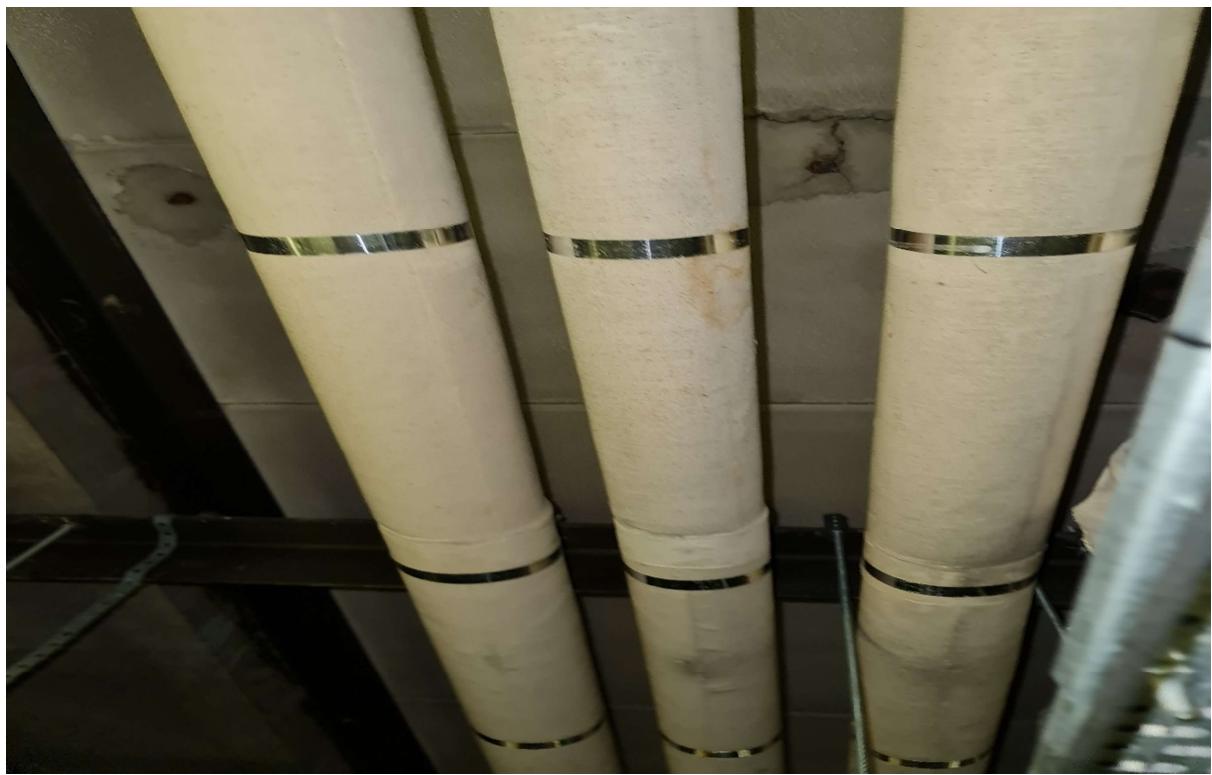
10. Existing patch repairs
