# Site Visit Report

<b>Project:</b>	<b>Scarborough Hospital Pathology</b>	<b>Job No:</b>
<b>Produced By:</b>	<b>JN</b>	<b>Date:</b> <b>20-12-2021</b>
<b>Date of Site Visit:</b>	<b>09-12-2021</b>	<b>Time of Site Visit:</b> <b>10:00 am</b>
<b>Visit By:</b>	<b>JN</b>	<b>Weather:</b> <b>Dry/Overcast</b>

To visit Scarborough Hospital Pathology department to review the reported reinforced autoclaved aerated concrete (RAAC), foamed concrete plank roof construction.

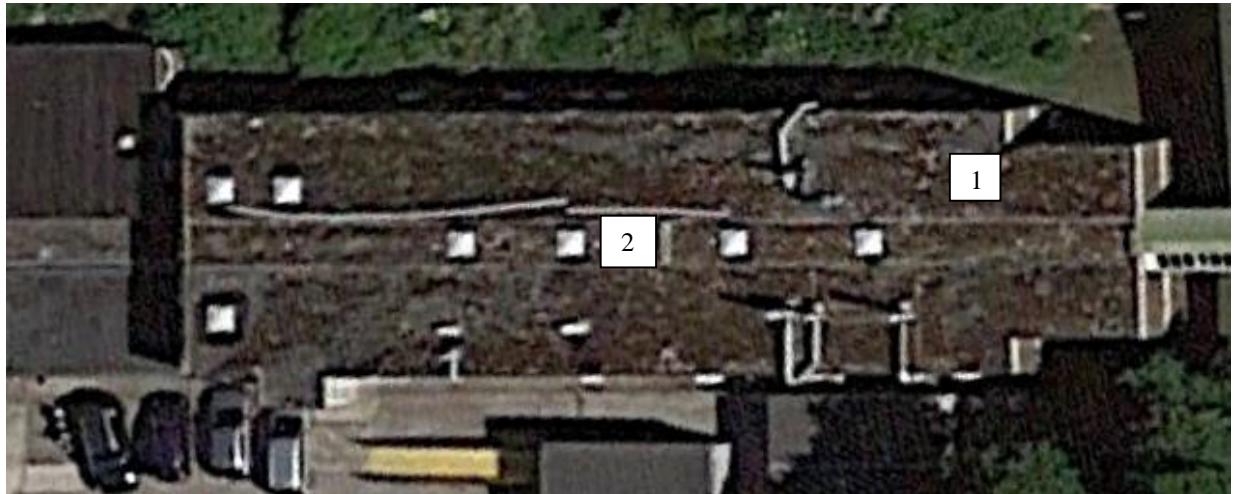
Photograph 1. Showing the roof of the Pathology Lab building. The numbers indicate the approximate locations of access to the u/s of the roof slab.

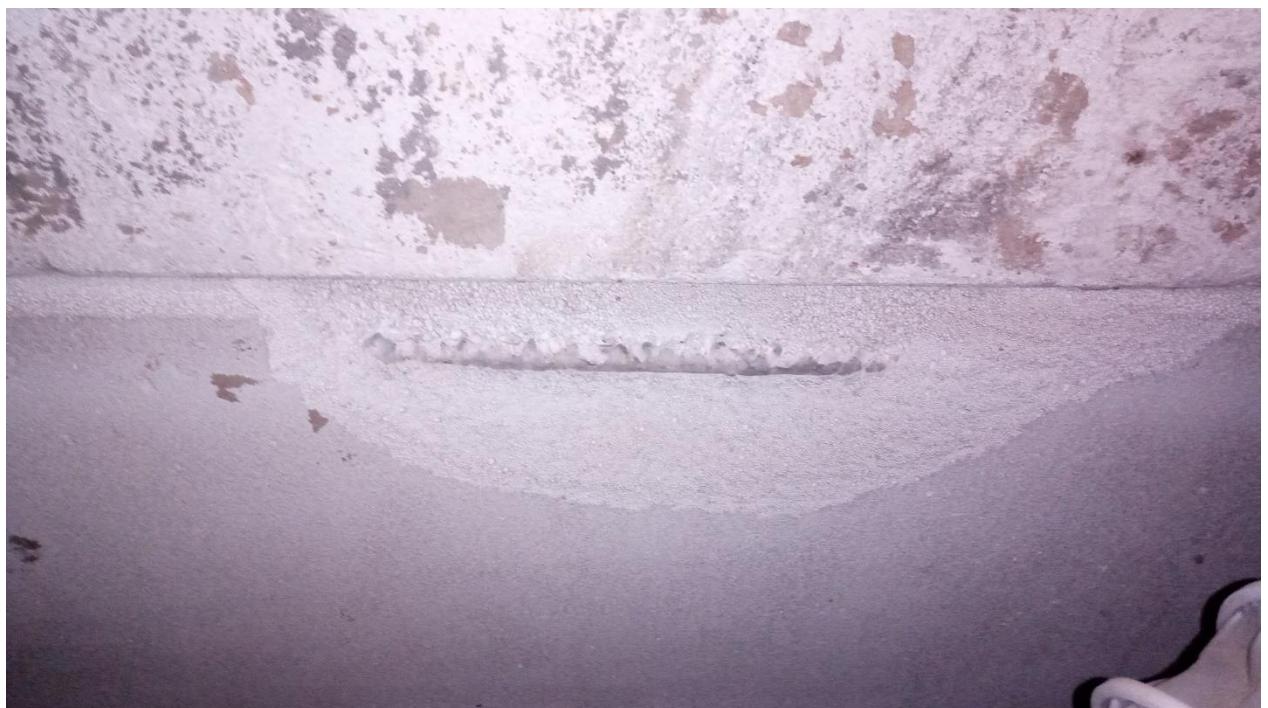
Photograph 2. (Location 1 in the Autoclave room), shows a spalled section of roof plank. Debris from the spalling could not be seen on the ceiling tiles. The aerated core of the lightweight concrete plank can be clearly seen to the damaged area, confirming that that the planks are reinforced autoclaved aerated concrete (RAAC).

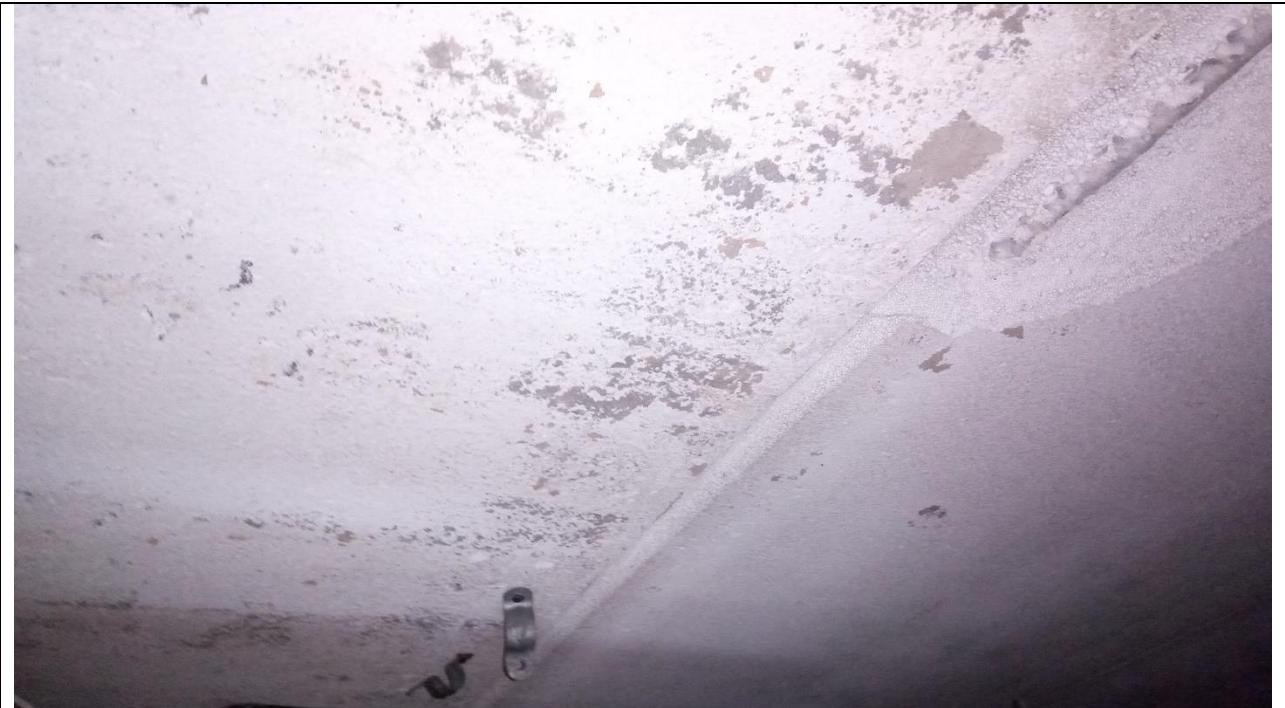
Photograph 3. (Location 1 in the Autoclave room), shows the soffit of the roof planks and some redundant pipe supports.

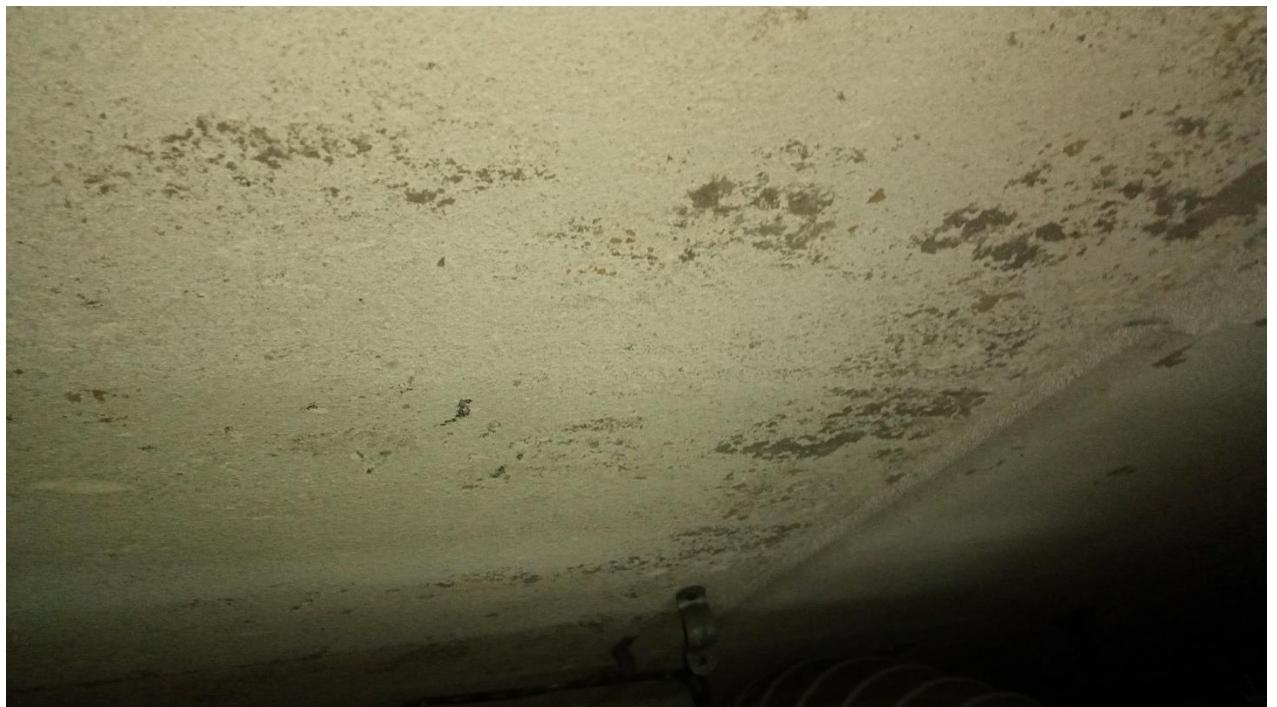
Photograph 4. (Location 1 in the Autoclave room), shows the soffit of the roof planks and some redundant pipe supports can also be seen screwed to the planks.

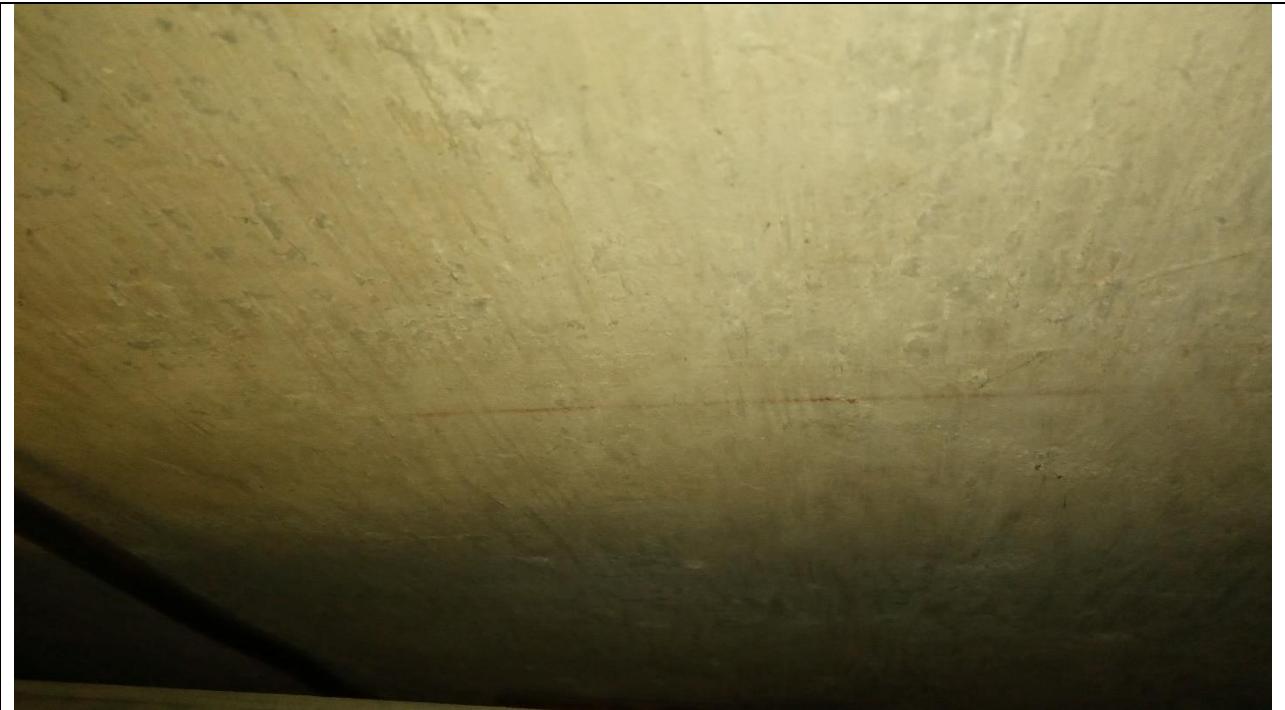
Photograph 5. (Location 2 in the central corridor area), shows the soffit of the roof planks.

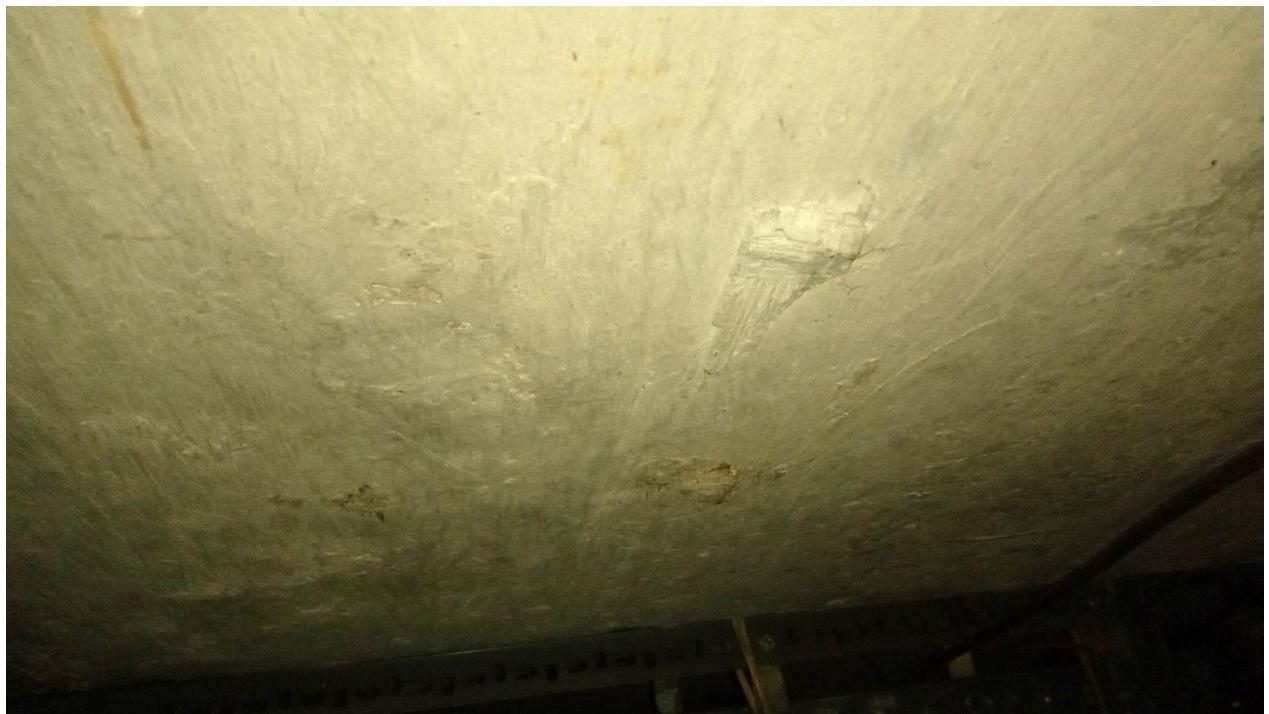
Photograph 6. (Location 1 in the central corridor area), shows the rough surface of the soffit of some roof planks. Some brown staining possibly from corroding reinforcement can be seen.

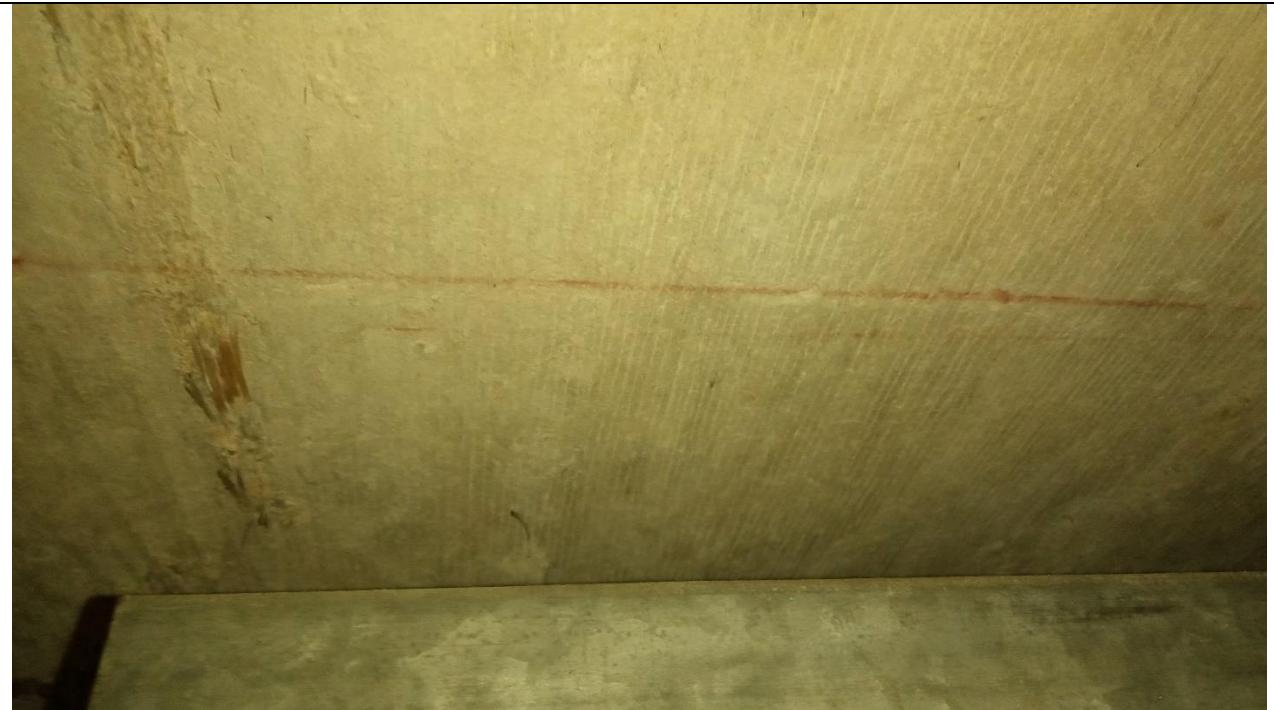
Photograph 7. (Location 1 in the central corridor area), shows the soffit of the roof and interface with a concrete wall.

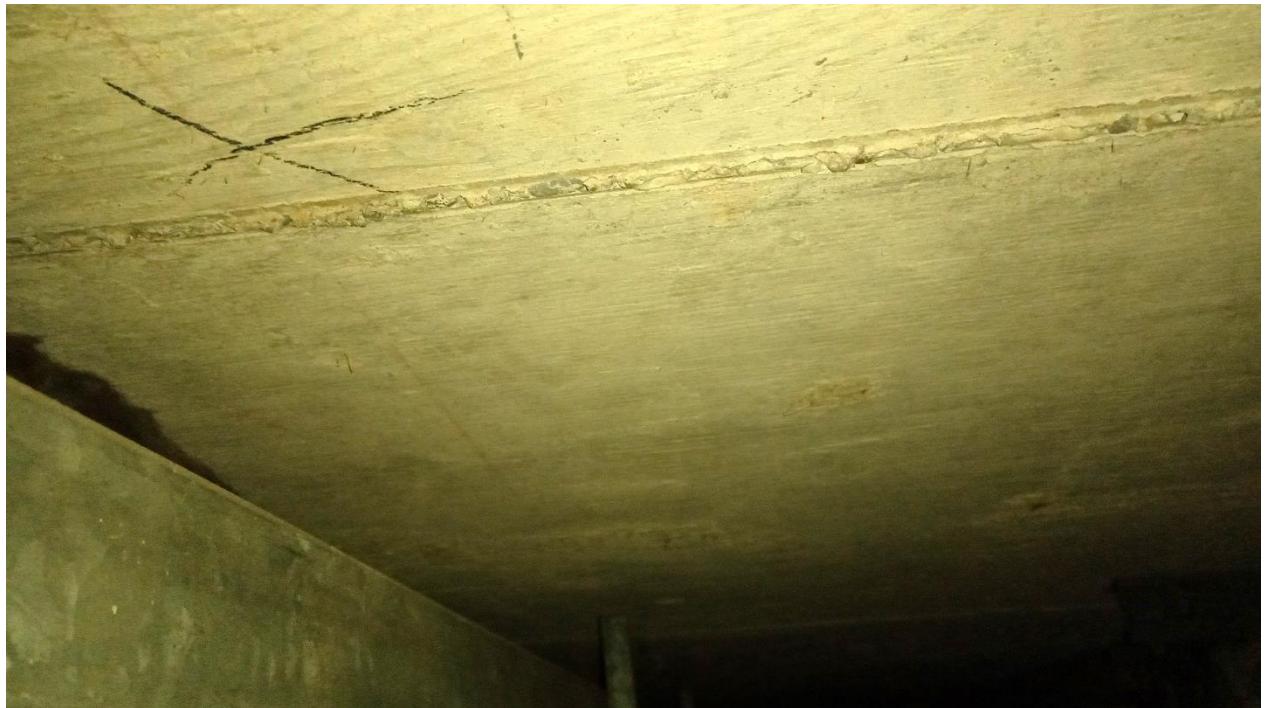
Photograph 8. (Location 1 in the central corridor area), shows the soffit of the roof

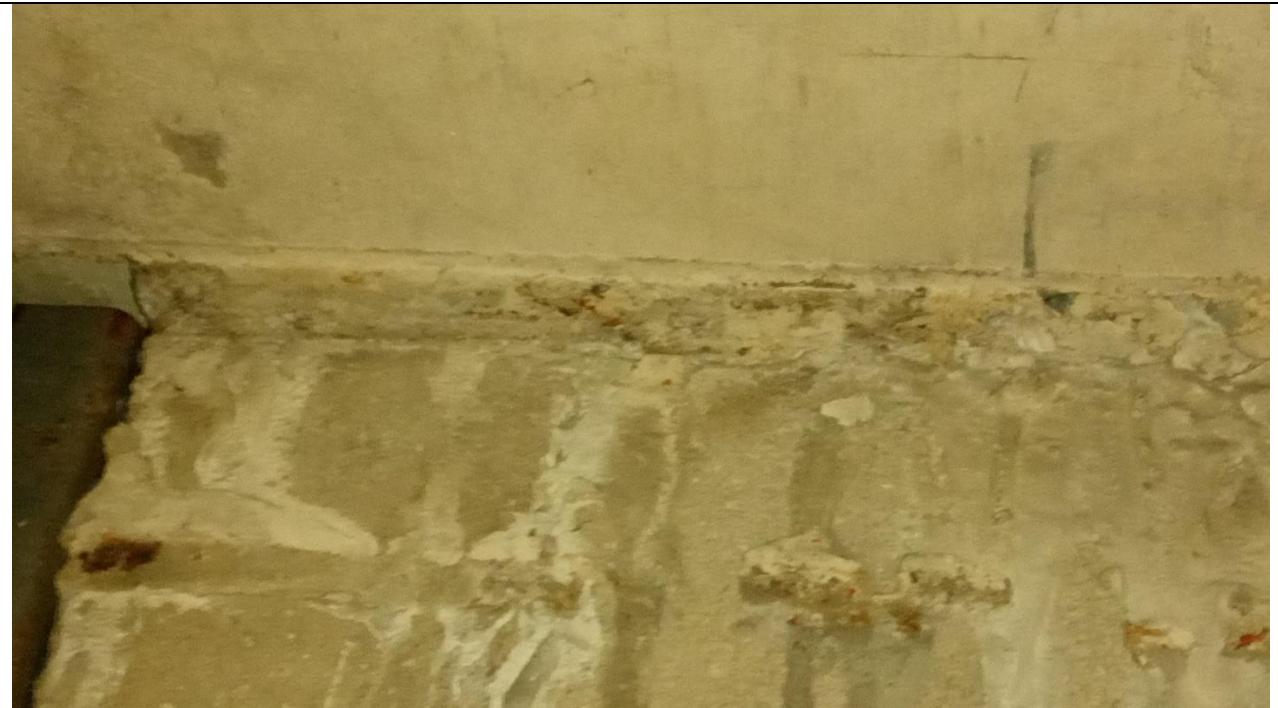
Photograph 9. (Location 1 in the central corridor area), shows the interface with a concrete column.

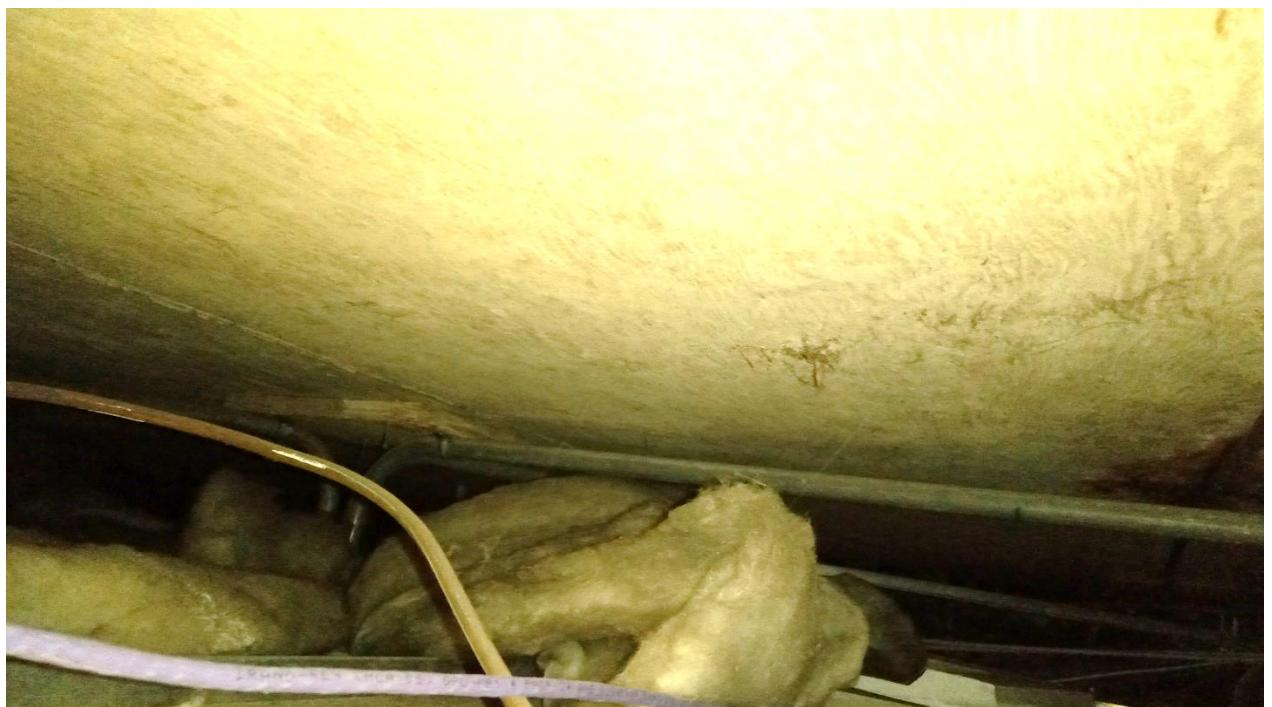
Photograph 10. (Location 1 in the central corridor area), shows the soffit of the roof with restricted space above the ceiling and numerous services / insulation etc.
