alan johnston partnership  
Consulting Structural & Civil Engineers

Ref. 219-390

# STRUCTURAL INSPECTION REPORT

Blackpool Victoria Hospital, RAAC units

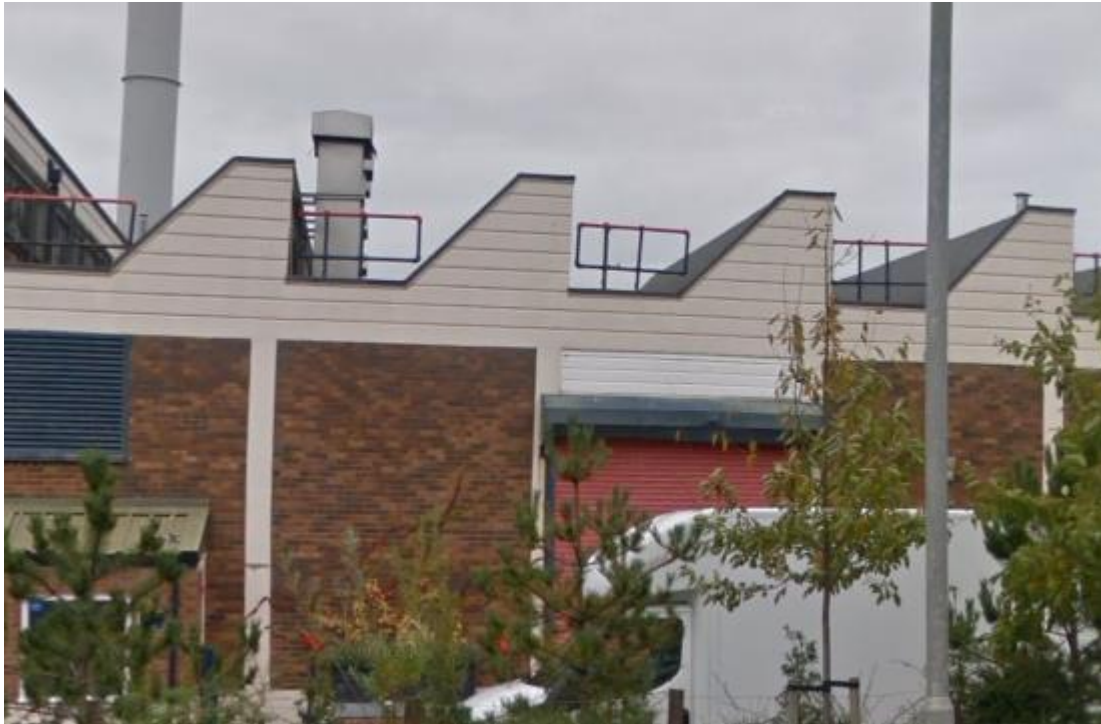
***NORTH LIGHT ROOF PROFILE***

Although the timber panels were a hindrance to the inspection, the panels were sufficiently visible to allow several signs of deterioration to be identified as follows:

- Excessive deflection due to creep
- Discoloured and spalling concrete near to supports and roof cowl
- Broken concrete at edges and fixing locations

These findings suggest that many of the panels are nearing the end of their useful life, and deterioration is light/moderate. The extent of the deflection of the horizontal planks which form the valley gutters is concerning. It will be necessary to undertake a more detailed inspection following the removal of the timber panels which prevent a clear view of the RAAC units.

The units may will require full scale replacement with an alternative construction such as structural steel metal deck. Alternatively, it may be possible to prolong the building service life with the introduction of additional steelwork to reduce the current span of the planks by approximately 50%.

Until further inspections have been undertaken, based on the low risk/occupancy of the building it is recommended that evacuation is considered in certain conditions. Due to the shape of the roof there is a risk of significant snow build up in the valleys during adverse weather. We would recommend that access to the building is restricted if there is a risk of significant snow fall which could lead to a build-up of snow in the valley gutter areas. Significant loading of the units could lead to collapse if their performance is compromised. There should be no access to the roof at any time until the planks have been replaced/resupported.

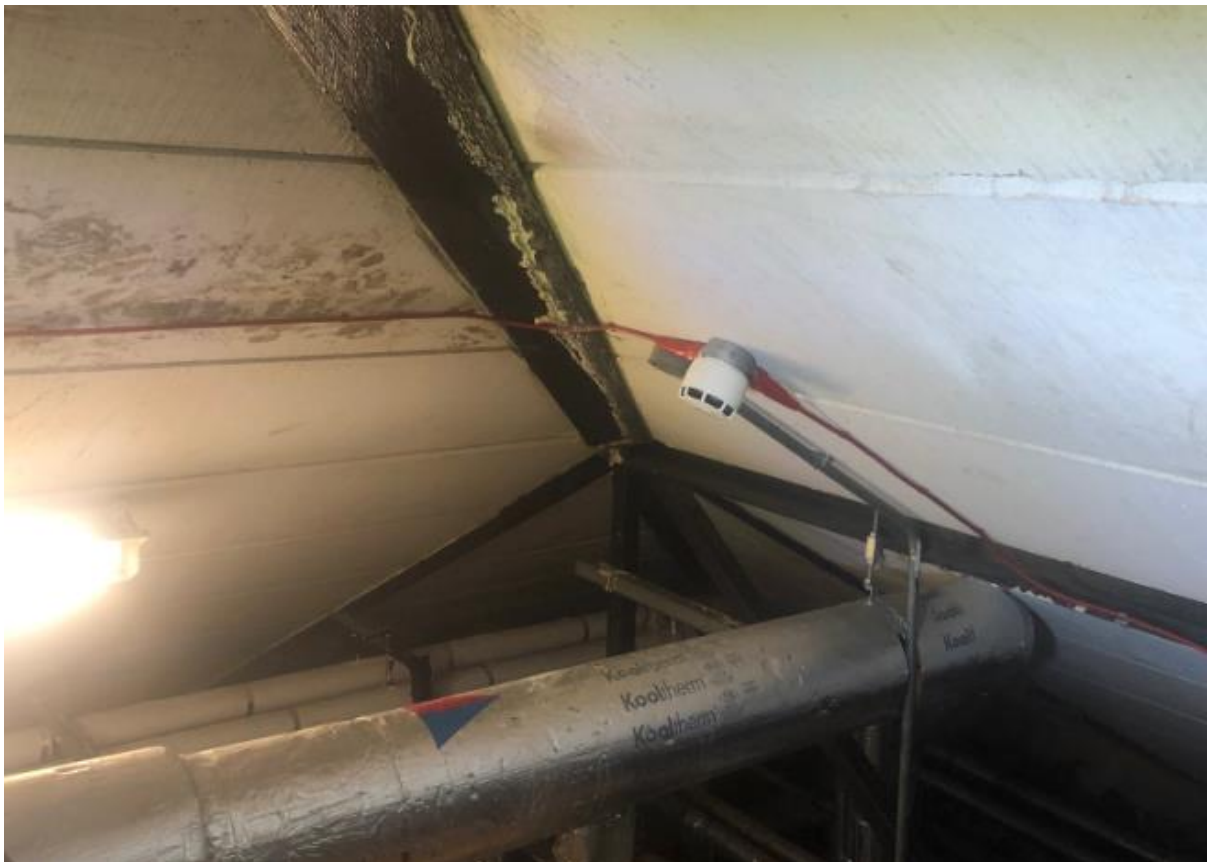
***INTERNAL ROOF SPACE IN PHASE 4***

The roof in this area is pitched in all areas and finished with tiles. AJP were able to readily access the roof space and assess each RAAC unit without hindrance. The apparent signs of deterioration were very limited, none giving rise for concern. It is important to note that the tiled roof and associated waterproofing have failed in several key areas as follows:

- Head of main access stair
- Above the medical records store
- Above the disused mechanical plant to the West of the main access stair

It is recommended that these leaks are repaired as a matter of urgency to prevent water related damage.
