Ref. 219-390

STRUCTURAL INSPECTION REPORT

Blackpool Victoria Hospital, RAAC units

This document details the findings of the inspection carried out in December 2019 with regard to the Reinforced Autoclaved Aerated Concrete (RAAC) roof units in various locations

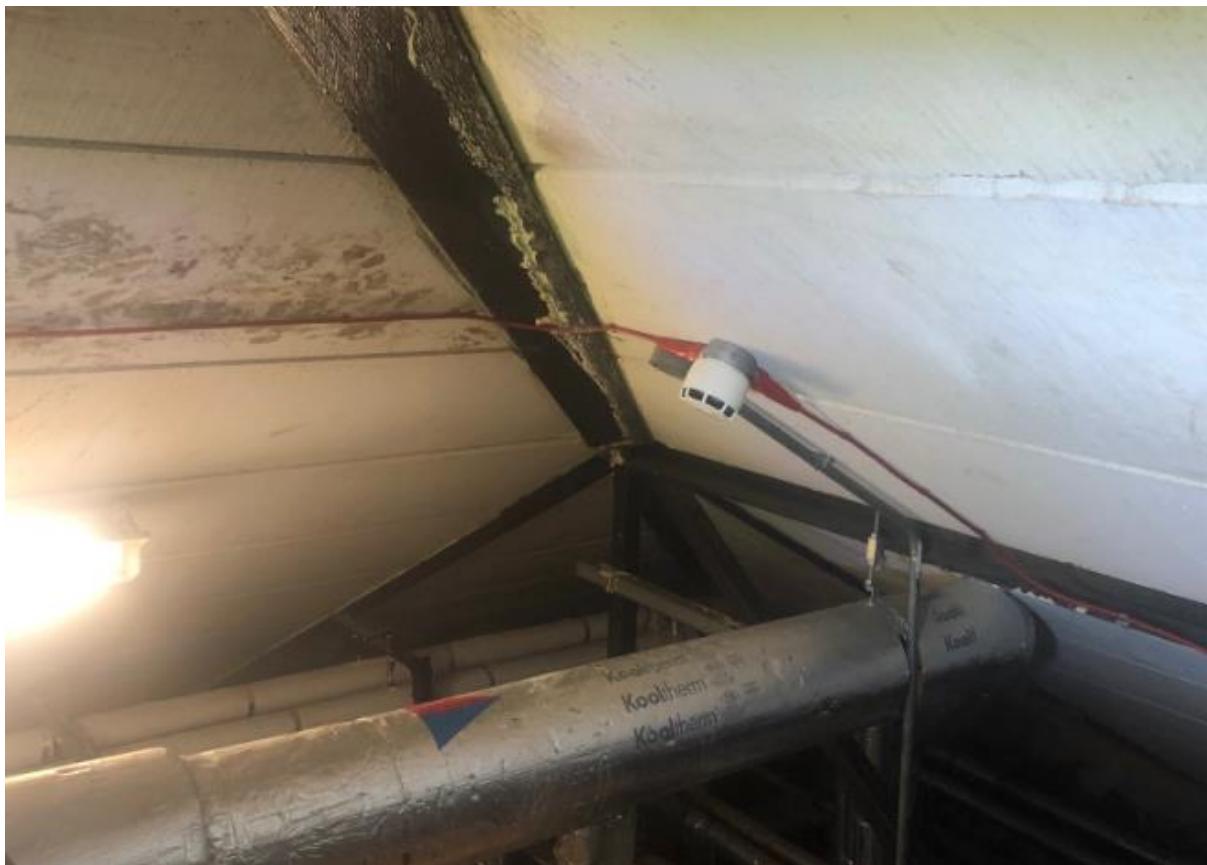
INTERNAL ROOF SPACE IN PHASE 4

The roof in this area is pitched in all areas and finished with tiles. AJP were able to readily access the roof space and assess each RAAC unit without hindrance. The apparent signs of deterioration were very limited, none giving rise for concern. It is important to note that the tiled roof and associated waterproofing have failed in several key areas as follows:

- Head of main access stair
- Above the medical records store
- Above the disused mechanical plant to the West of the main access stair

It is recommended that these leaks are repaired as a matter of urgency to prevent water related damage.
