Ref. 219-390

STRUCTURAL INSPECTION REPORT

Blackpool Victoria Hospital, RAAC units

This document details the findings of the inspection carried out in December 2019 with regard to the Reinforced Autoclaved Aerated Concrete (RAAC) roof units in various locations

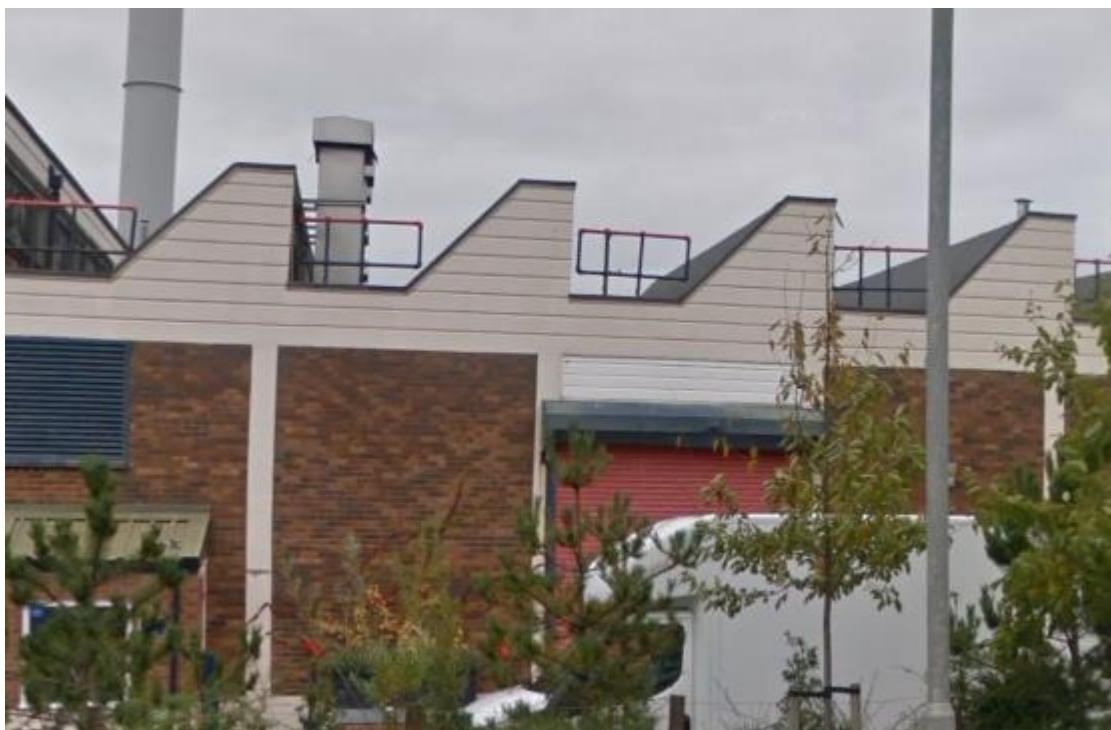
NORTH LIGHT ROOF PROFILE

Although the timber panels were a hindrance to the inspection, the panels were sufficiently visible to allow several signs of deterioration to be identified as follows:

- Excessive deflection due to creep
- Discoloured and spalling concrete near to supports and roof cowl
- Broken concrete at edges and fixing locations

The units may will require full scale replacement with an alternative construction such as structural steel metal deck. Alternatively, it may be possible to prolong the building service life with the introduction of additional steelwork to reduce the current span of the planks by approximately 50%.

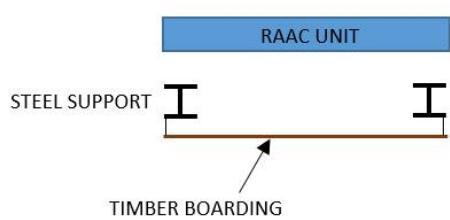
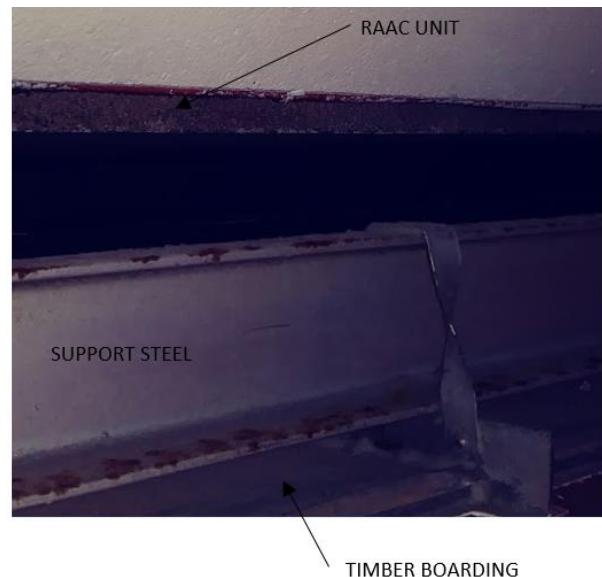
GENERAL ARRANGEMENT OF FLAT ROOF AREAS

These findings suggest that many of the panels are nearing the end of their useful life, and deterioration is light/moderate. The extent of the deflection of the horizontal planks which form the valley gutters is concerning. It will be necessary to undertake a more detailed inspection following the removal of the timber panels which prevent a clear view of the RAAC units.

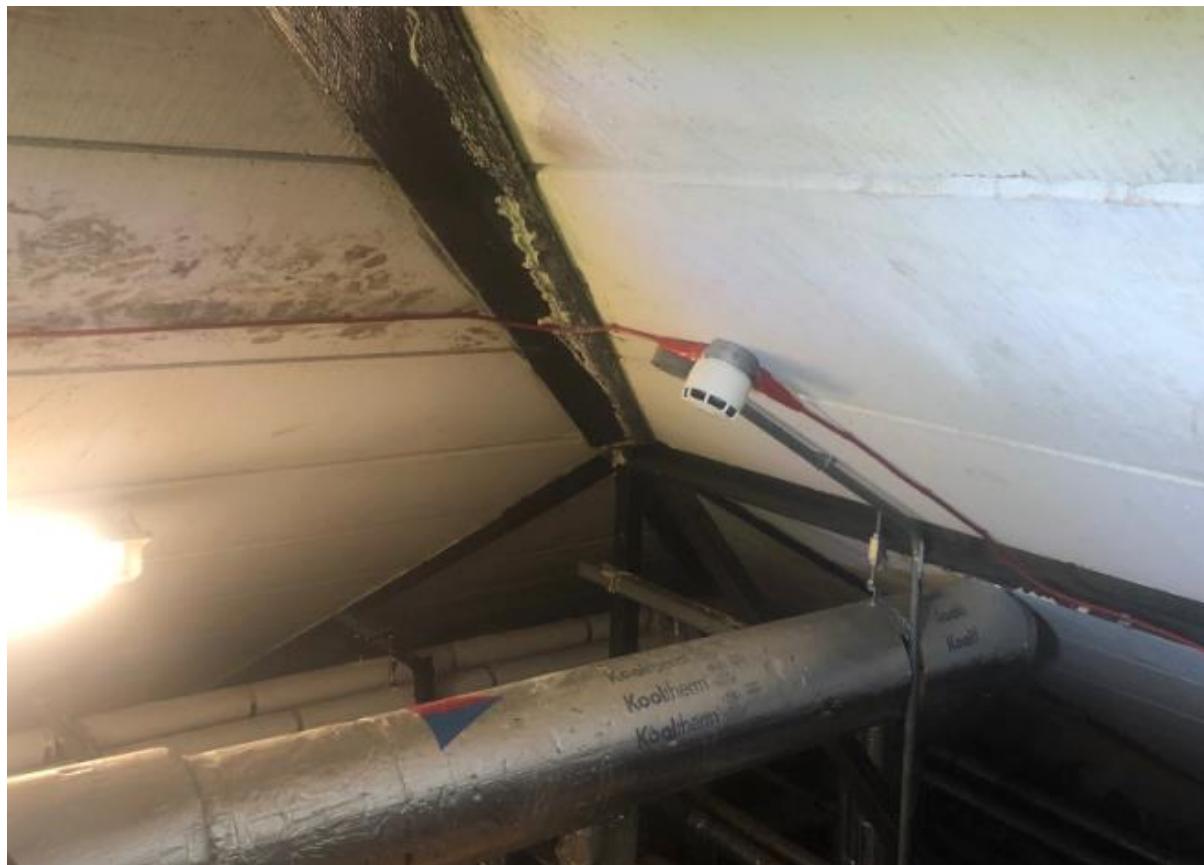
INTERNAL ROOF SPACE IN PHASE 4

The roof in this area is pitched in all areas and finished with tiles. AJP were able to readily access the roof space and assess each RAAC unit without hindrance. The apparent signs of deterioration were very limited, none giving rise for concern. It is important to note that the tiled roof and associated waterproofing have failed in several key areas as follows:

- Head of main access stair
- Above the medical records store
- Above the disused mechanical plant to the West of the main access stair

It is recommended that these leaks are repaired as a matter of urgency to prevent water related damage.
