BASSETLAW HOSPITAL, PHASE 1

STRUCTURAL INSPECTION REPORT

22nd October 2021

RAAC PLANK INSPECTION

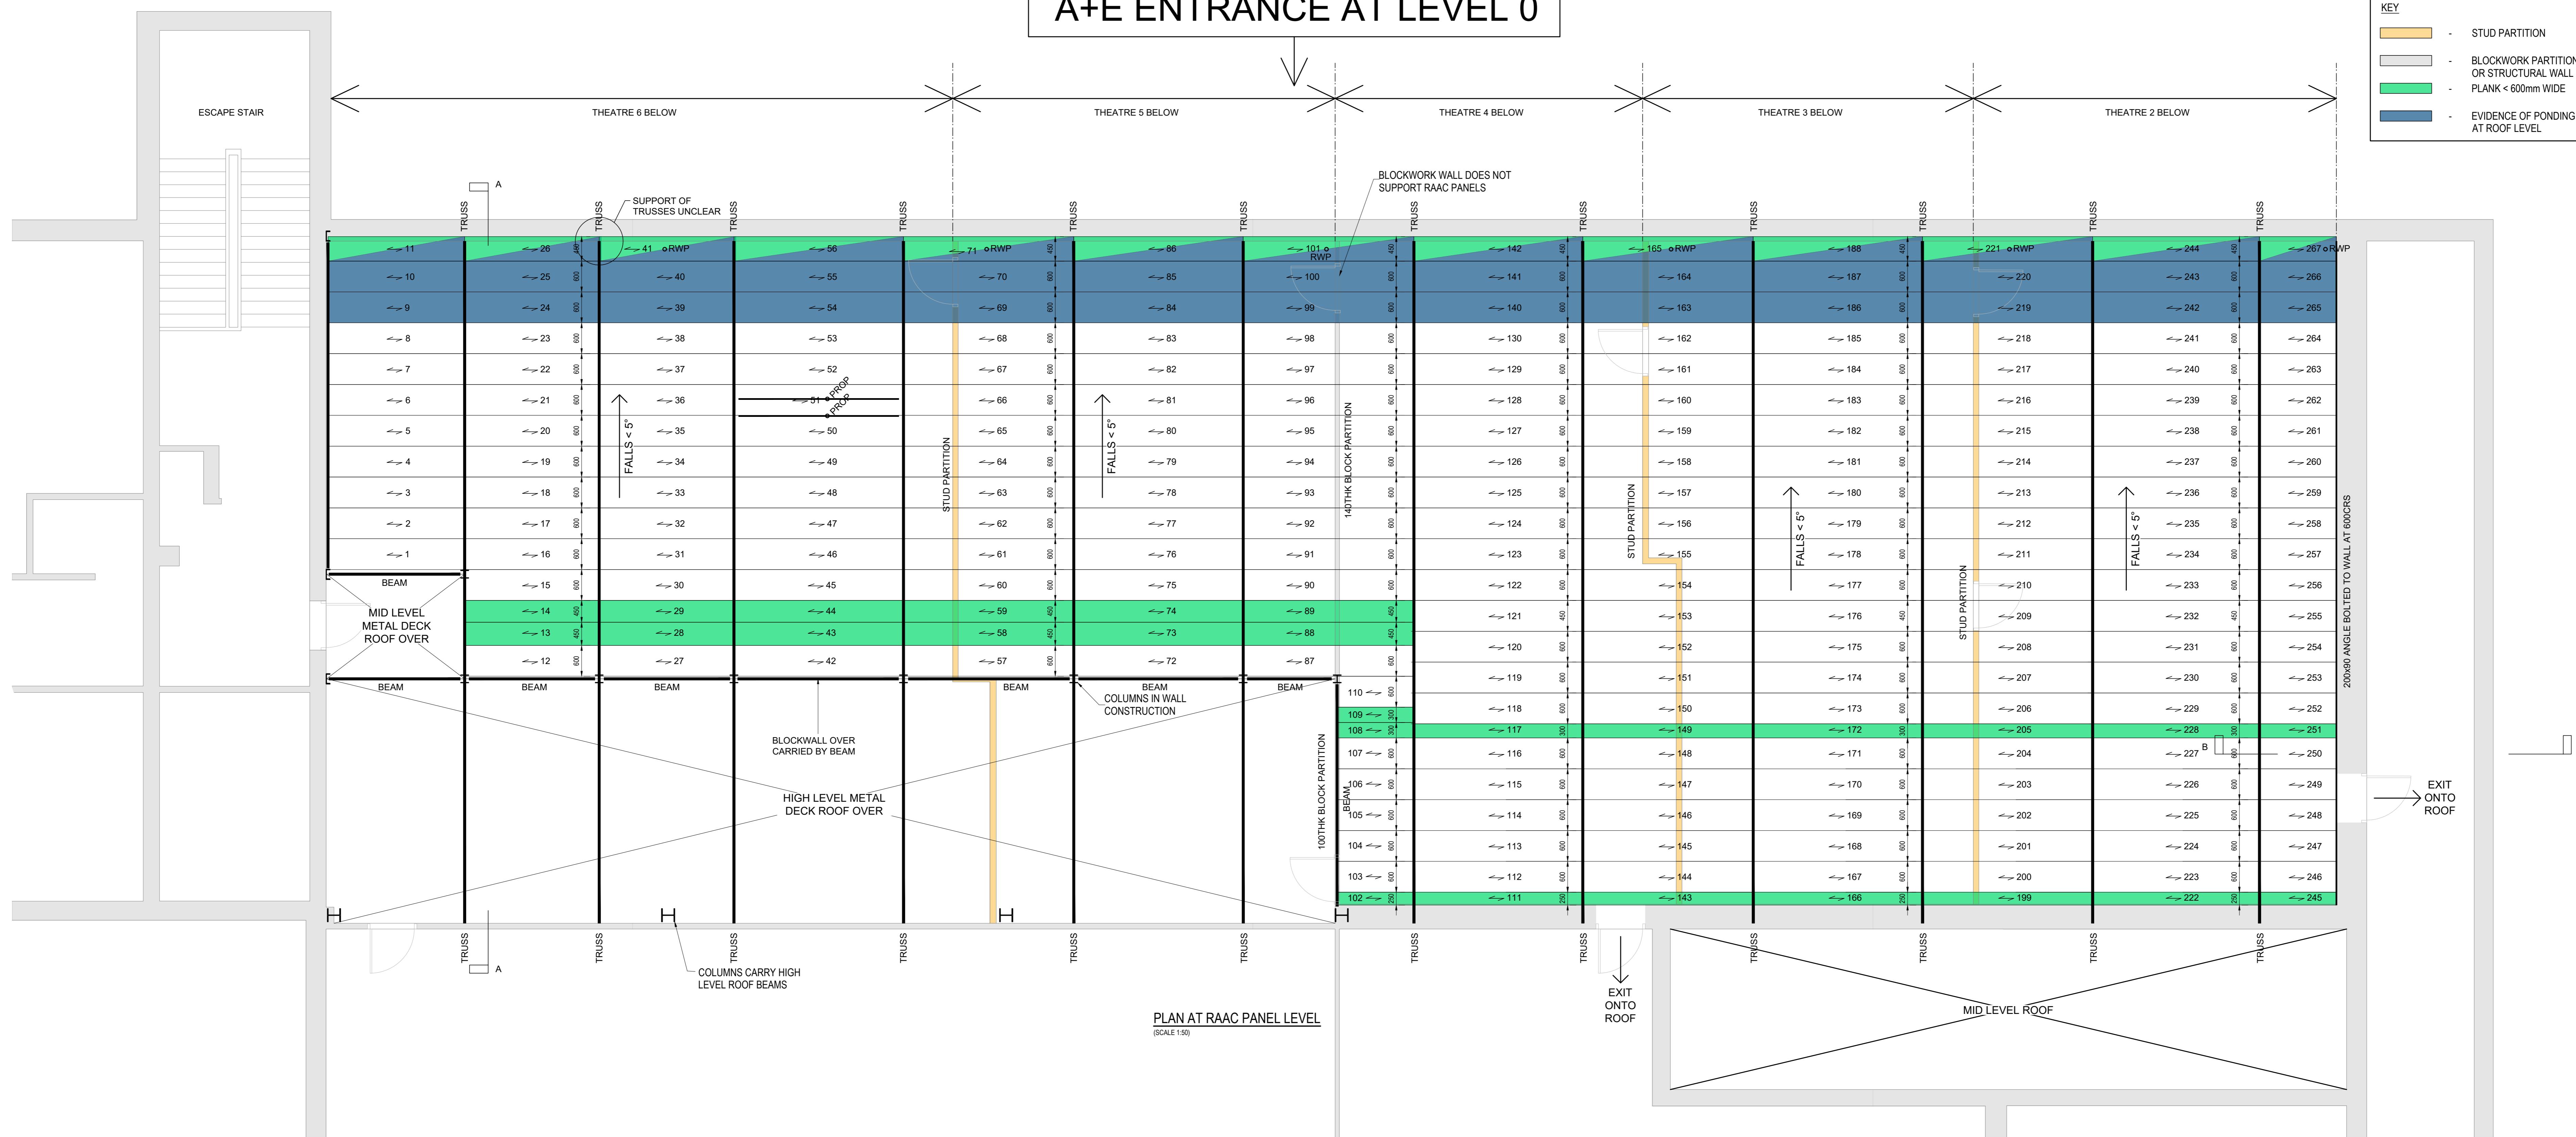
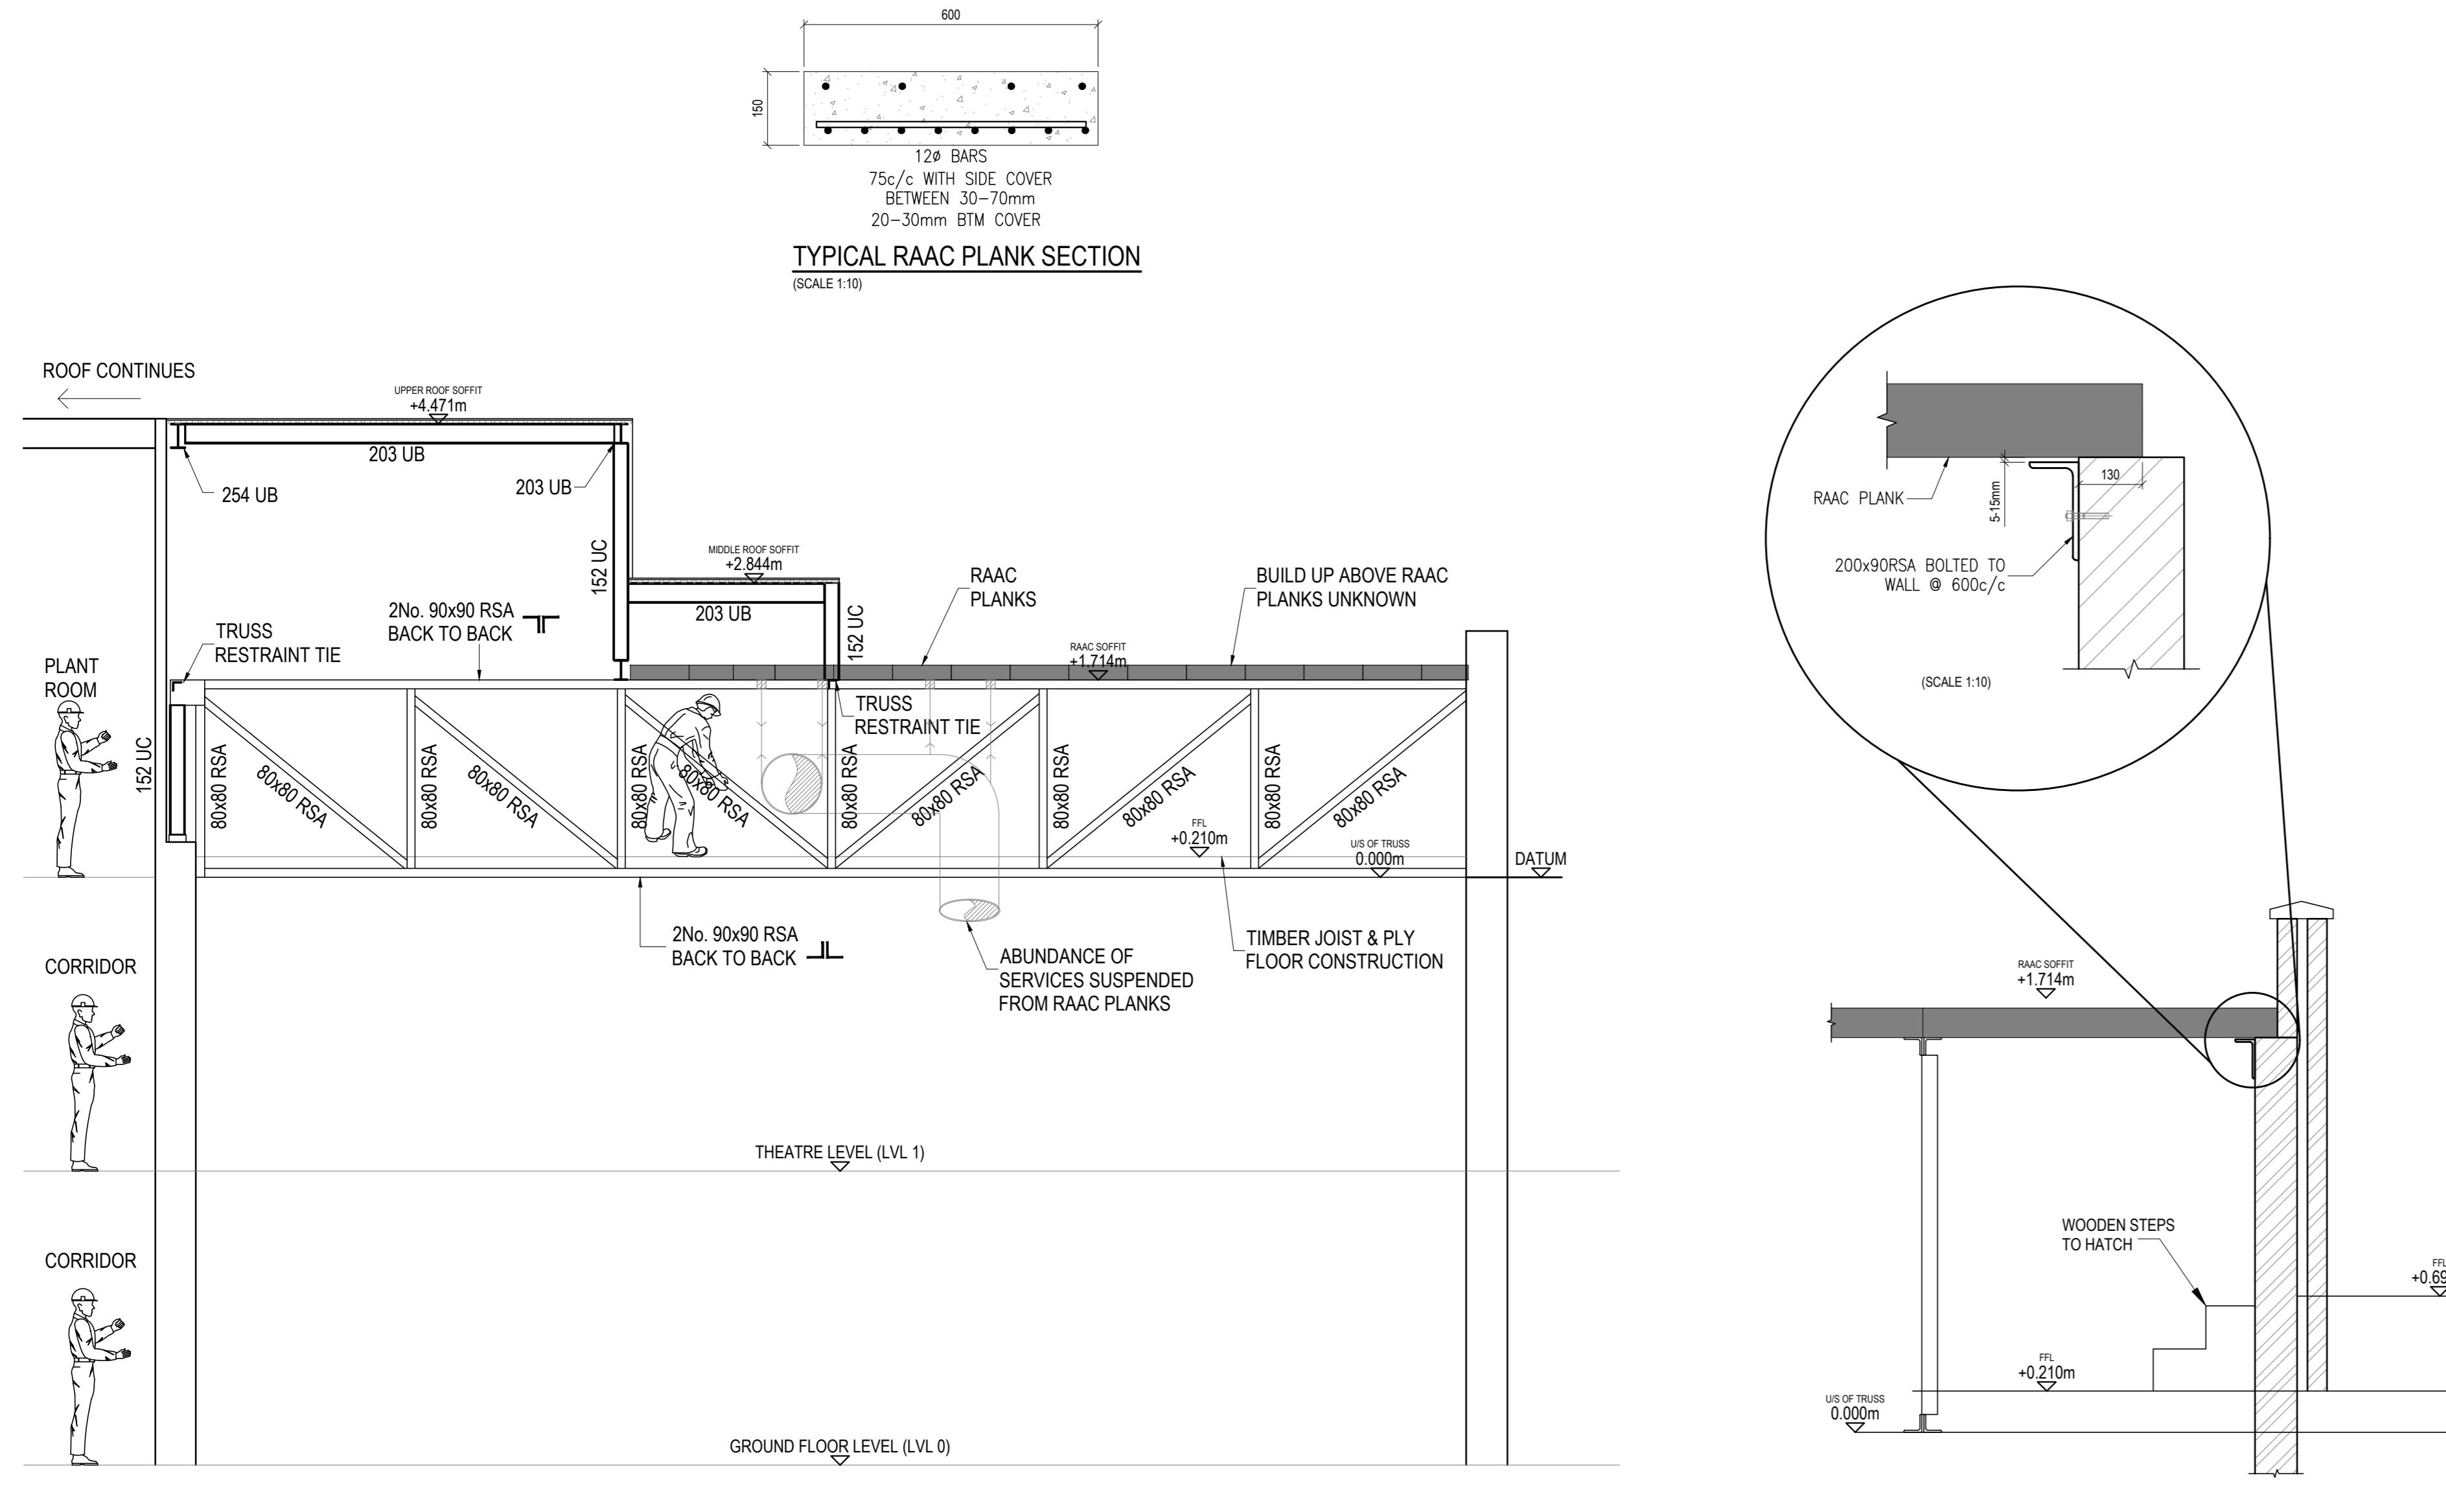
Appendix A – AJP drg BLH-AJP-ZZ-RF-DR-S-0001, overall layout of the building showing RAAC planks

Refer to AJP drg BLH-AJP-ZZ-RF-DR_S-0001 in the appendix. 267 no. RAAC planks were identified in the building generally measuring 600mm in width, and 6" (152mm) in depth based on site measurements. A small number of planks were measured between 250mm and 450mm in width. Although several planks were partially obscured by ducts and services, AJP were able to uniquely identify each plank within the roof void. The external roof condition was inspected from above; build-up over the planks is likely to contain insulation topped with waterproof finishes.
