Structural Appraisal Report for RAAC Roof Planks at Haywood Hospital, Stoke-On-Trent

Prepared for Midlands Partnership NHS Foundation Trust

28/01/2020

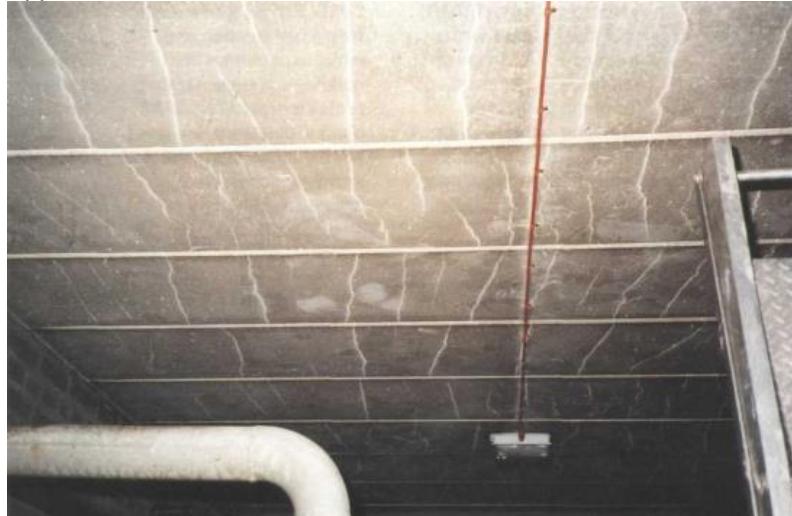
- Hair line cracking to the soffits of the planks, an example of this is shown in Figure 1. Specifically, near to the supports.

Figure 1 Hairline cracking to soffit of planks

If any of the above are observed, then we would recommend an assessment is carried out by a structural engineer.

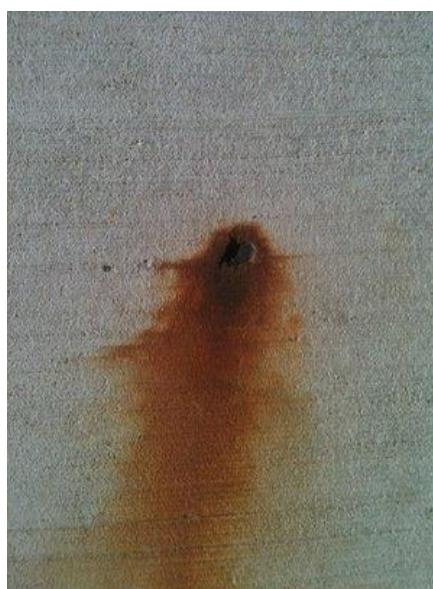
Figure 2 Example of rust staining

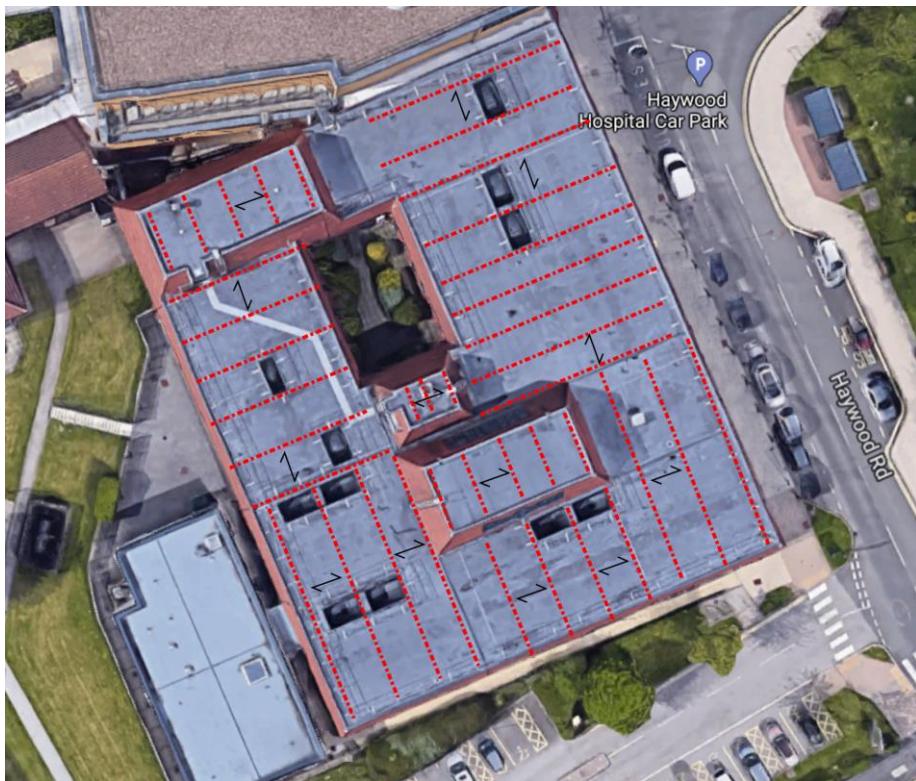
- All roof access should be limited to light maintenance and be limited to point loads of 0.9kN (roughly 90kg) per plank.
- There should never be more than one person on a single plank. This is approximately 4x1m in the span direction of the plank. The below Figure 3 shows the assumed configuration of the structural arrangement supporting the roof. (This would be required to be confirmed before access is permitted so that not to overload a single planks).

Figure 3 Assumed Structural Arrangement

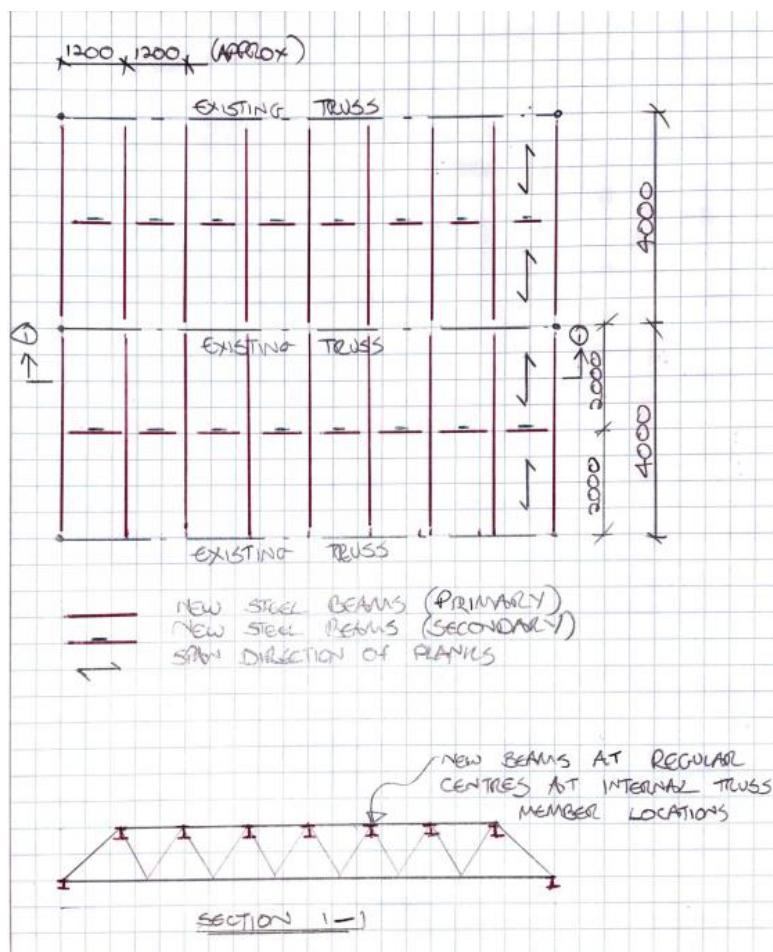
Figure 4 Option 1

This could be achieved by installing a new arrangement of steel beams supported off the existing steel structure as indicated in the below Figure 4.

Regular primary beams, which are set out to suit the intersection of internal truss members, and span between existing trusses and then provide support the new secondary beams located at mid span of the roof planks.

For this option 178x102UBs would required for the primary beams and secondary beams, with the possibility of the secondary beams being reduced to a 120x120x12 angle.

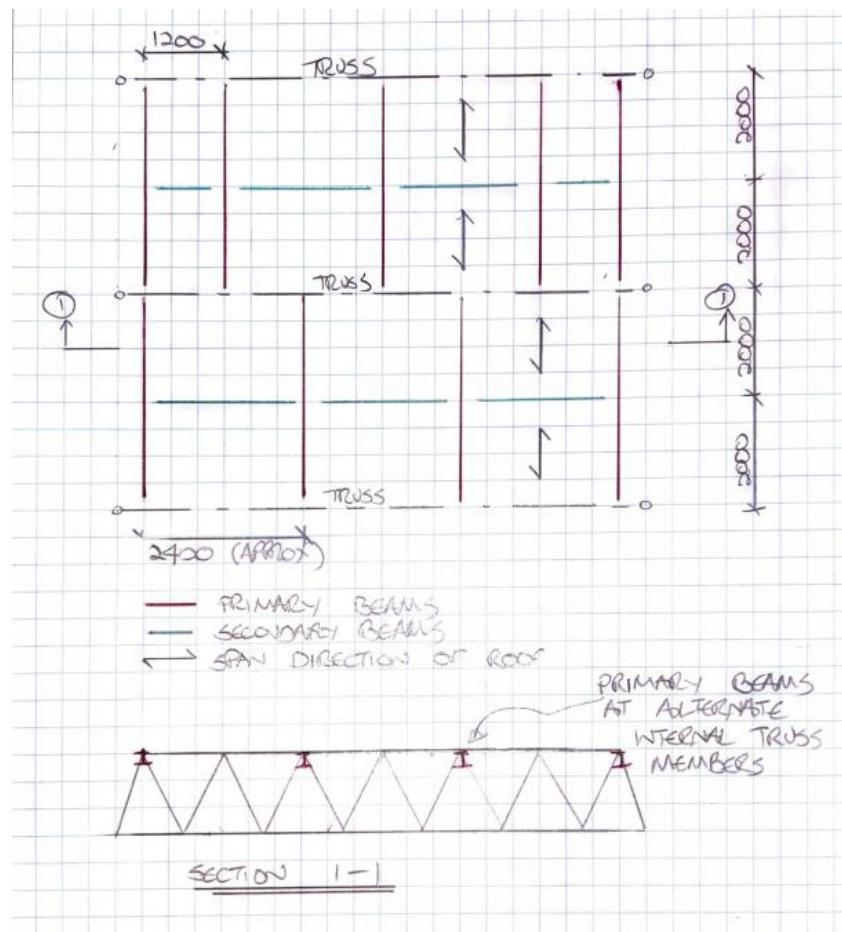
Figure 5 Alternative Option 1

An alternative method could be to utilise a "hit and miss," approach that alternates the locations of the incoming primary beams to the existing trusses. Which would utilise longer span secondary beams. This is shown in Figure 5.

The alternative option would reduce the number of beams required; however, this arrangement would be dependent on the existing arrangement and may not be suitable across the whole structure.

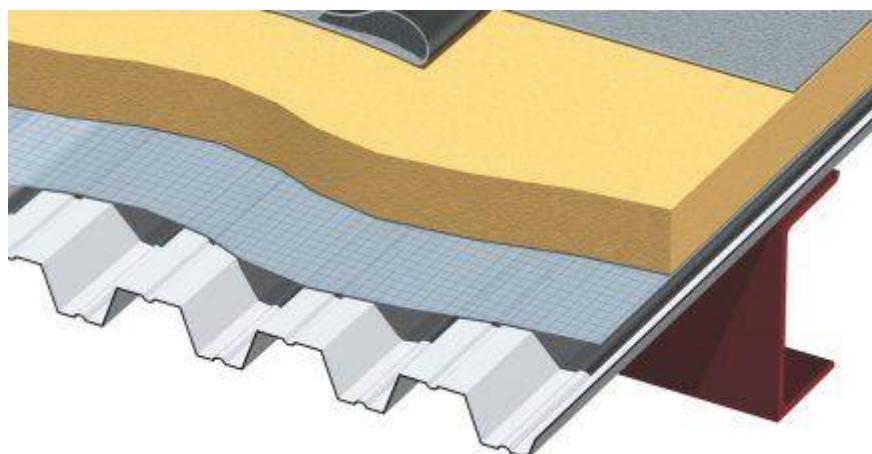
Figure 6 Typical TATA RoofDek build-up

This could be achieved by installing a structural metal roof deck, such as TATA RoofDek, that would span between the existing steel structure. Figure 6, indicates a typical structural roof deck build up.

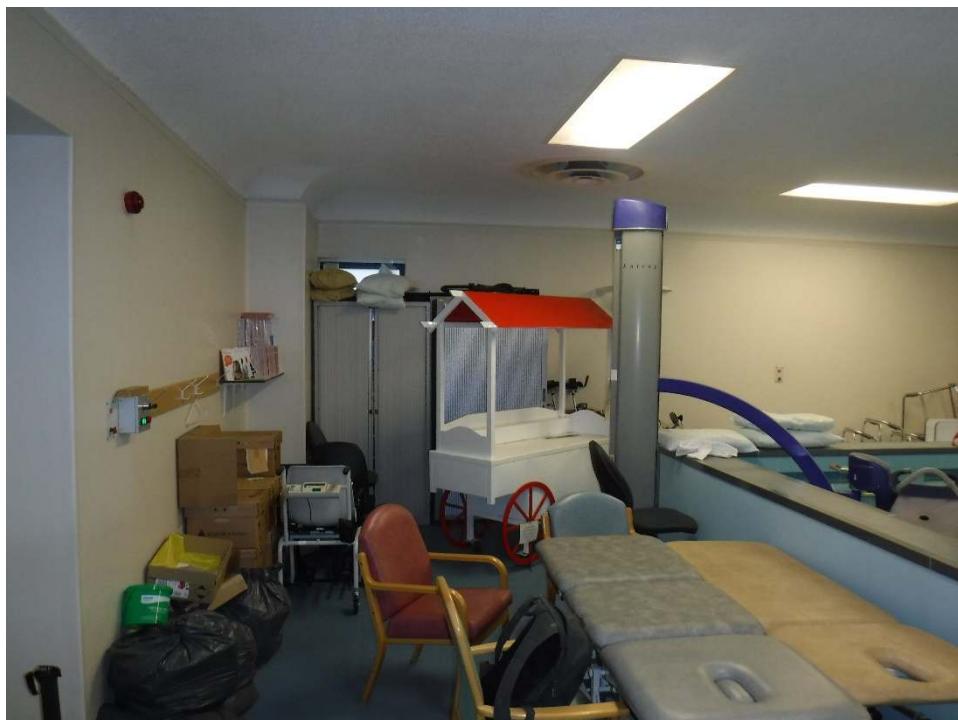
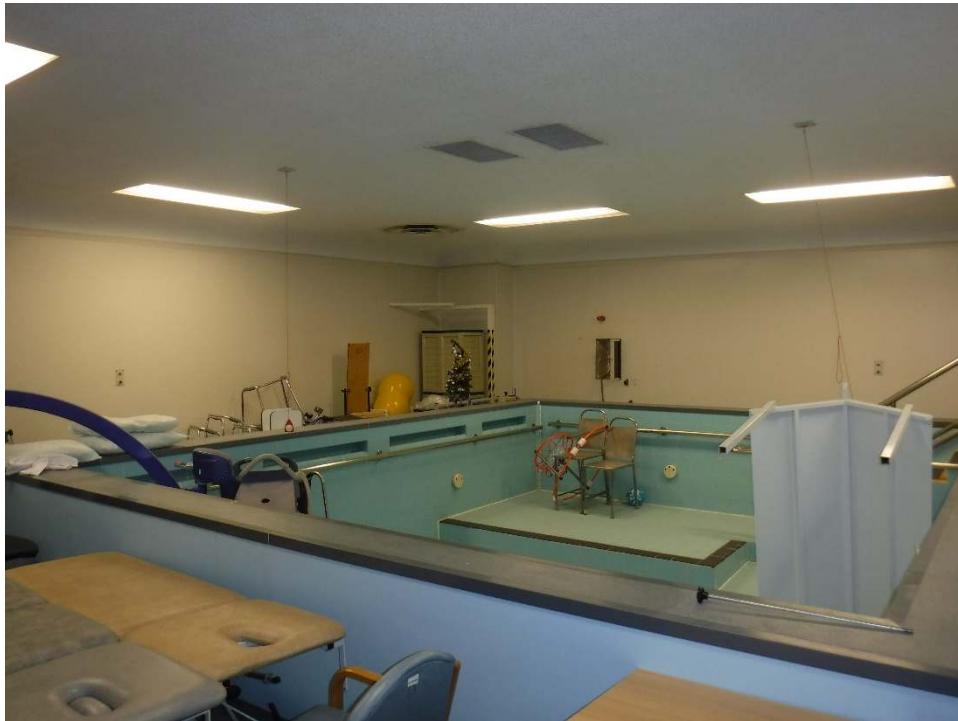
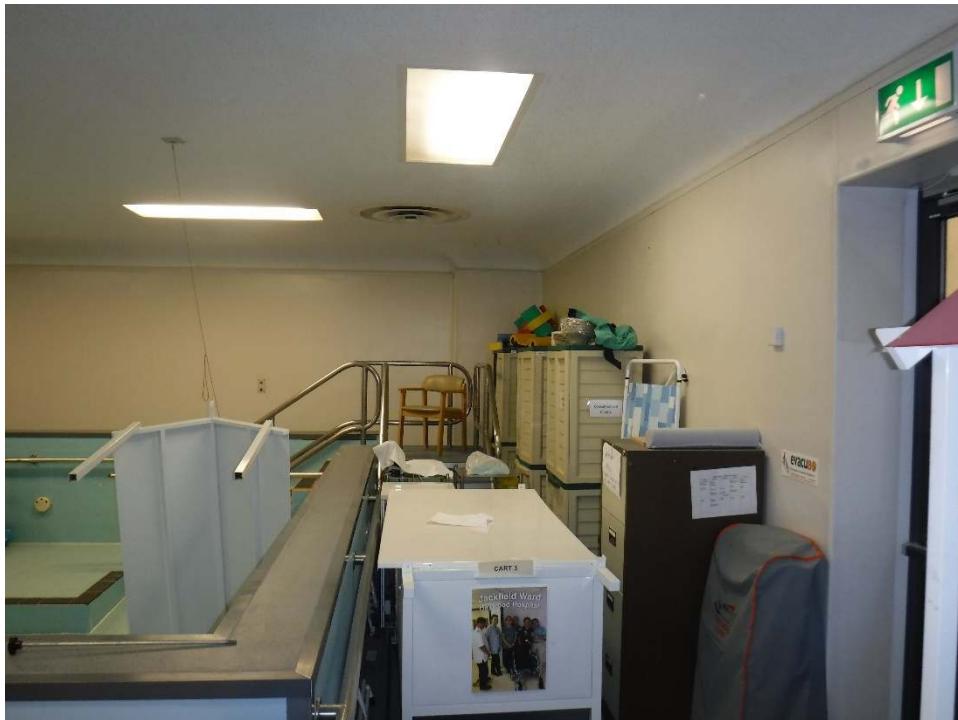
Photograph 001 – General view of Hydrotherapy room

Photograph 002 – General view of Hydrotherapy room

Photograph 003 – General view of Hydrotherapy room

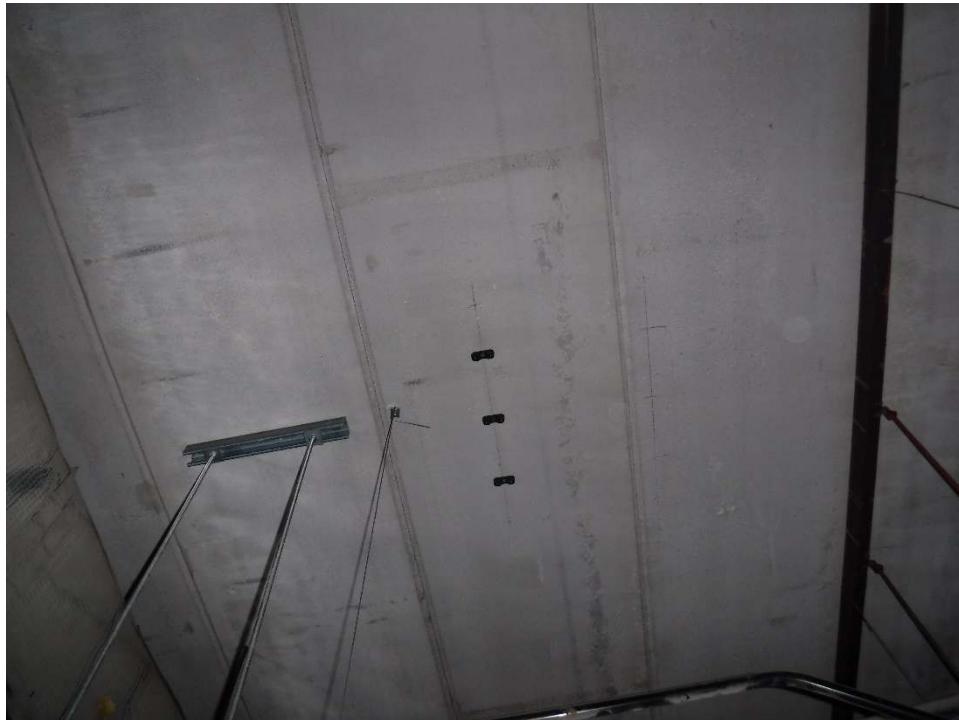
Directly above the Hydrotherapy room, a plant area between roof slab and soffit slab was located. The soffit of the plant area (below roof level) was constructed of RAAC planks.

Photograph 005 – General view to soffit above plant area

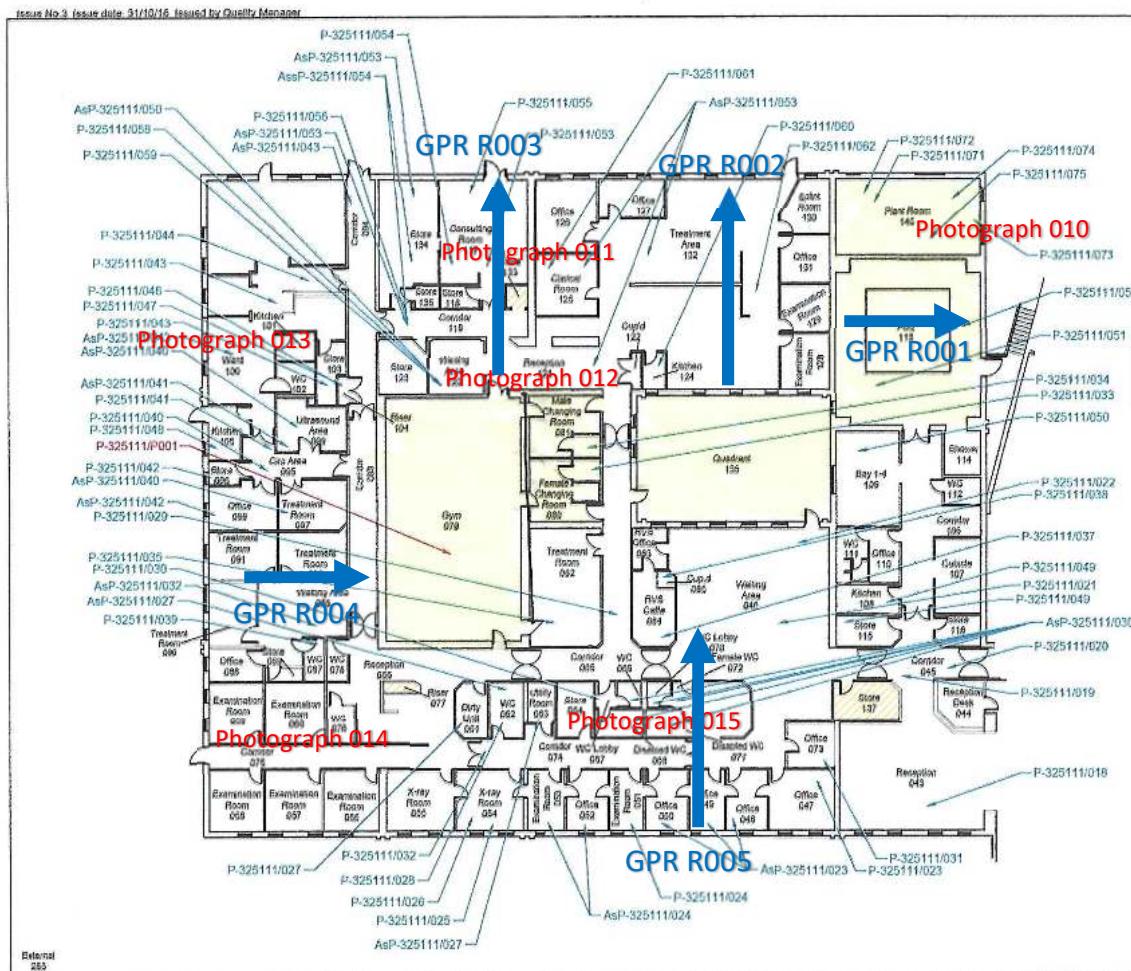
Figure 003 – Plan of building (areas scanned marked with direction). Span direction opposite to direction of scan.

The scans showed the orientation of the planks (opposite direction to the arrows on Figure 003 above).

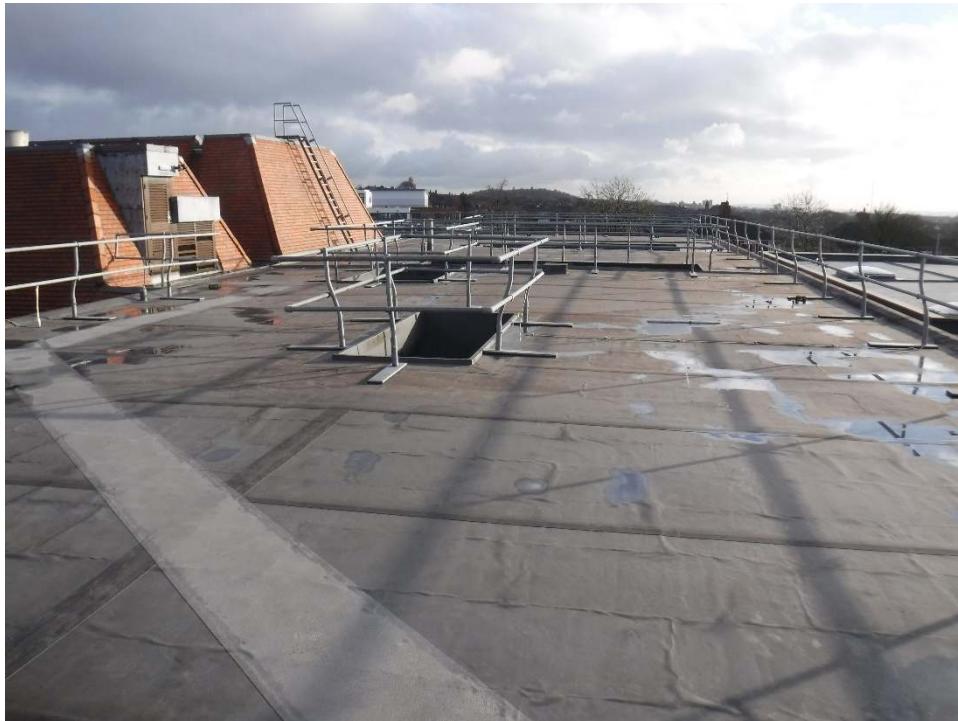
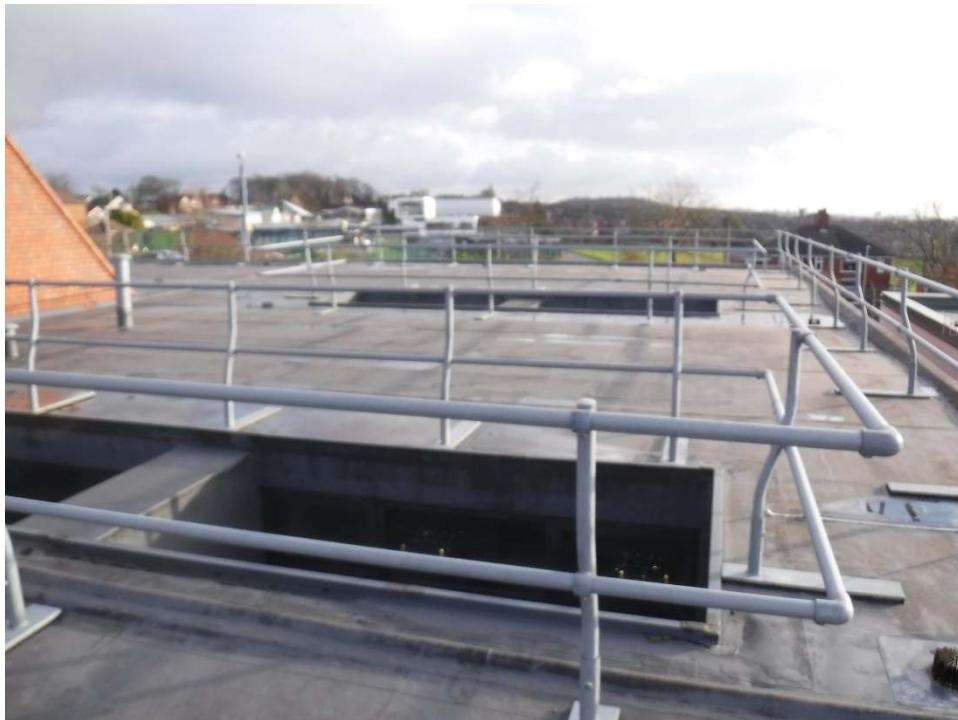
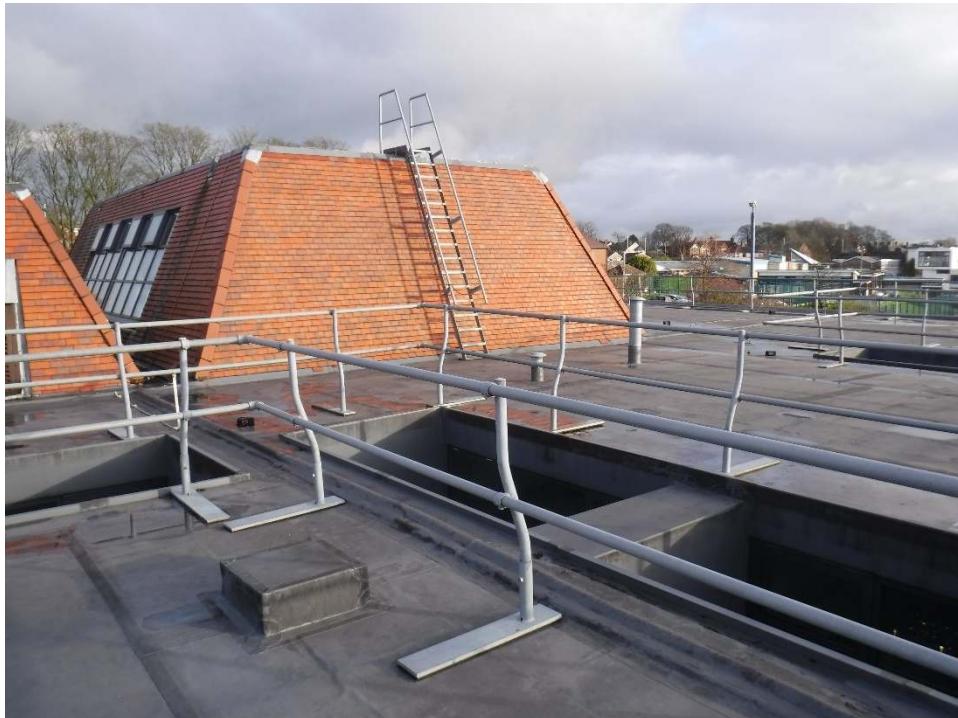
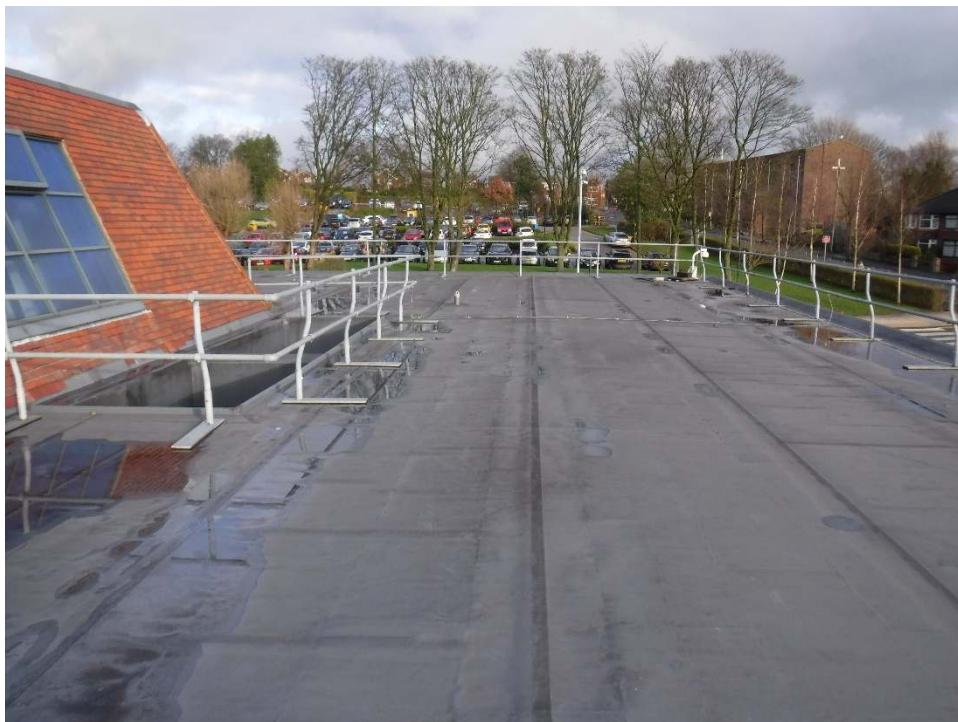
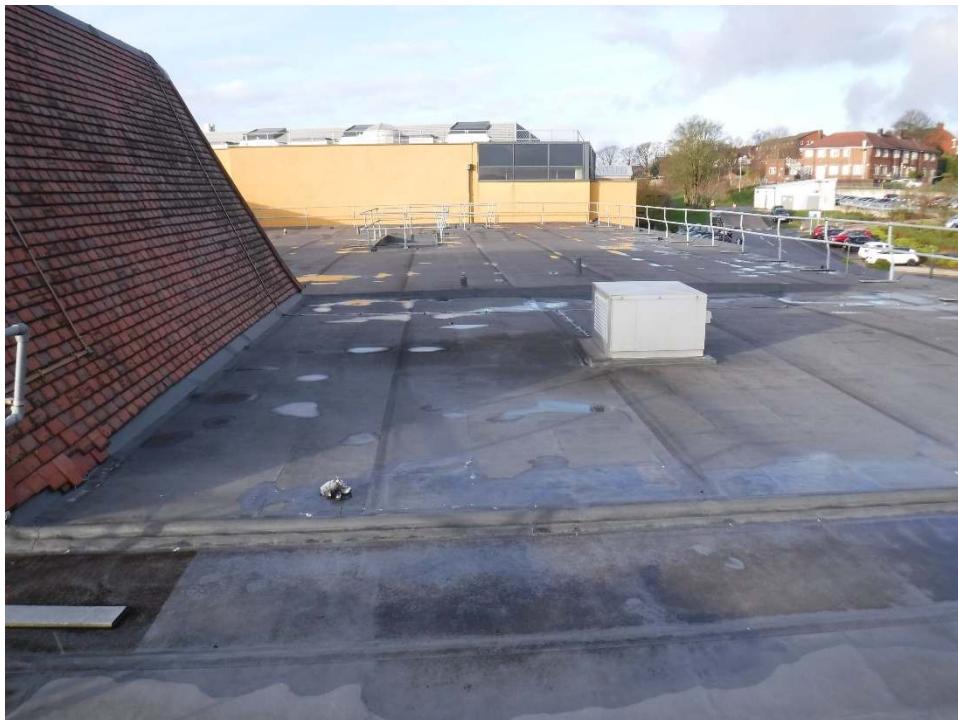
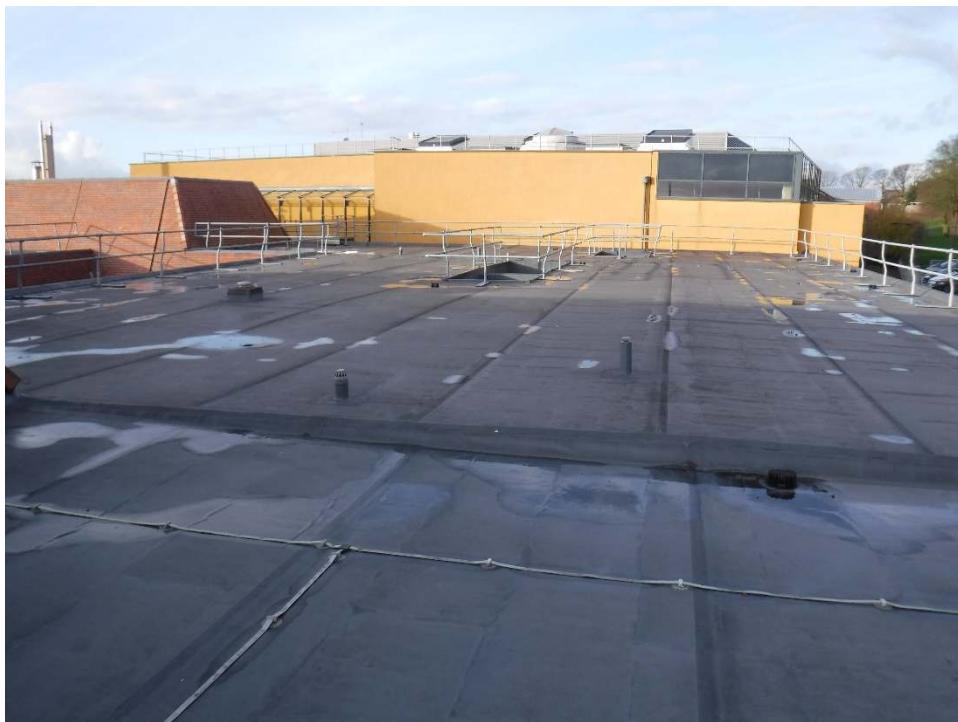
Photograph 010 – General view over roof

The GPR scans from above showed evidence of uniform construction with the findings from the RAAC planks below.
